Impacts to Structures, Concrete Erosion, and Inspection

Tappan, Leesville, Piedmont and Clendening Dams - Ohio

Thomas Plummer

July 30, 2002

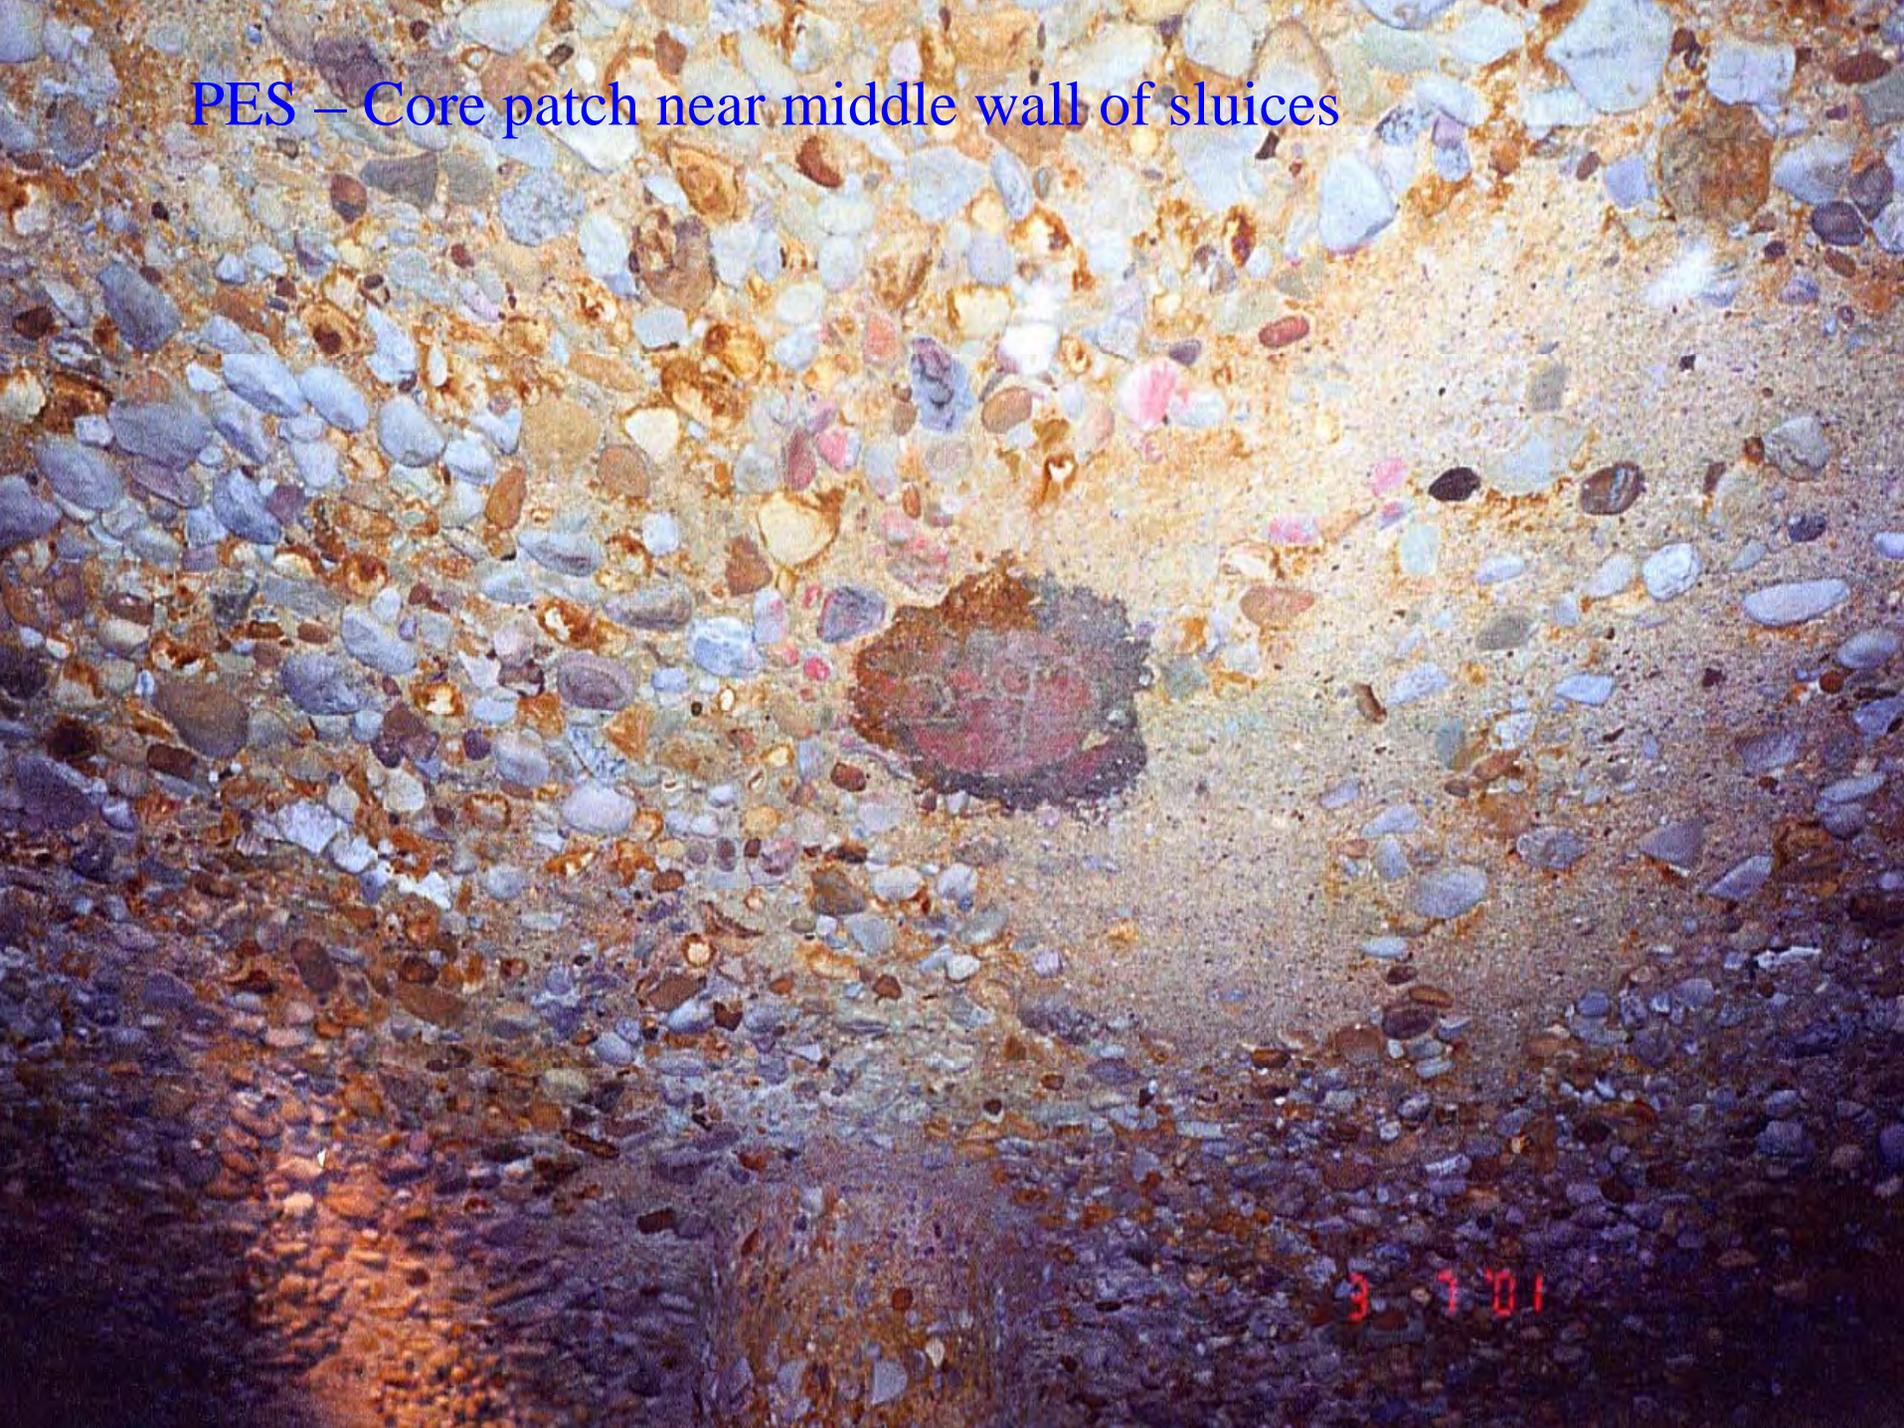
PES – Core patch near middle wall of sluices

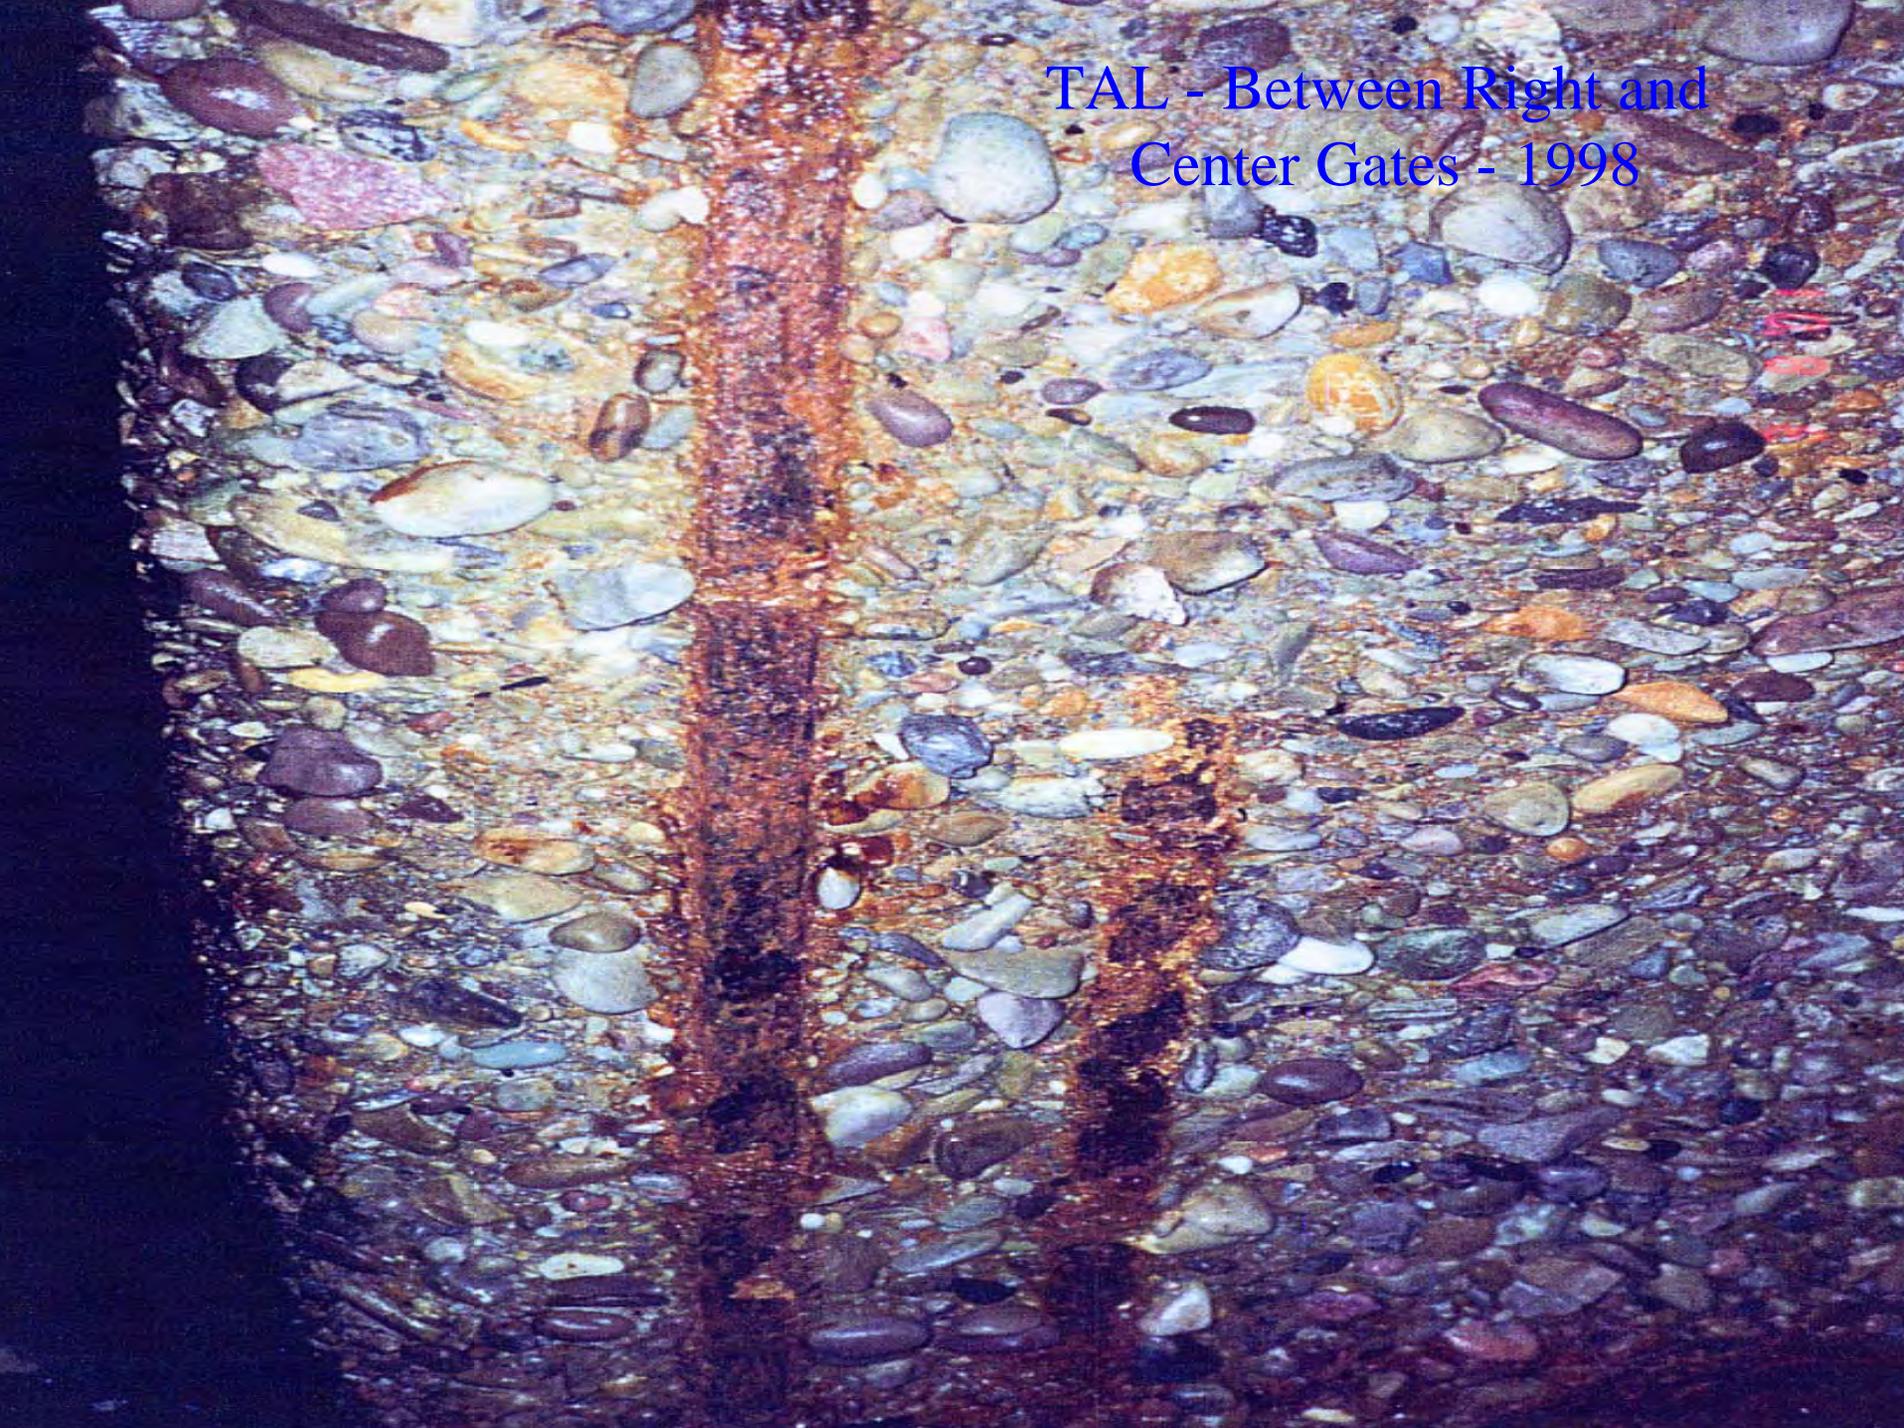
TAL - Between Right and
Center Gates - 1998

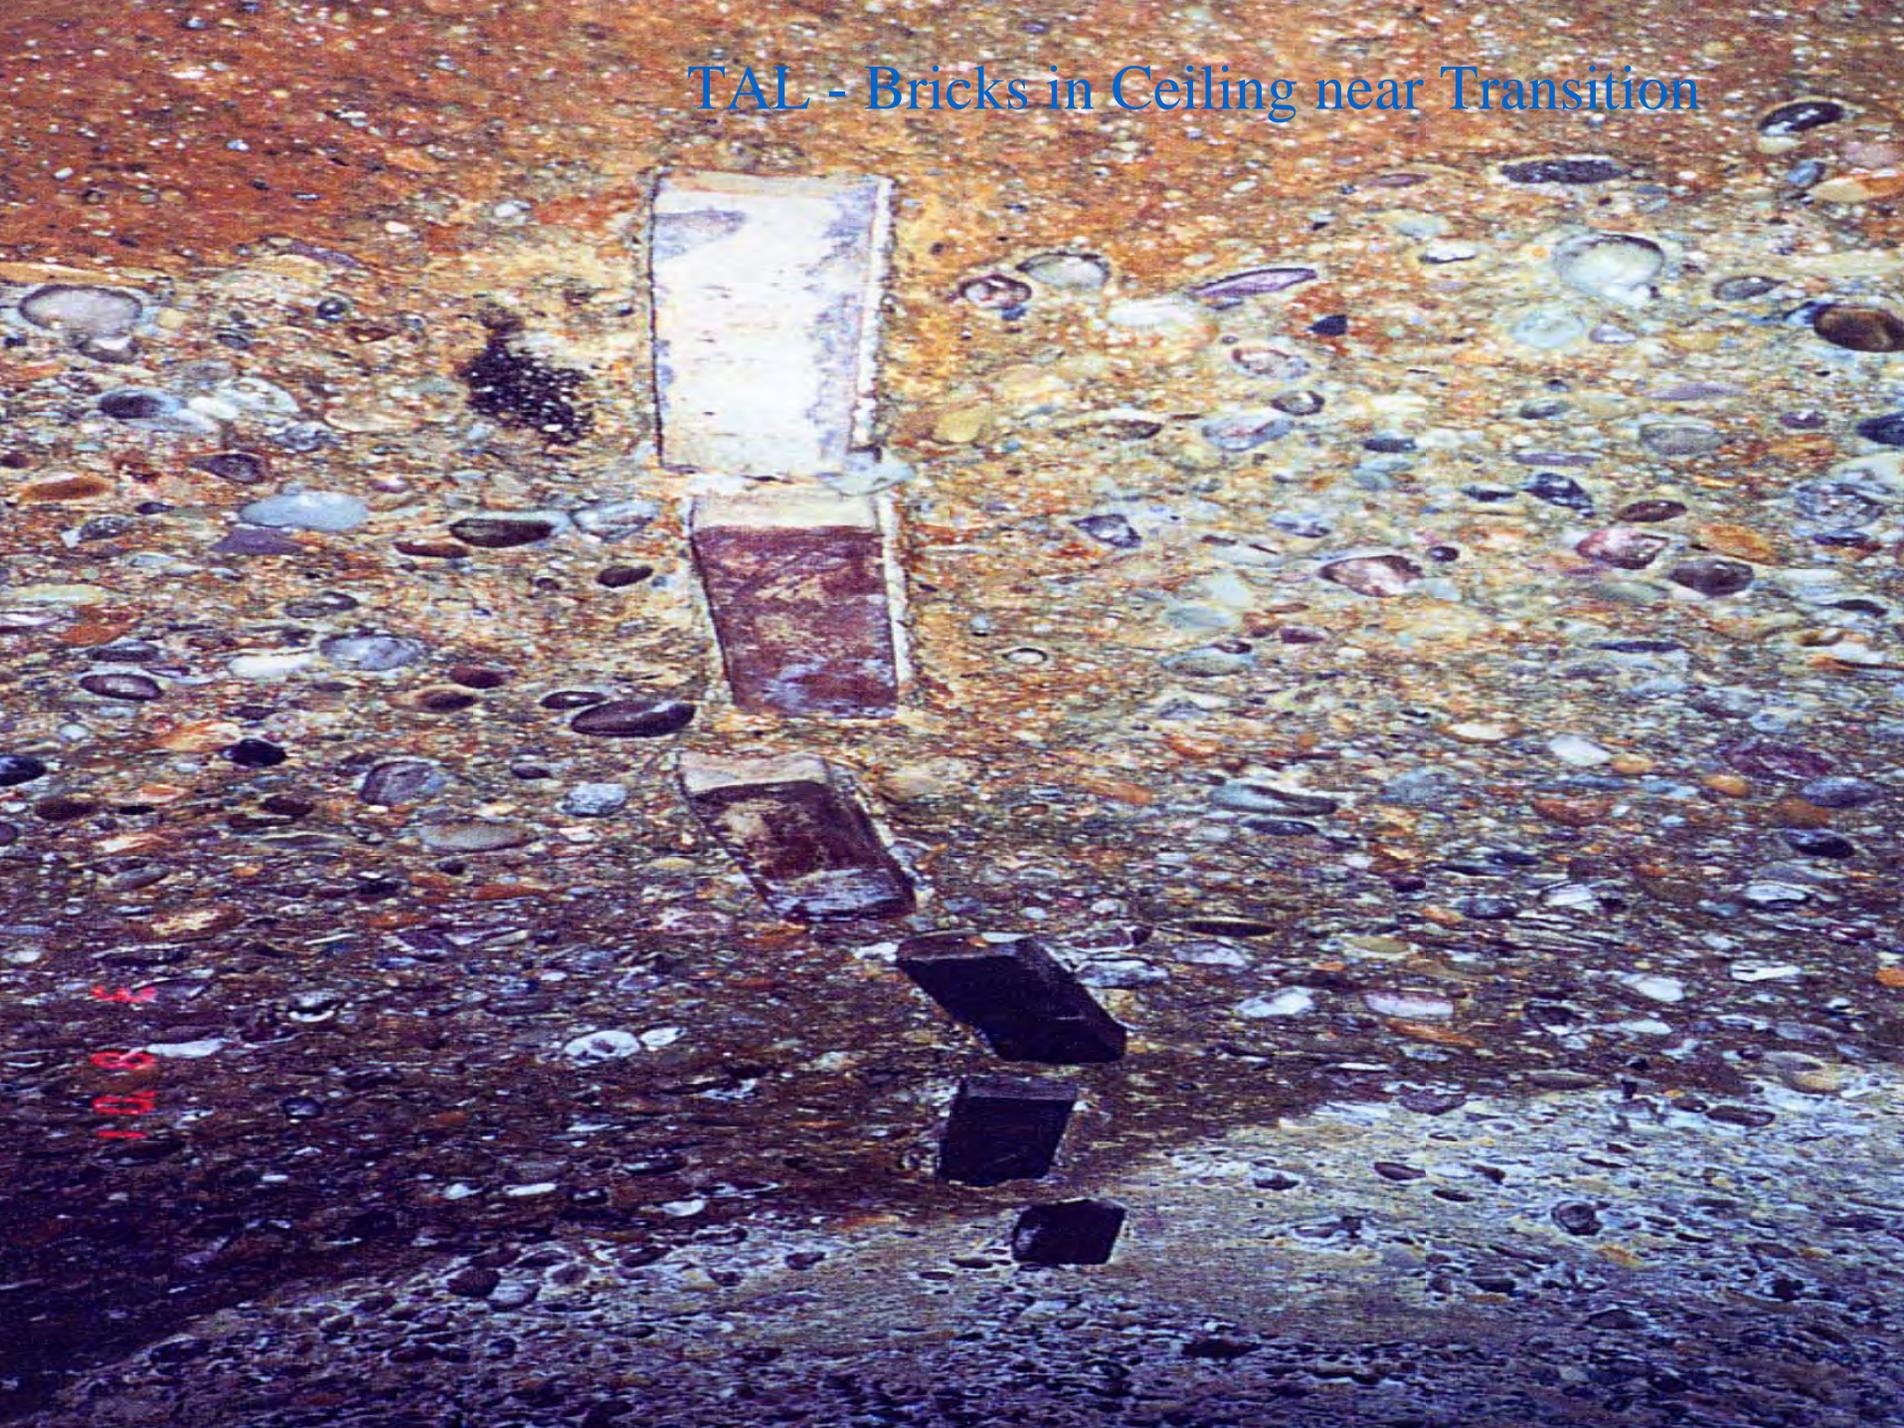
TAL - Bricks in Ceiling near Transition
