Miscellaneous Paper W-93-1
August 1993

Proceedings, U.S. Army Corps of Engineers Workshop on Reservoir Shoreline Erosion: A National Problem

**26-30 October 1992
McAlester, OK**

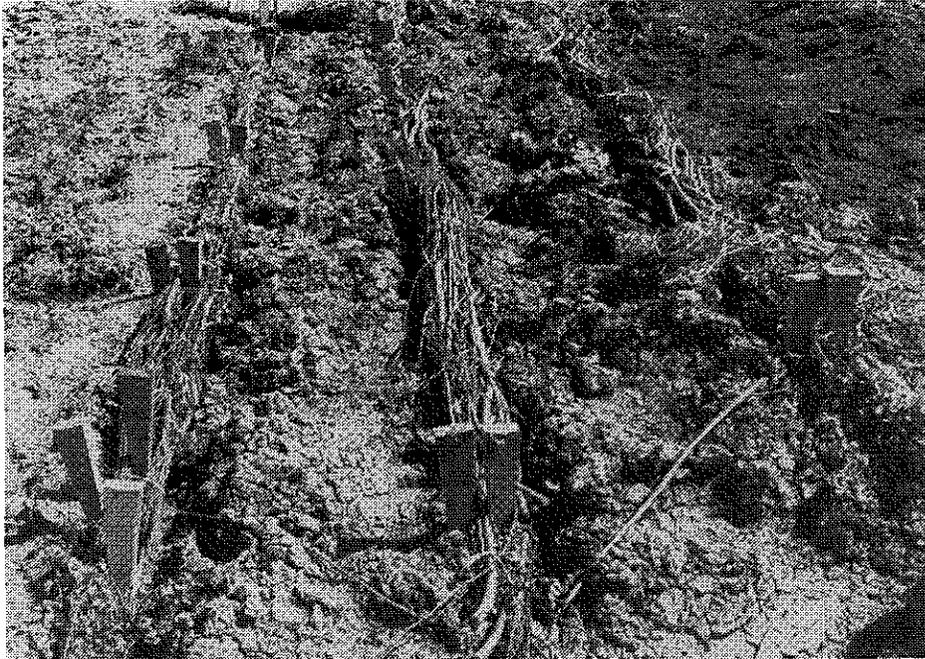
Figure 3. Baker Bay project site, horizontal wattles before initial inundation

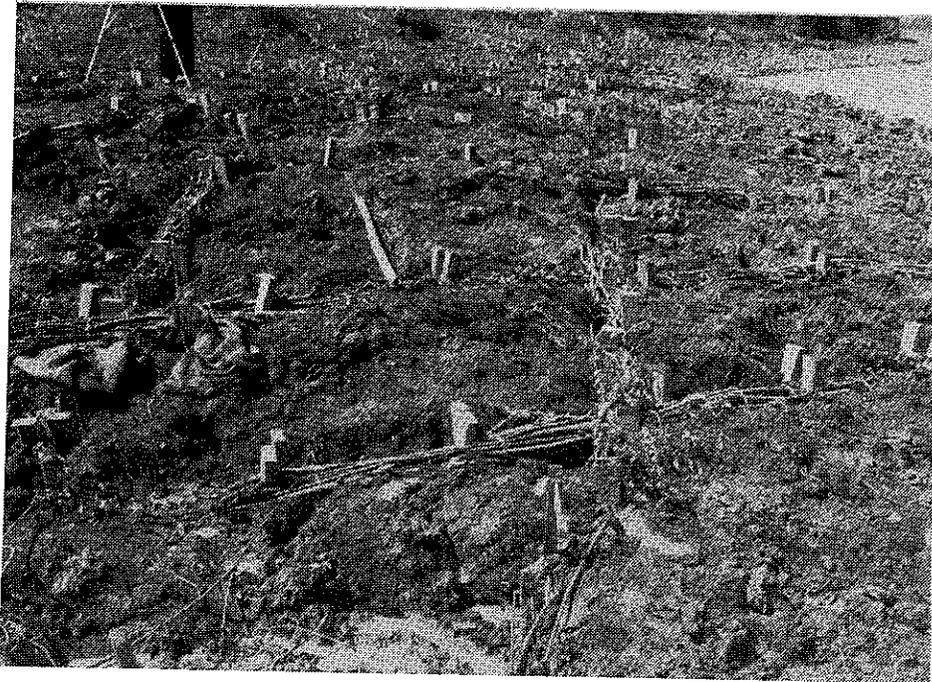
Figure 6. Baker Bay project site, diagonal wattles before inundation

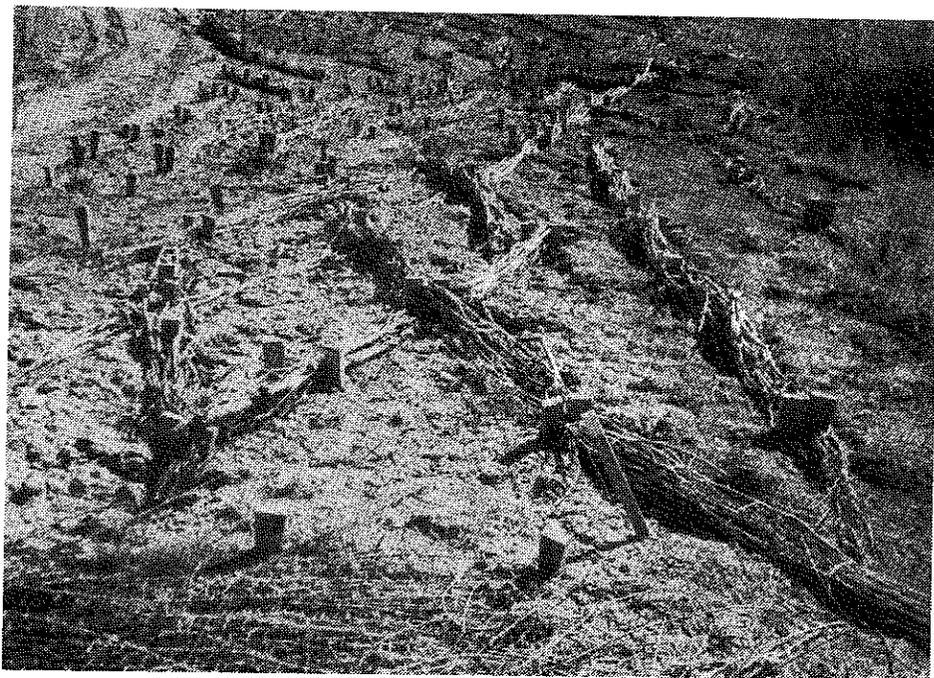
Figure 7. Baker Bay project site, diagonal wattles after two inundations

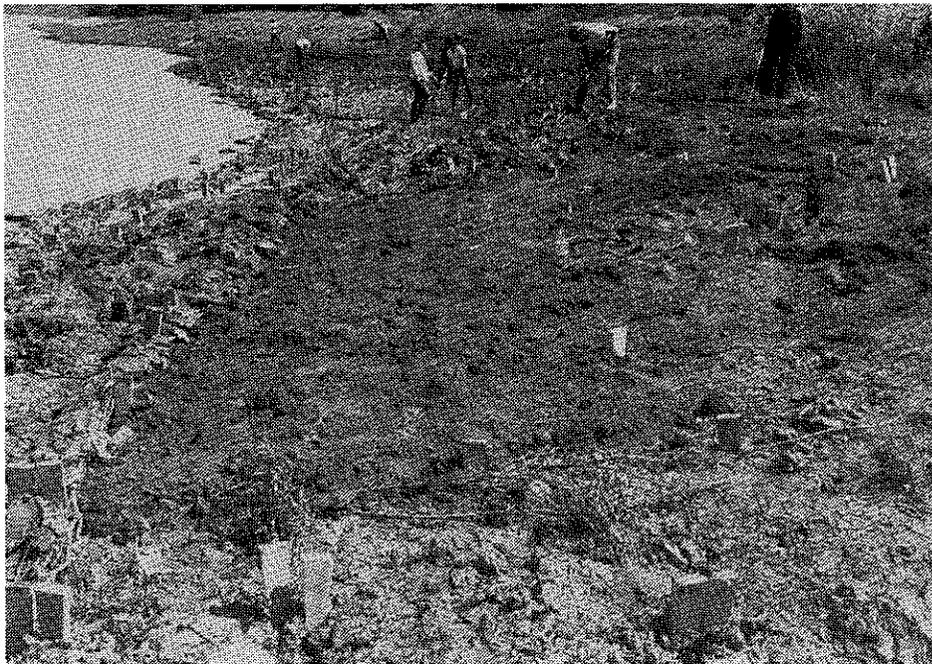
Figure 11. Baker Bay project site, willow matting before inundation.
Note mat covered by soil

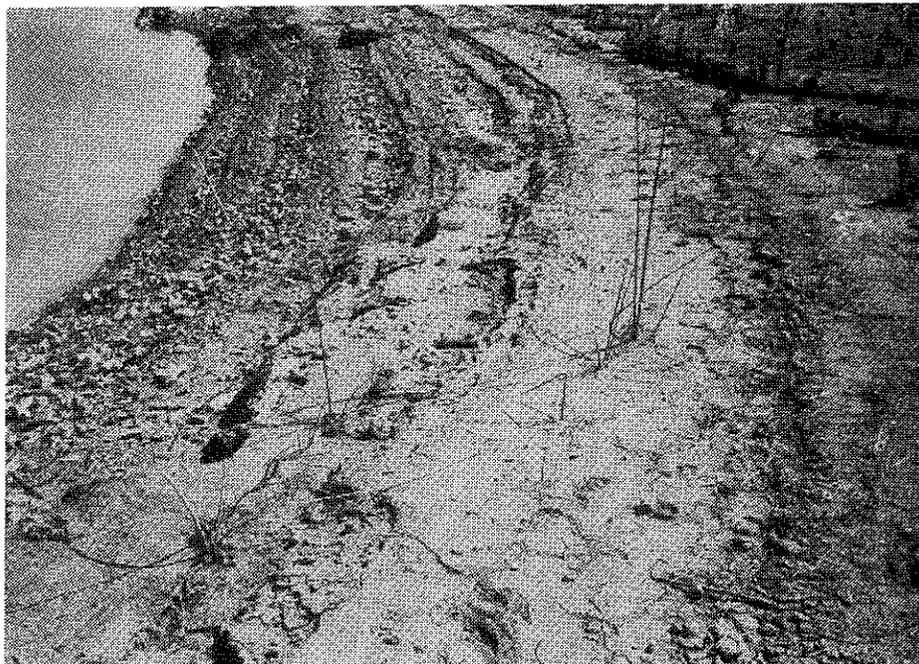
Figure 15. Dorena Reservoir, bulrush vigor after first inundation.
Note that plant rolls are buried

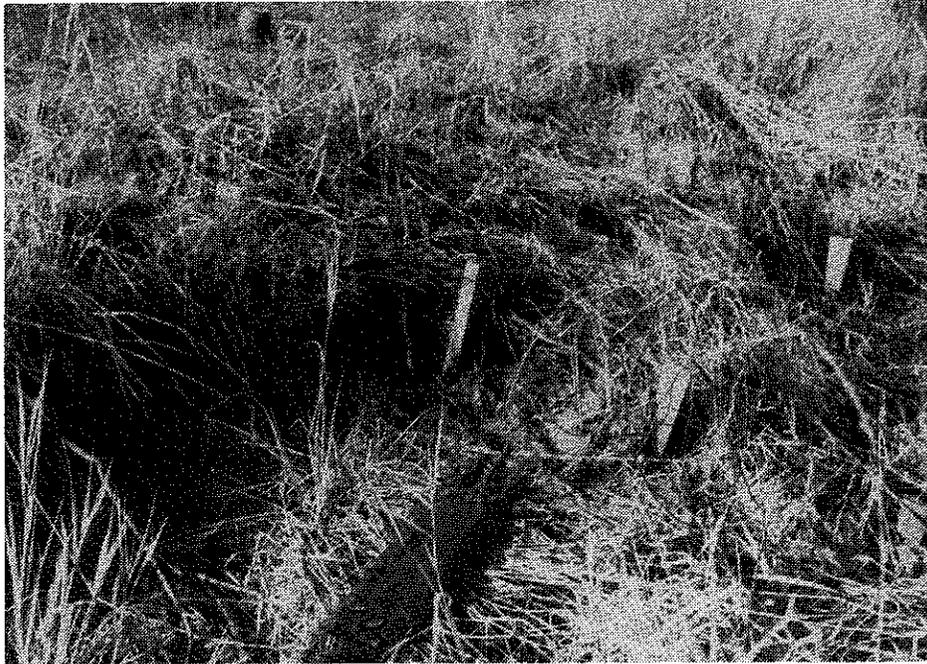
Figure 23. Baker Bay project site escarpment reformation in left foreground (horizontal wattling treatment) and no scarp behind center stake (matting treatment)

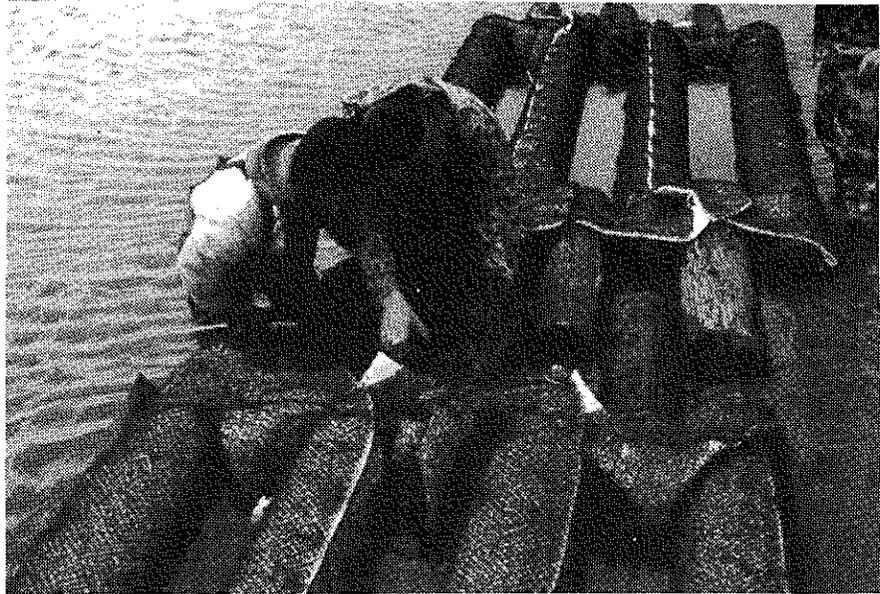
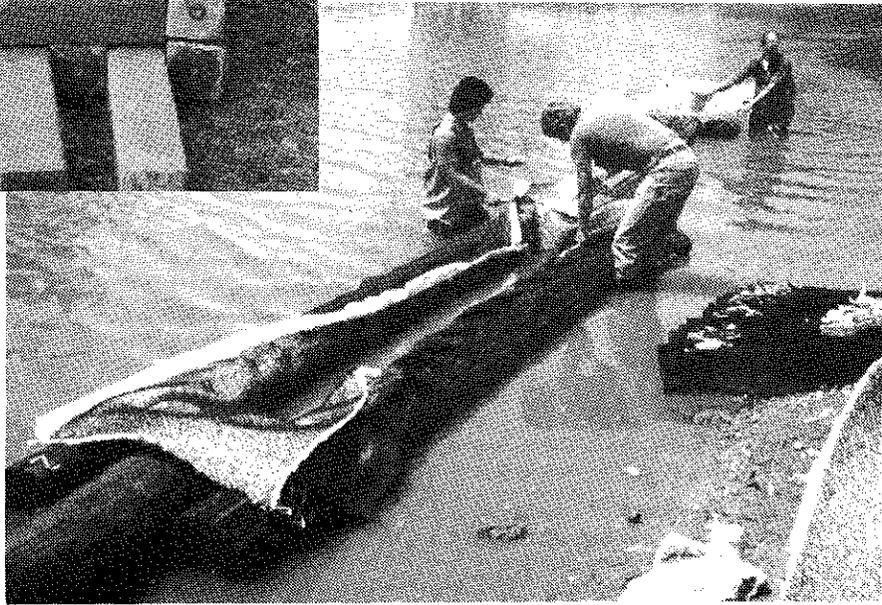
Figure 4. Three floating island designs
