ERDC TN-SWWRP-08-4
March 2008

The Use of Sand Fences in Barrier Island Restoration: Experience on the Louisiana Coast

By Syed M. Khalil

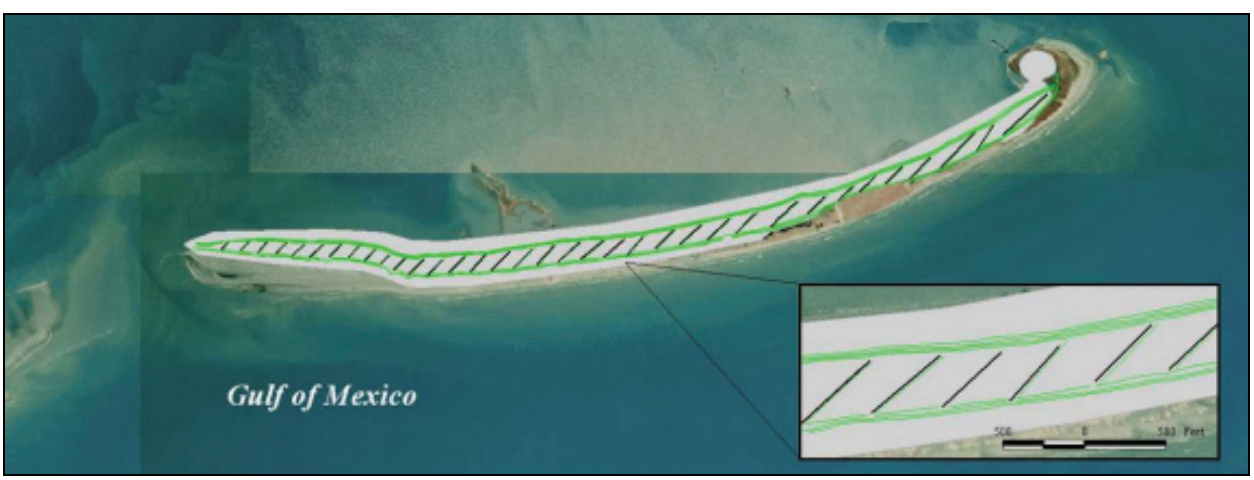
Figure 9. General orientation and pattern of sand fence (dark lines) in East Island.

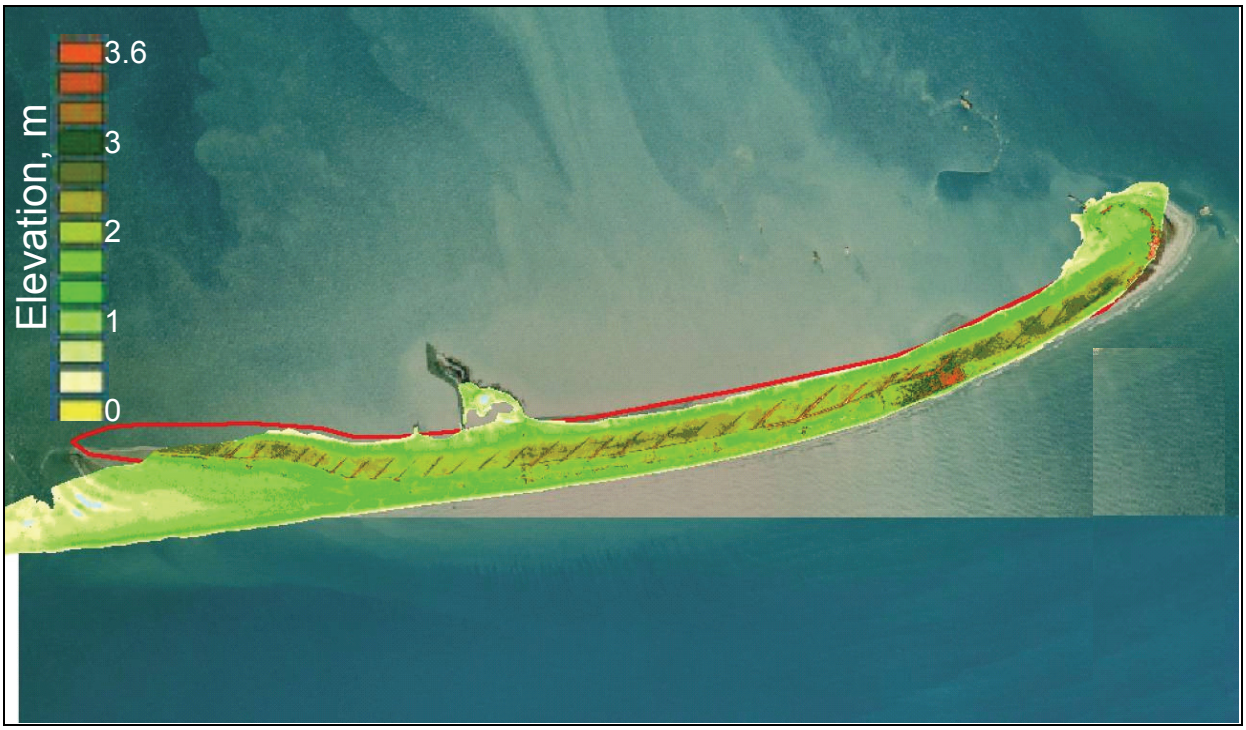
Formation of these dunes indicates the capability of sand fences in trapping and redistributing sand which otherwise would have been lost or eroded. LiDAR data showed an overall increase in the elevation of the island especially in the central portion where dunes were built by the fences (Figure 11).

Figure 11. LiDAR photograph indicating general elevation in East Island. Note central elevated portion with diagonal sand fences.
