PROTOTYPE EVALUATION OF SLUICEWAY AERATION SYSTEM LIBBY DAM, KOOTENAI RIVER, MONTANA

March 1984
Final Report

1. REPORT NUMBER	2. GOVT ACCESSION NO.	3. RECIPIENT'S CATALOG NUMBER
Technical Report HL-84-2

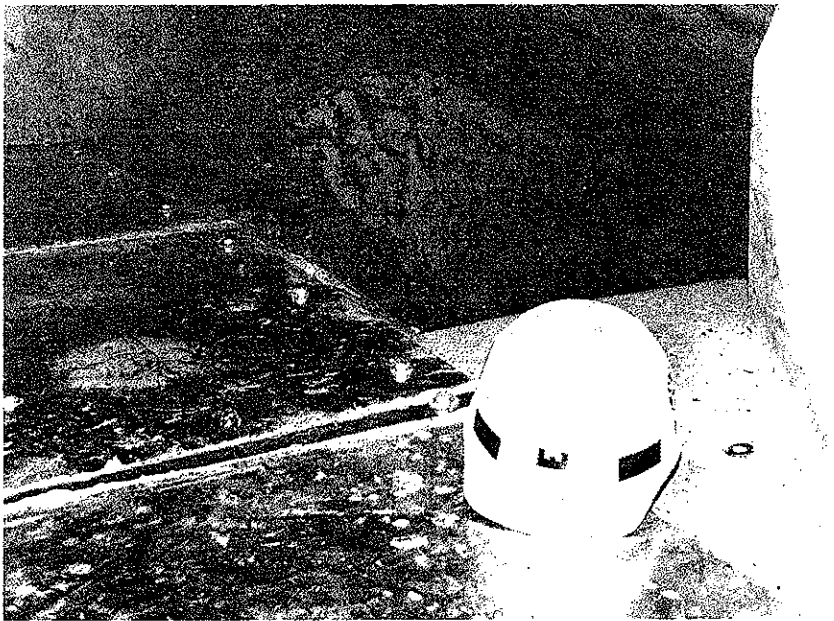
Figure 5.   Upper portion of air vent to center sluice

vent geometry. The existing center sluice routing was made independent by directly connecting the crossover conduits with the upper one-third of each outboard air vent. This was accomplished by installing a splitter plate extending the entire length of each air vent and connecting this upper portion to the crossover conduits with a streamlined 90-deg bend gradually expanding from 12 sq ft (area of each upper vent) to 16 sq ft (area of each crossover conduit). This modification, shown in Plate 2, almost equally distributes the total available cross-sectional area of airflow among all sluices and creates independent air vents for each sluice. Figures 5 and 6 show the upper and lower portion of the vents created by the splitter plate leading to the center and right sluices, respectively.

a.   Center sluice (upper) air vent

b.   Transition from upper air vent to crossover conduit

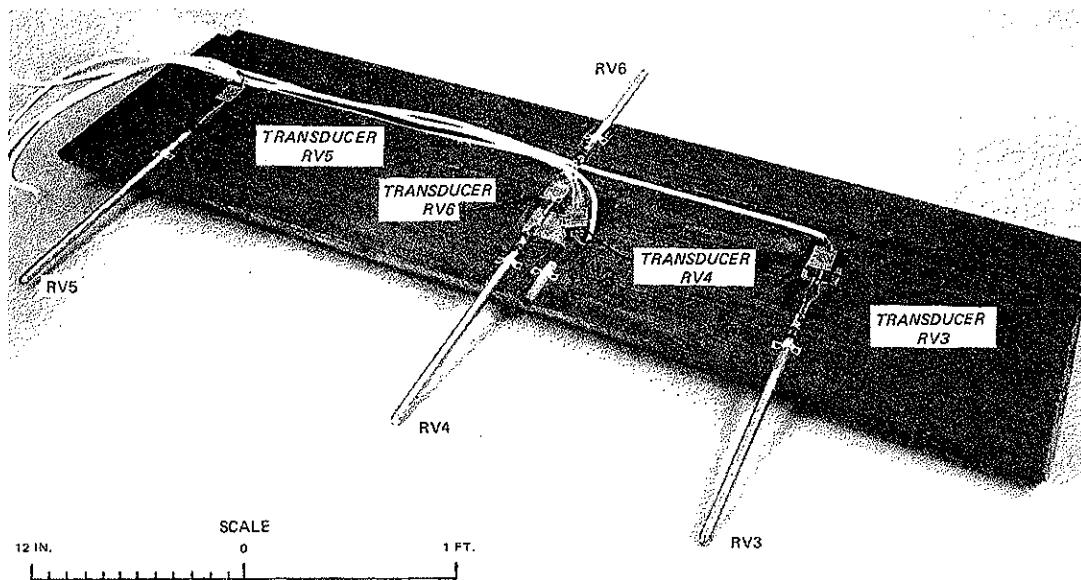
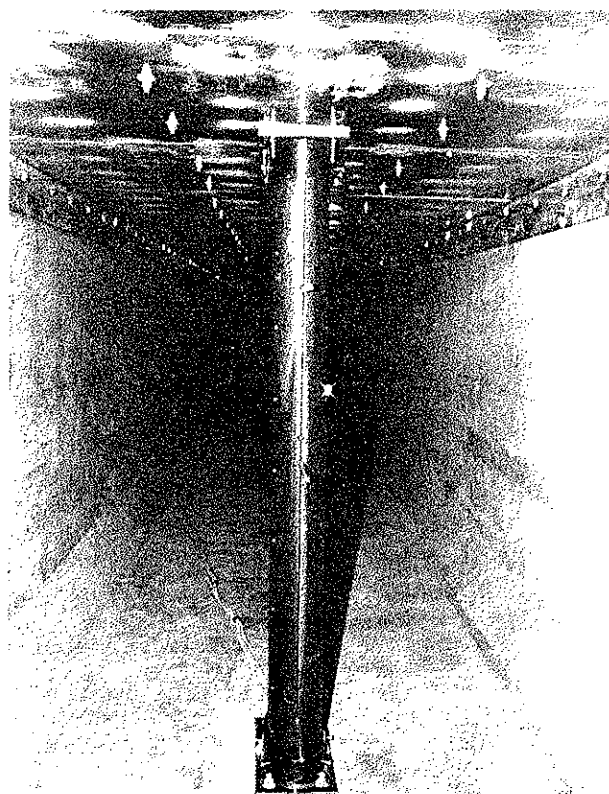
Figure 7. Right sluice air vent strut (RV3, 4, 5, 6)

a. Right sluice air vent strut instrumentation exposed

b. Right sluice air vent strut installed (looking upstream)

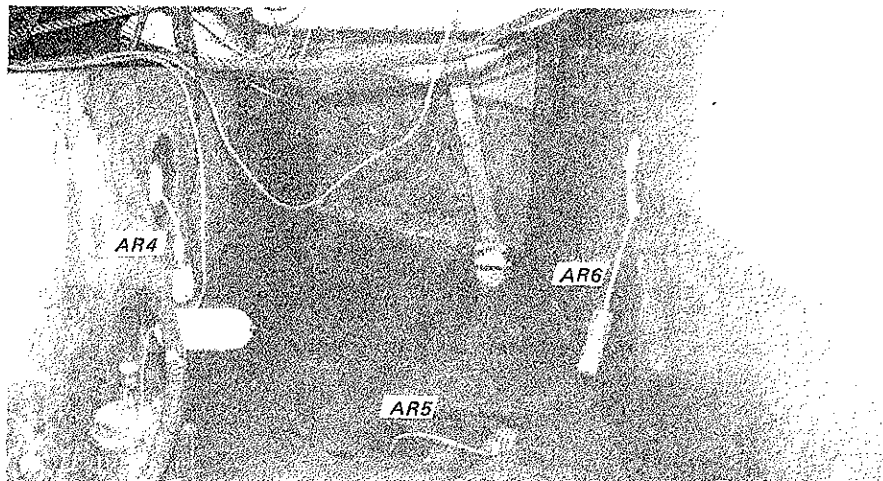
Figure 8. Aerator slot pressure transducers (AR4, 5, 6)

15. Six pressure transducer mounting boxes were installed in the center sluice aerator slot as shown in Plates 1 and 3. Two interchangeable cover plates were fabricated for each mounting box, one for a permanent cover and one for WES to install the pressure transducer just prior to testing. Three were located in the slot in the right wall (looking downstream) and three in the floor along the center line of the sluice. Figure 8 shows the aerator slot transducers located in the floor during installation.

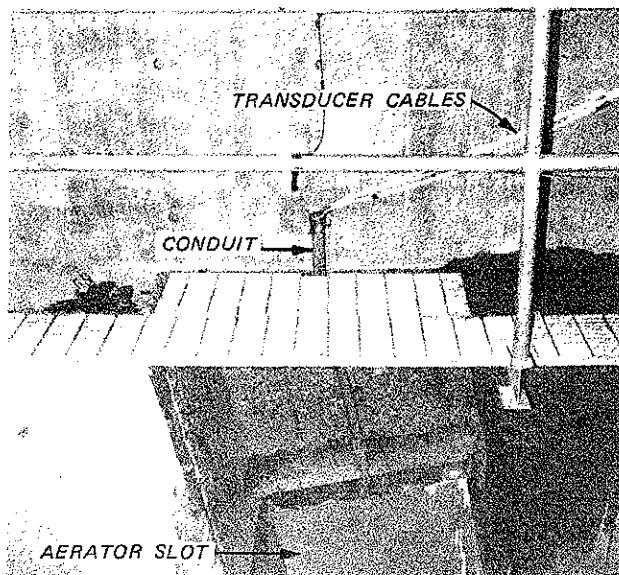
Figure 9. Entrance to aerator slot

16. The transducer cables passed from the mounting boxes through embedded electrical conduit upward to the center sluice gate chamber. Junctions in the center mounting box of each transducer cluster allowed all cables to be fed through a common conduit terminating above the aerator slot. Figure 9 shows the entrance to the aerator slot and the transducer cable conduit terminating in the gate chamber.

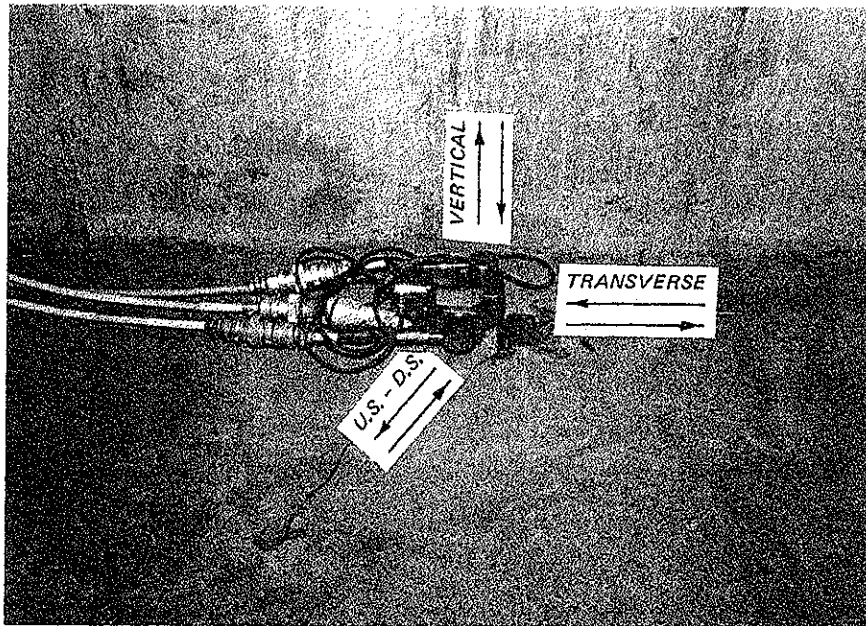
Figure 11.   Accelerometer clusters on gallery floor
and emergency gate

21. Structure vibrations in the vicinity of the center sluice gate were measured with a cluster of three accelerometers, SGAV, SGAT, SGAL, measuring accelerations in the vertical, transverse (perpendicular to flow), and longitudinal (upstream/downstream) directions, respectively. The cluster was located directly over the center sluice on the service gallery floor at el 2240.25 (Plate 1). An identical cluster, housed in a waterproof canister, was epoxied to an interior beam of the emergency gate as shown in Plate 5. The transducer cables passed to the top through 3-in. drain holes in each beam of the gate and then down a utility shaft to the monitoring station. Figure 11 shows the accelerometer clusters on the gallery floor and the emergency gate.

a. Accelerometers attached to service gallery floor
at el 2240.25

b. Accelerometer canister attached to emergency gate

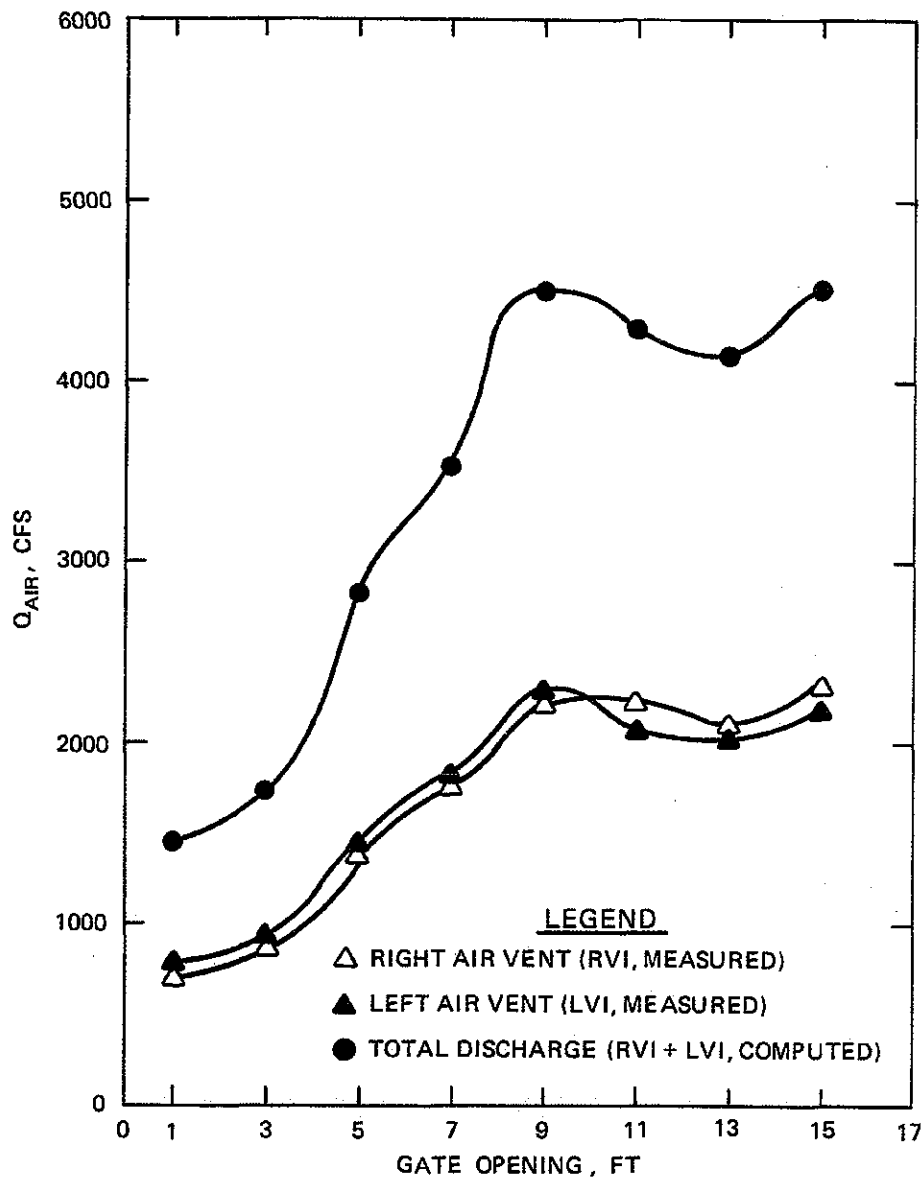
Figure 14. Average airflow versus gate opening,
Series A, center sluice

the right vent discharge (RV1) and the left vent discharge (LV1). A typical example showing that the right and left vents feed the center sluice essentially equal quantities is shown by the plot of average airflow versus gate opening in Figure 14.

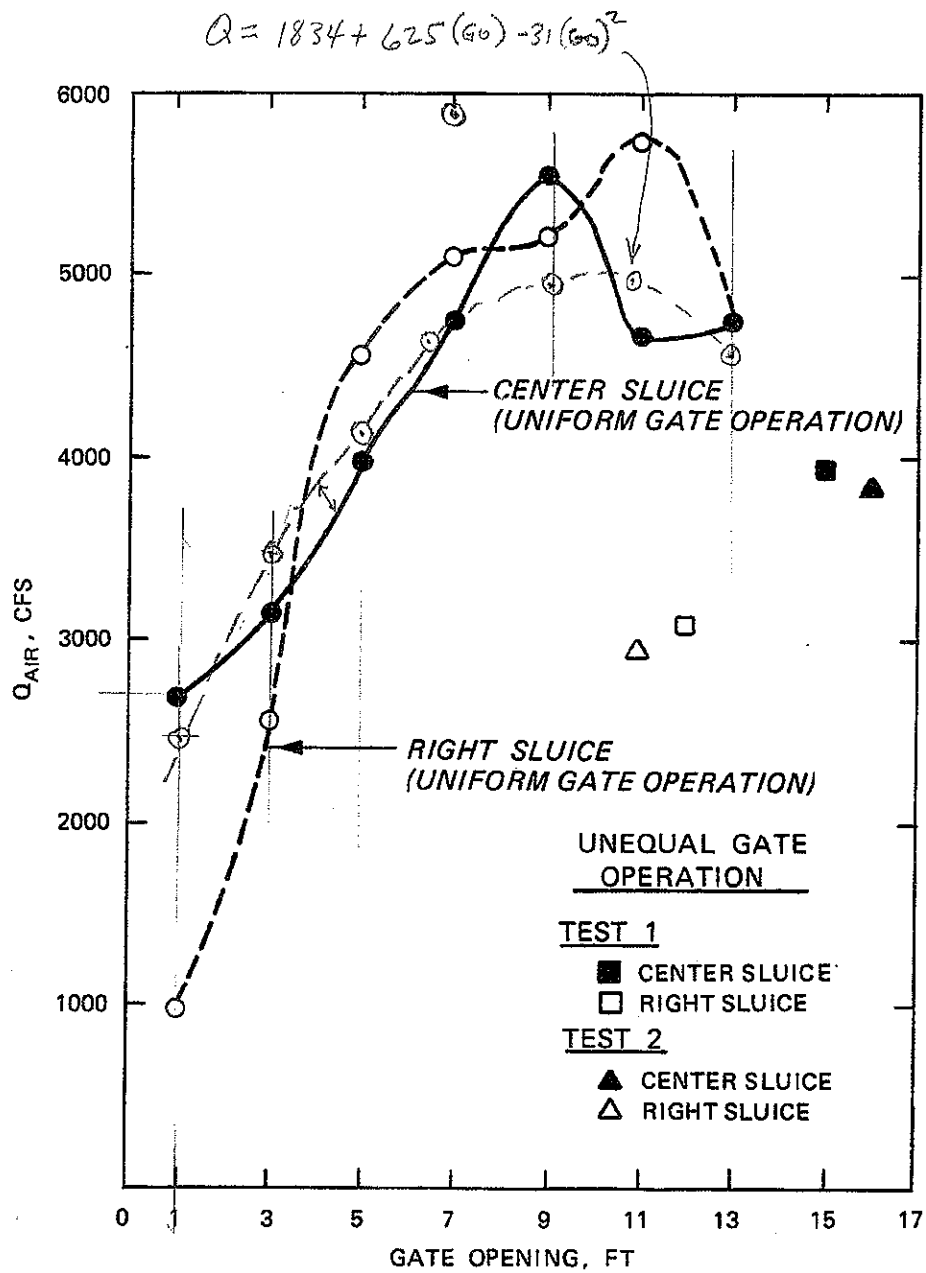
Figure 16. Average airflow versus gate opening, Series D

The airflows in the right vent during Tests 1 and 2 were considerably less than the corresponding airflows during uniform gate operations. This is shown in Figure 16. These results suggest that unequal gate operation may cause airflow to be different from that existing with uniform gate operation.

40. An overall increase of air discharge through the vents was observed for tests conducted with combined sluice and spillway flow, i.e. Series B and D. Because of the outlet works configuration (Figure 3), spillway discharge is directed over the sluice exit portals. This hinders ventilation through the exit portals and causes more air to be drawn through the air vent system. Therefore the actual quantity of air required by the flow, or air demand, is not necessarily higher during combined sluice and spillway flow, as the airflow curves of Plates 7 and 8 indicate; rather, for the stated reason, the airflow is simply higher through the air vent system. However, values given for

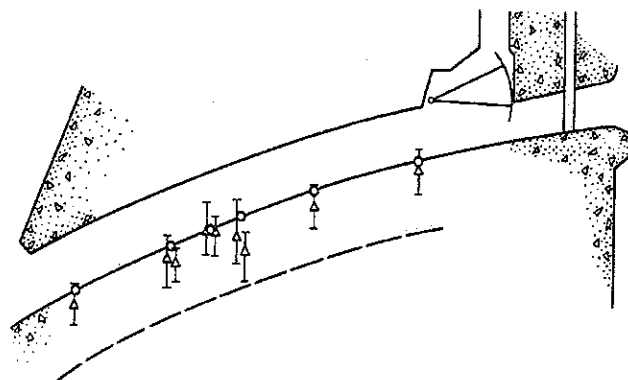
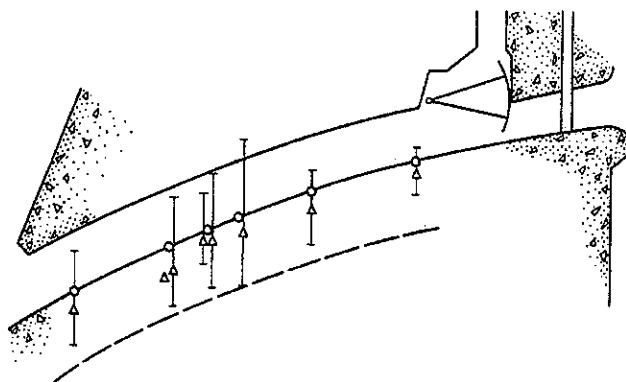
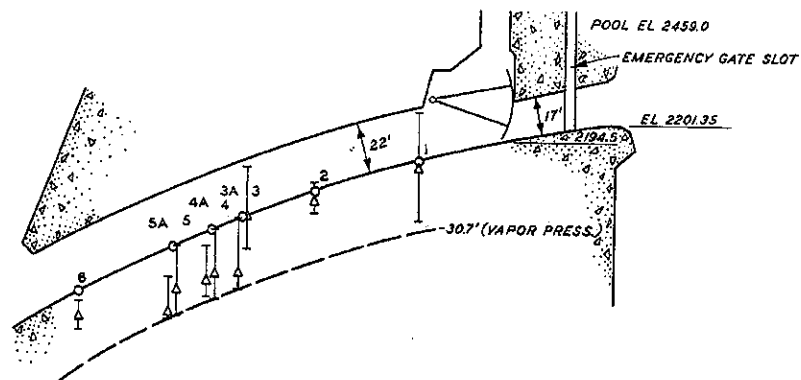
PLATE 17

49. A primary objective of these tests was to determine the effectiveness of the aerator in reducing the negative pressures acting on the sluice inverts which caused the cavitation damage experienced in the early operation of Libby Dam. Plate 17 shows the pressures acting on the invert at the gate openings which created the most severe conditions prior to the installation of the aerator. In contrast, Plates 18 and 19 show the pressures existing at these same gate positions with the aerator in operation. As shown by these graphics, the adverse pressure conditions have virtually been eliminated. The following tabulation lists the comparative data given in Plates 17 (without aerator) and 18 (with aerator, Series A).

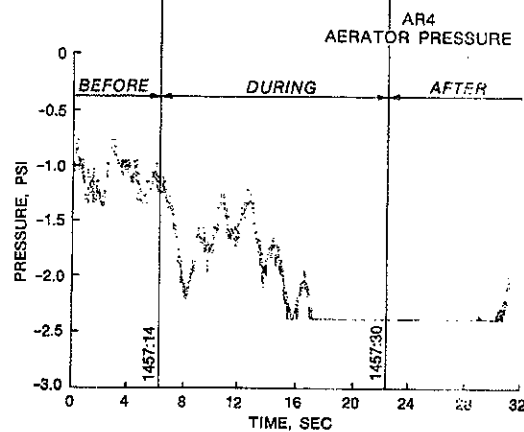
PLATE 22

53. On 22 September 1982, a test was conducted (Series E) lowering the project's sluice emergency gate, weighing approximately 23 tons, under flow conditions into the center sluice. The closure was not successful. The attempted closure was conducted with a center sluice service gate opening of 11 ft (approximately 9,400 cfs). A cluster of three accelerometers located on an interior beam of the emergency gate (Plate 5) measured accelerations of the gate throughout the gate lowering procedure while all other data channels were also being monitored. This section presents the recorded data and describes the procedures and observations made during the test. The data are listed in Table 19 with time-histories presented in Plate 22-24.

54. Emergency gate lowering was uneventful until the paint marks on the gate cable indicated approximately 2-ft gate opening. At this time, estimated to be about 15 min after the lowering commenced, action in the gate slot became very violent and the lifting cables began a swaying (2 to 3 ft) and bouncing motion that caused the slack cable limit switch to trip and shut down the gantry crane. During this time, a span of about 12 sec, the data showed a drastic increase in magnitude. For reference, this time is referred to as the "during" period. This "during" period shows an increase in air discharge of approximately 50 percent to 8,233 cfs, which corresponds to velocities in excess of 350 fps in each center sluice air vent, while the pressure drop through the air vent system approximately doubled. Also, pressures in the aerator slot were generally 50 to 100 percent lower and minimum pressures on the sluice invert were 40 percent lower. However, these values do not indicate the actual maximum discharge or pressures experienced because the pressures at some transducers greatly exceeded the transducer range, as shown by the time-histories of Plate 22. Pressures acting on the lower service gallery wall at the center sluice chamber also exceeded the transducer range (CSC) and may have exceeded the wall design pressure (-2 psi). In addition, peak-to-peak accelerations on the lower service gallery floor almost tripled (Plate 23). Emergency gate

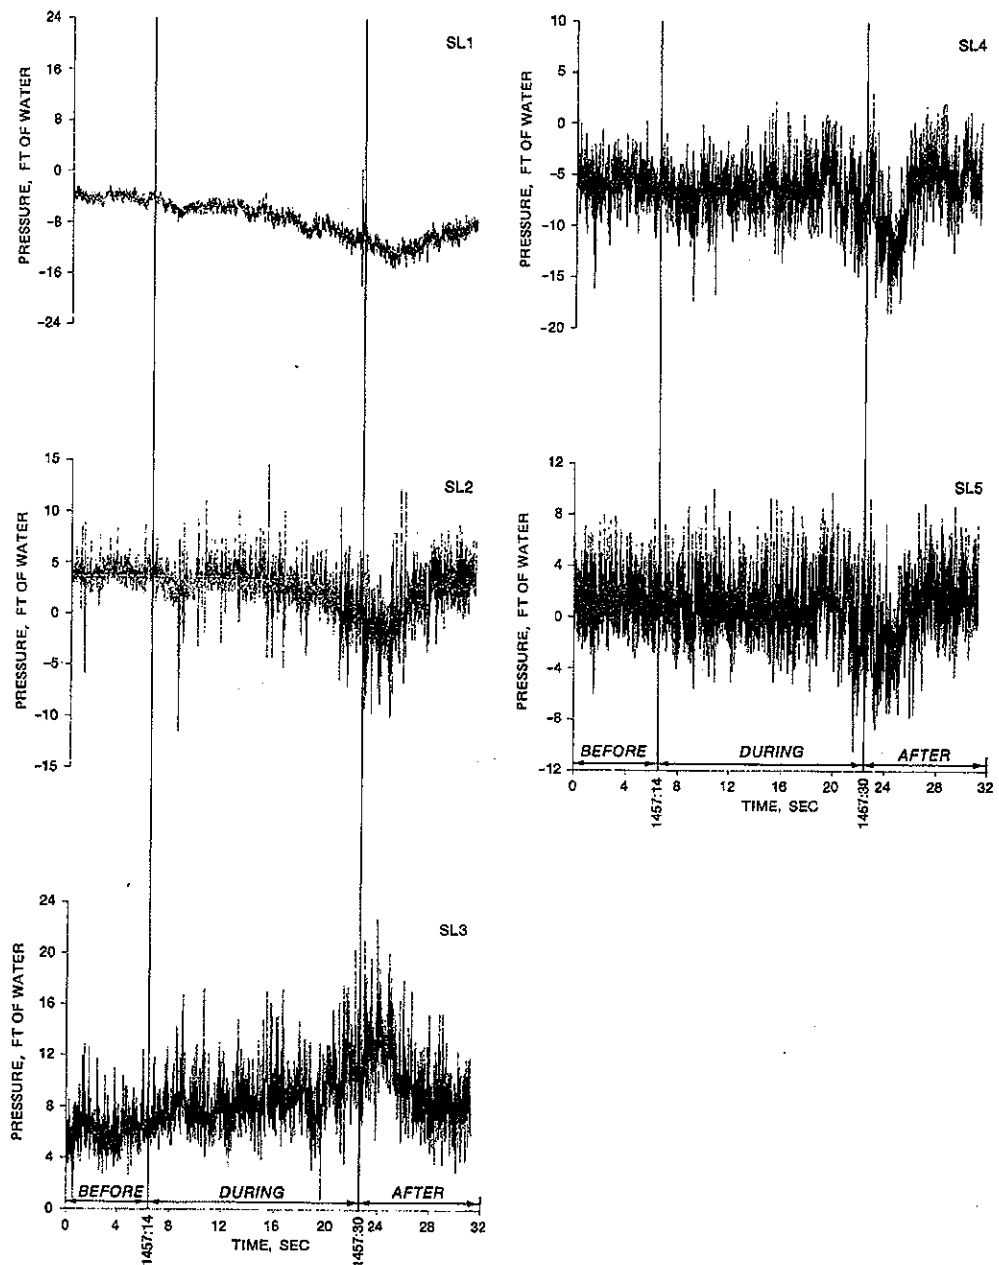
PLATE 24

a. The sluice emergency gate failed to close under flow during the controlled test.
