4. TITLE AND SUBTITLE  The Effects of Vegetation on the Structural Integrity of Sandy Levees	5. FUNDING NUMBERS  WU 32374
--	------------------------------------

8. PERFORMING ORGANIZATION REPORT NUMBER  Technical Report REMR-EI-5	9. SPONSORING/MONITORING AGENCY NAME(S) AND ADDRESS(ES)  US Army Corps of Engineers, Washington, DC 20314-1000
---	--

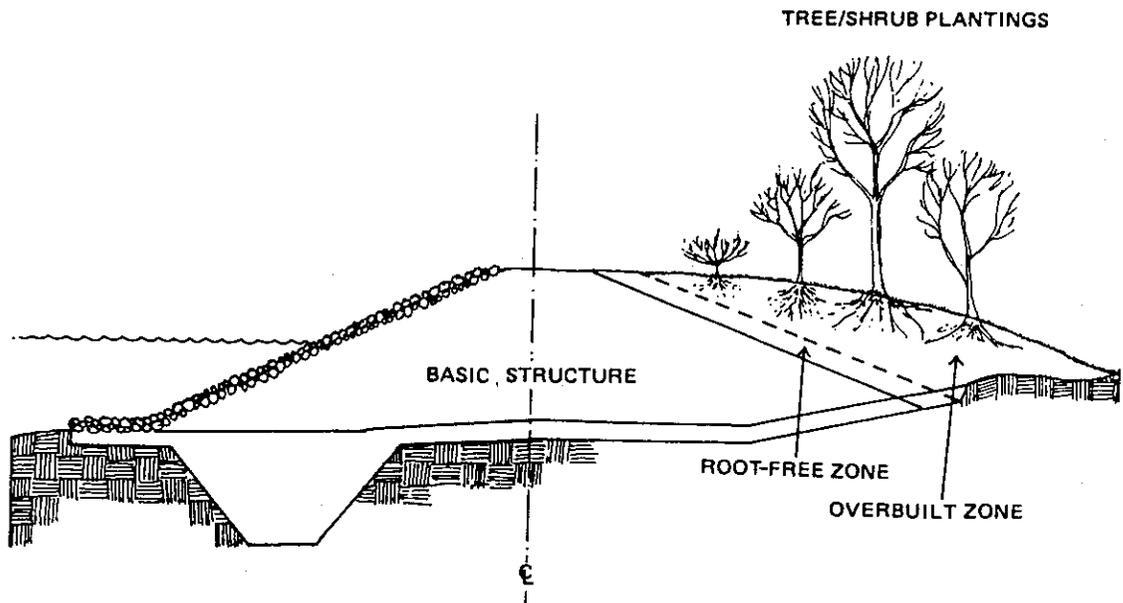
Figure 1. Cross section of an overbuilt levee

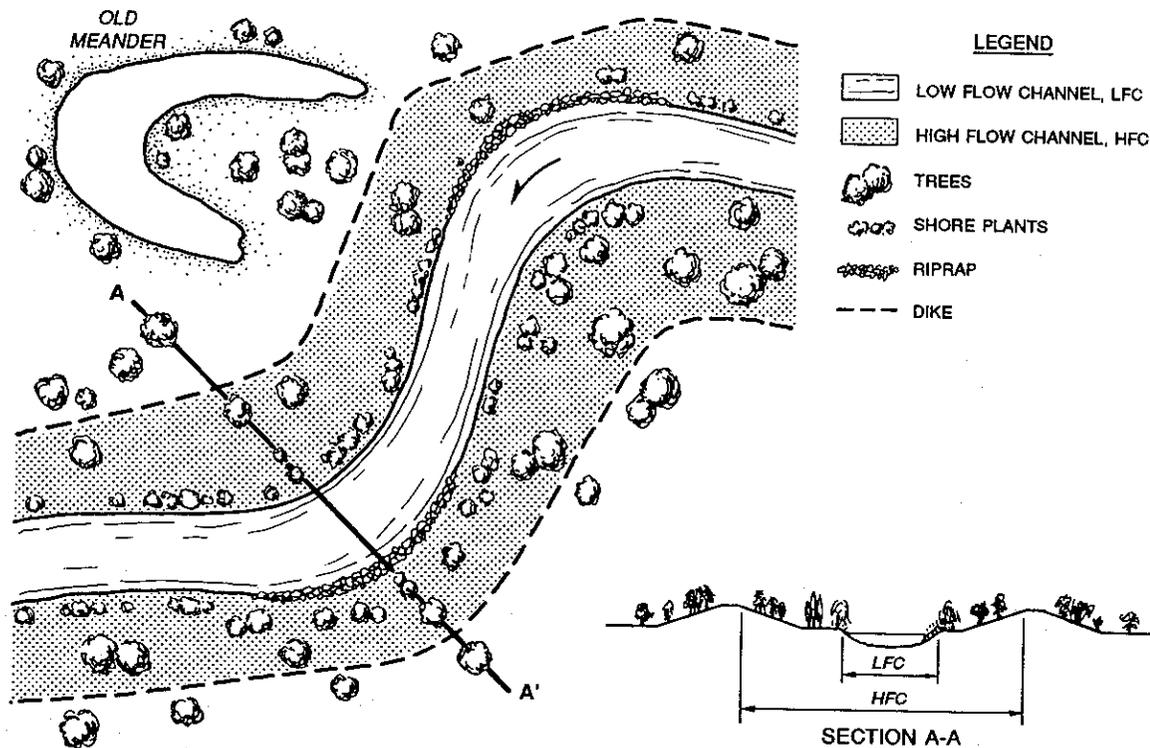
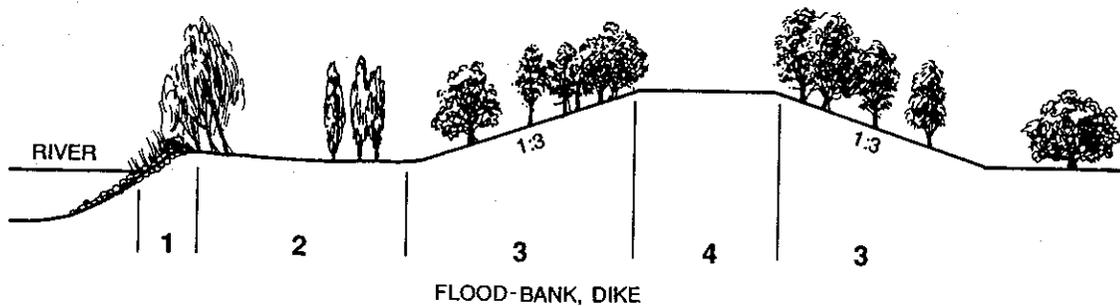
IDEALIZED DIAGRAM SHOWING THE CONCEPT OF "NATURAL RIVER ENGINEERING" BEING PRACTICED IN BAVARIA, WEST GERMANY.

1. SHORE PLANTS; REEDS, LARGE SEDGES, ETC. PLANTED IN RIPRAP.
2. TREES (NEAR WATER TABLE) POPULAR, ALDER, WILLOW, ETC.
3. TREES (HIGHER, LESS WET SITES) OAK, MAPLE, ASH, ETC.
4. GRASS

Figure 2. Use of vegetation on flood dikes in Bavaria, West Germany (after Keller and Brookes 1984)

18. In European practice, vegetation is promoted as a means of stabilizing streambanks and levee slopes. In Bavaria, West Germany, a common design practice is to construct widely spaced, vegetated levees as shown in Figure 2. A mixture of plants, including reeds, grasses, and trees, is used with riprap and other standard engineering control measures to retard erosion (Keller and Brookes 1984).

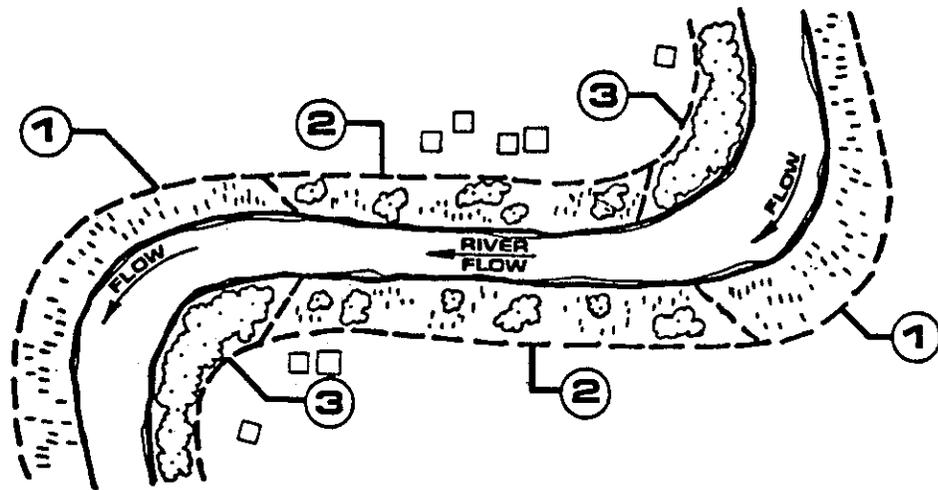
- ① Areas of HIGH potential damage, such as the outside of river bends, historically flooded areas, or levees adjacent to residences and critical use facilities should be cleared of trees and brush which could obstruct access for inspection and repair. In these levee sections, only grass and small forbs would be permitted.

- ② Areas of INTERMEDIATE damage potential such as relatively level, straight reaches and gentle bends could be selectively cleared, leaving clumps or strips of vegetation while allowing unimpeded access for inspection and repair. The type, amount and distribution of this vegetation would be carefully coordinated with the Corps of Engineers to insure levee integrity.

- ③ Areas of LOW potential damage, i.e., the inside portion of river bends, levees which are seldom damaged or which protect large areas of undeveloped or relatively low value land could be maintained in a manner which would leave most levee vegetation intact, removing only that vegetation which could constitute a threat to the levee or impede levee accessibility.

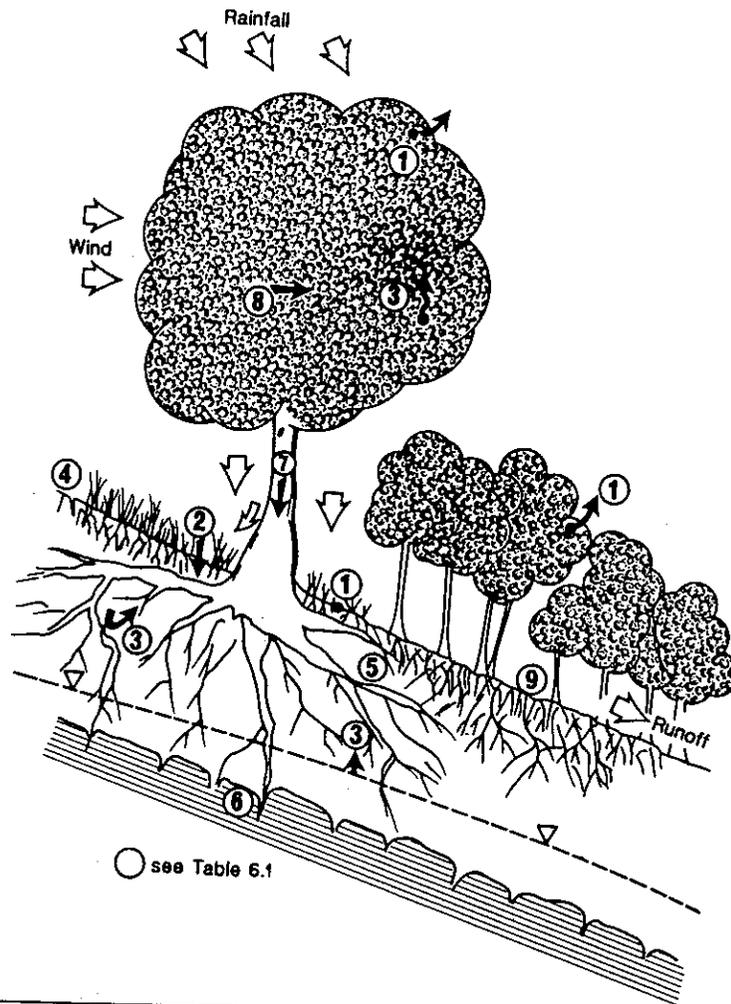
**Hydrological Mechanisms**

- 1 Foliage intercepts rainfall, causing absorptive and evaporative losses that reduce rainfall available for infiltration.
- 2 Roots and stems increase the roughness of the ground surface and the permeability of the soil, leading to increased infiltration capacity.
- 3 Roots extract moisture from the soil which is lost to the atmosphere via transpiration, leading to lower pore-water pressures.
- 4 Depletion of soil moisture may accentuate desiccation cracking in the soil, resulting in higher infiltration capacity.

31. The effects of vegetation on slope stability are best documented in the soil conservation and forest engineering literature. Greenway (1987) has provided a good summary of the hydromechanical influences of vegetation as related to mass stability. These influences are depicted schematically in Figure 4 and tabulated according to whether they exert a beneficial or adverse effect. The most obvious way in which woody vegetation enhances mass stability is via root reinforcement. Extensive laboratory studies (Gray and Ohashi 1983; Gray and Maher 1989) on fiber-reinforced sands indicate that small amounts of fiber can provide substantial increases in shear strength. These findings have been corroborated by field tests on root-permeated soils (Endo and Tsuruta 1969; Ziemer 1981; Riestenberg and Sovonick-Dunford 1983).

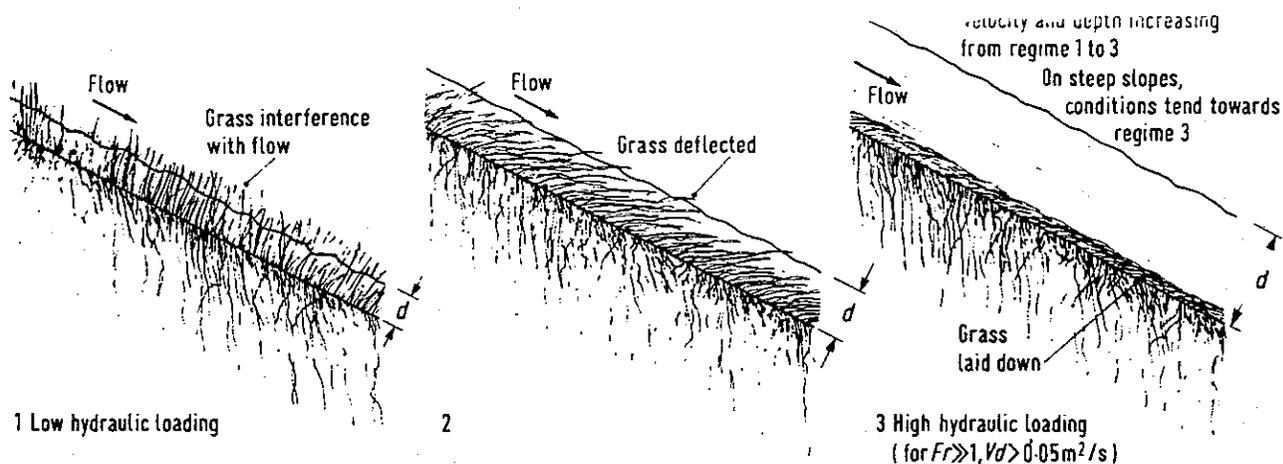
Figure 5. Effect of hydraulic loading on a grassed surface (from Hewlett, Boorman, and Bramley 1987)

In flow regime 1, the flow depth is significantly less than the height of the vegetation, which is not deflected, and the velocity at the soil surface is low due to the interference effect of the vegetation. In flow regime 2, the combined effect of increasing flow velocity and depth causes the vegetation to deflect and oscillate in the flow. In regime 3, the velocity is high enough to flatten the vegetation and a relatively smooth, stationary surface is presented to the flow. The effect of this laydown is to armor the surface and to assist in reducing local surface irregularities which might otherwise be subject to high drag forces during floods.

physically hold soil particles in place. The extent to which vegetation provides these benefits depends upon the surface area of vegetation presented to the flow and the flexibility of the stems (Kouwen and Li 1980). Dense grass swards and low shrubs which extend numerous, non-rigid branches and leaves into the flow are the most effective in this regard. Uniformly rooted grasses (as opposed to tussocks) and supple, young willows have proven to be valuable for erosion protection (Parsons 1963; Seibert 1968). In large, wide-leveed rivers, this additional channel roughness will have a negligible effect on the stage of the design flood. In the case of a grassed surface, the hydraulic roughness depends upon the physical characteristics of the grass sward such as its height, stiffness and density, and its interaction with the flow. This interaction can be divided into three basic regimes (Hewlett, Boorman, and Bramley 1987) as shown schematically in Figure 5.

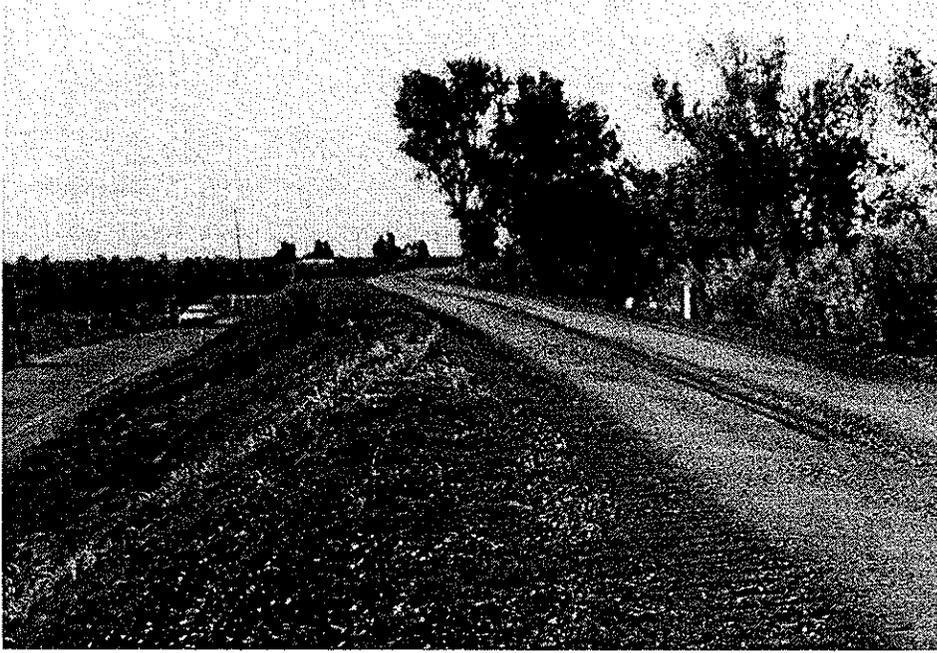
Figure 7. General view of levee at study site showing vegetation growing on riverward side and burned-over slope on landward side

58. The levee embankment is composed primarily of sandy soils which support mature, 30+-year-old cottonwoods and valley oaks. Black locust, shrubby willows, wild rose, and poison oak make up the balance of the woody plant community growing on the levee. Burning is used to maintain the levee vegetation at its current levels. The fire environment can significantly modify or change levee vegetation. Unfortunately, reliable information on the frequency and timing of burning was not readily available. Only limited information was gathered about the extent to which past burning practices might have altered the vegetative spectrum and other conditions, e.g., root structure and distribution, relative to that which would exist under natural succession. California ground squirrel burrows are ubiquitous in the levee. A general view of the levee illustrating some of the aforementioned features is shown in Figure 7.

59. The steeper, xeric landward slope of the levee generally faces to the west and receives not only the afternoon sun but also the force of occasional strong winds. Additionally, this face of the levee is burned annually to help prevent field fires (see Figure 7). Little grew in this harsh

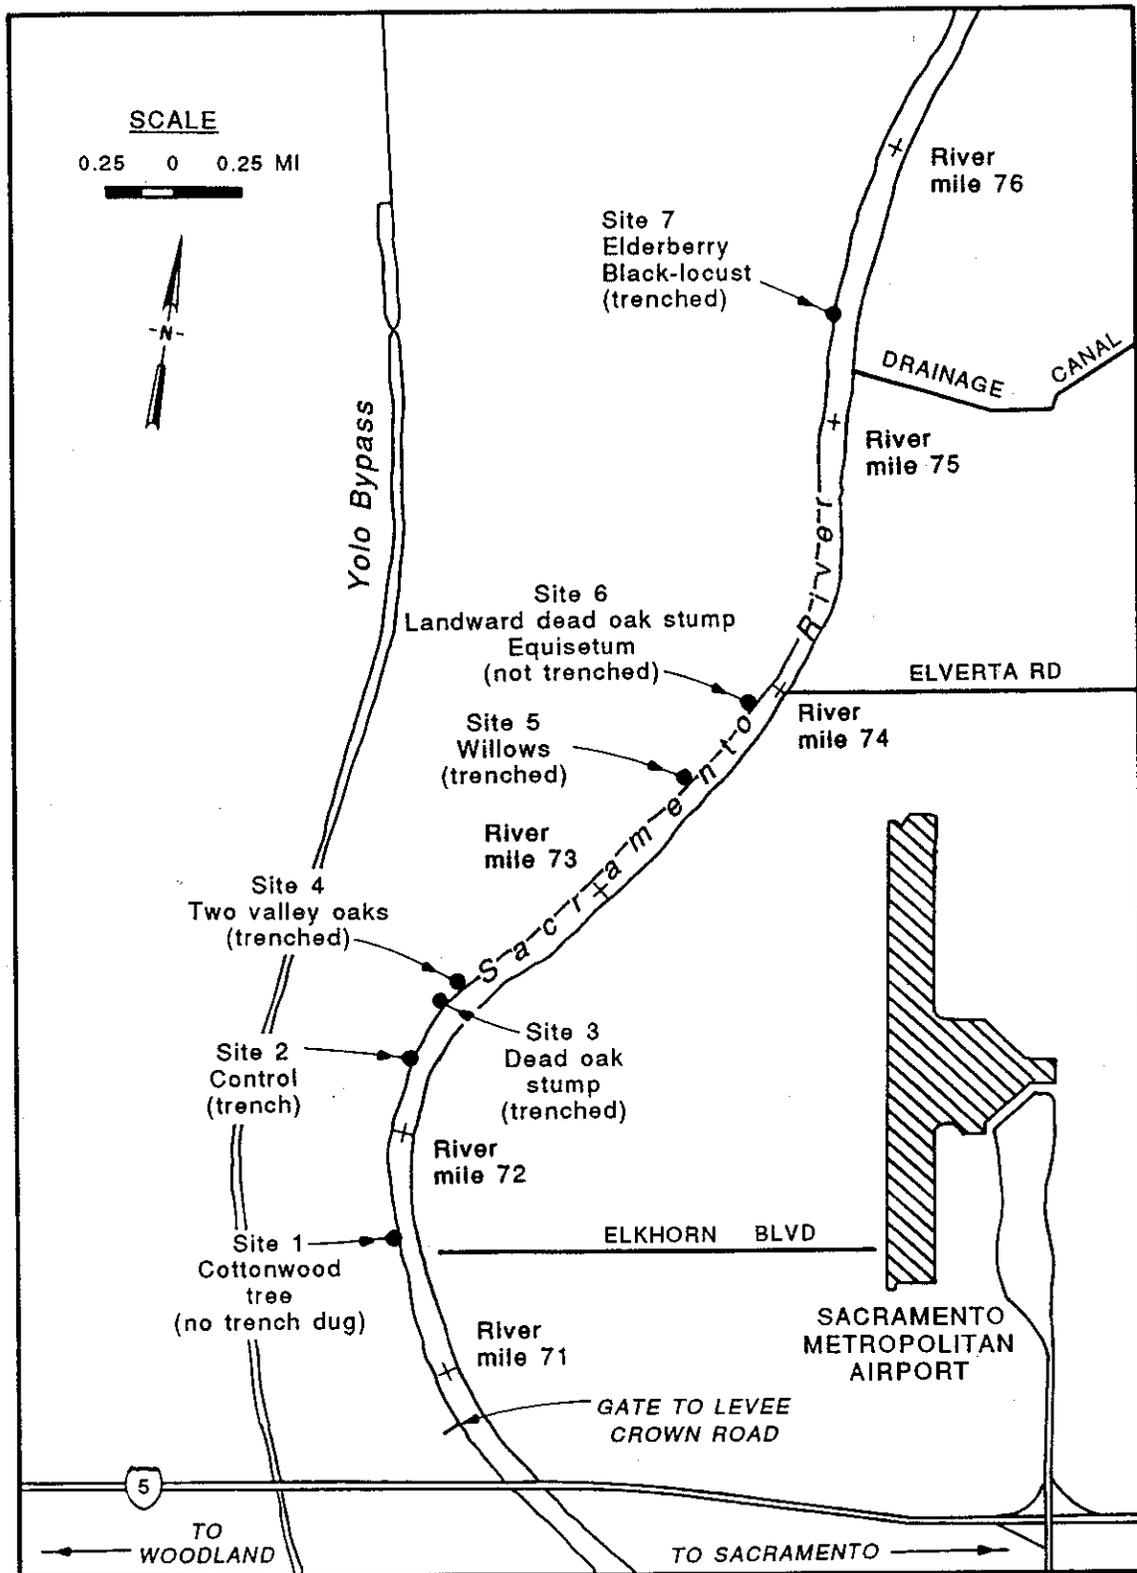
Figure 8. Location of trench sites for determination of root and biopore distribution associated with different types of vegetation

63. The distribution of roots and biopores at various locations in the levee was determined using an adaptation of the profile-wall method (Bohm 1979). This method requires the excavation of a narrow trench in order to expose and map roots, pedotubules, conduits, and other inclusions that intersect the vertical face of the trench. The trench sites were selected so that the root architecture and distribution of the principal woody species of interest growing on the levee could be mapped. Each trench site was located in an area dominated by the following woody species: live and dead valley oaks (*Quercus lobata*) willow (*Salix hindsiana*) elderberry (*Sambucus mexicana*), and black locust (*Robinia pseudoacacia*). In addition a control site consisting of herbaceous cover and low shrubs was also trenched. A total of seven sites were thus identified and selected for trenching; their location is noted on Figure 8. Site No. 1 (cottonwood) was not trenched simply because of time limitations.

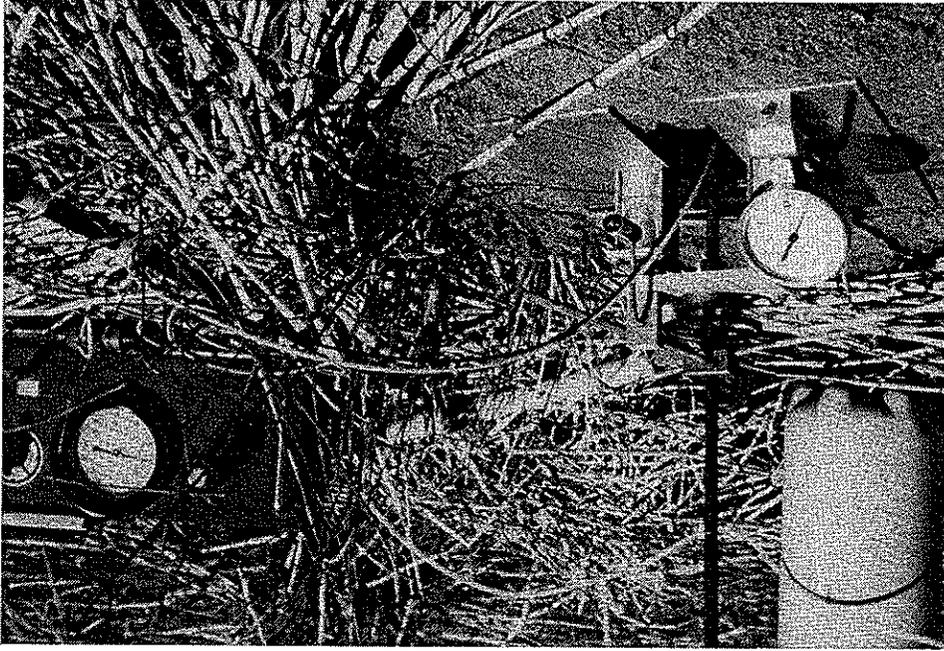
Figure 11. Iowa borehole shear test set up at levee site

borehole, direct shear device (Wineland 1975; Handy 1986). Shear strength can be determined rapidly as a function of depth with this device without the need to obtain samples. The borehole shear test consists of augering a pilot hole and then reaming to a diameter of 3 in. in order to create a borehole with smooth sides. A small pneumatic piston with serrated shearing heads at either end is then lowered down the borehole to the depth of interest. The serrated heads are next expanded out against the sides of the hole with a known normal stress. After an appropriate consolidation interval, the heads are pulled up the hole, thus creating a shearing stress. The tangential or shearing stress is recorded by means of a force platform at the surface which transfers the tensile force in the pulling rods to hydraulic cells which record the shearing stress at the serrated heads in the borehole as shown schematically in Figure 10. A photograph of a borehole shear test set up at a levee site is shown in Figure 11.

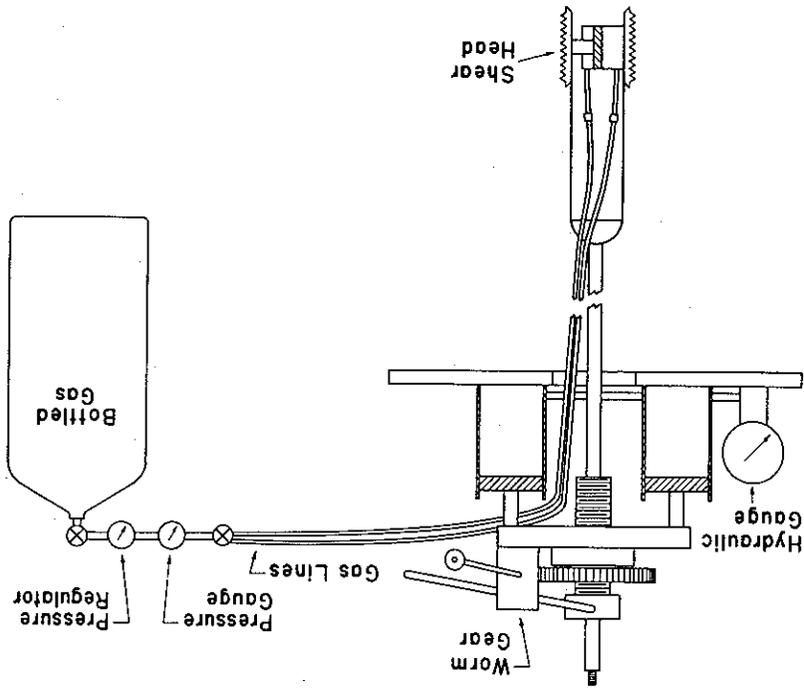
Figure 10. Schematic illustration of Iowa borehole direct shear device (from Wineiland 1975)

CONSOLE

PULLING DEVICE

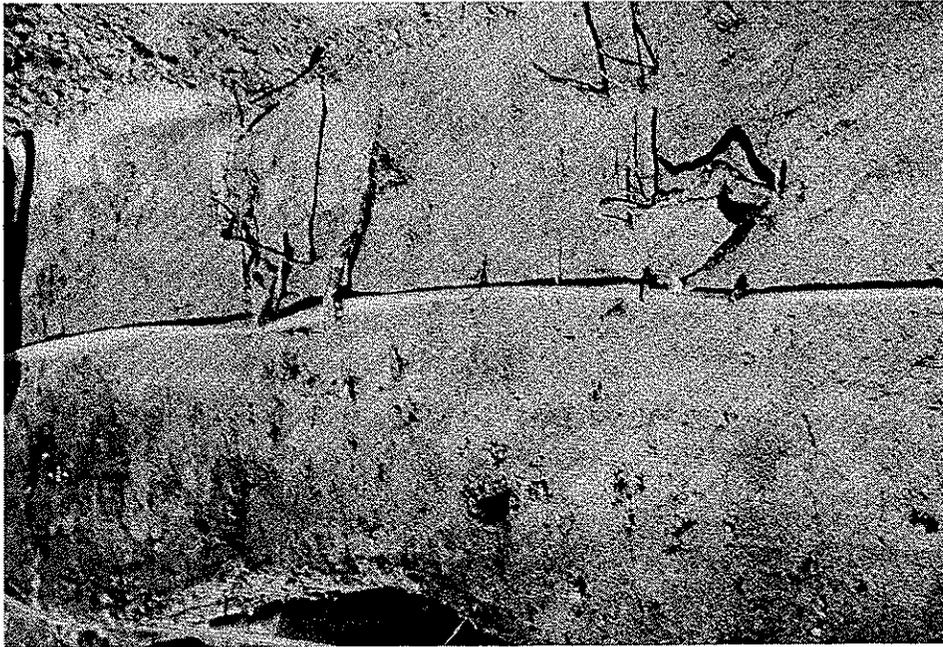
Figure 14. View of trench showing vertical mapping face and roots protruding from trench sides (burrrow is visible in upper center of photo)

78. After the backhoe work, the soil along the trench sides was trimmed back to the mapping face using hand tools. A square-nosed shovel was used for rough trimming followed by smoothing with a mason's trowel. Roots were cut back to the finished face with either a pruning saw or shears. Mist spraying was employed periodically to keep the face moist and to prevent sloughing or raveling. Hand trimming was done in two stages. The upper half of the trench was finished first, leaving a ledge on which to rest the mapping apparatus: General views of the trench layout and finishing operations prior to mapping are shown in Figures 13 and 14.

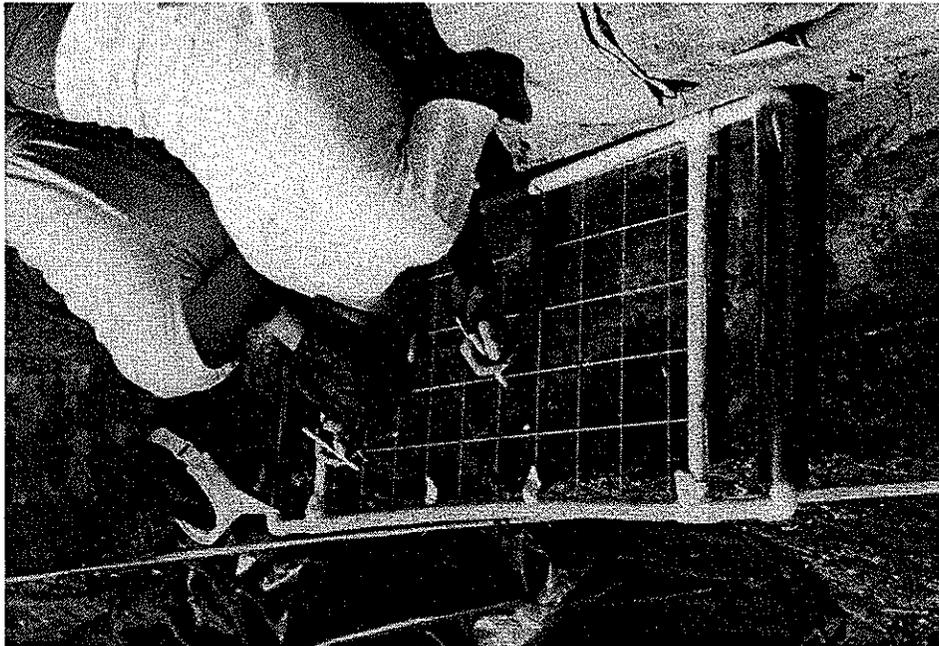
Figure 16. Closeup view of mapping frame showing acetate sheet, take-up and supply holders, and string grid

- Features mapped directly on the acetate. Mapping was done along the upper half of the trench by successively moving the frame along the ledge and advancing the acetate roll to a new position. After the upper half was mapped, the ledge at midheight was trimmed away, and the bottom half mapped in a similar fashion. Views of a mapping operation in progress are shown in Figures 15 and 16.

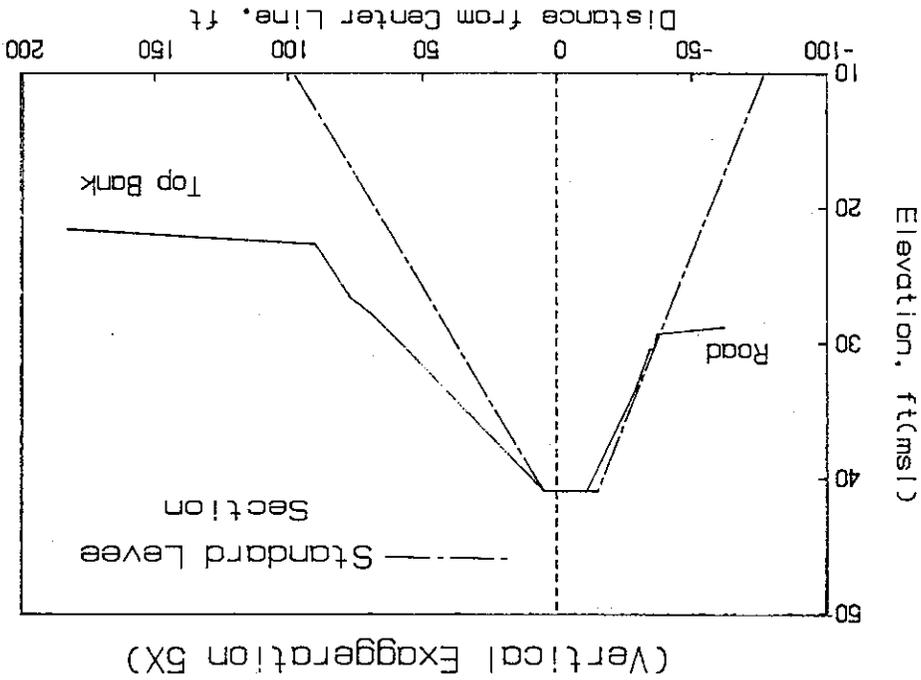
Figure 18. Levee cross-section profile, Live oak site (site 4)

83. Levee cross sections surveyed at each of the trench sites are shown in Figures 17 through 20. The standard levee section is superimposed on these diagrams for comparison. In general the actual cross sections closely matched the standard section. In some locations, e.g., sites 2-4, the riverward slope is less steep than the standard 3:1 slope. A relatively flat terrace of varying width separated the riverward toe of the levee from the top of the riverbank.

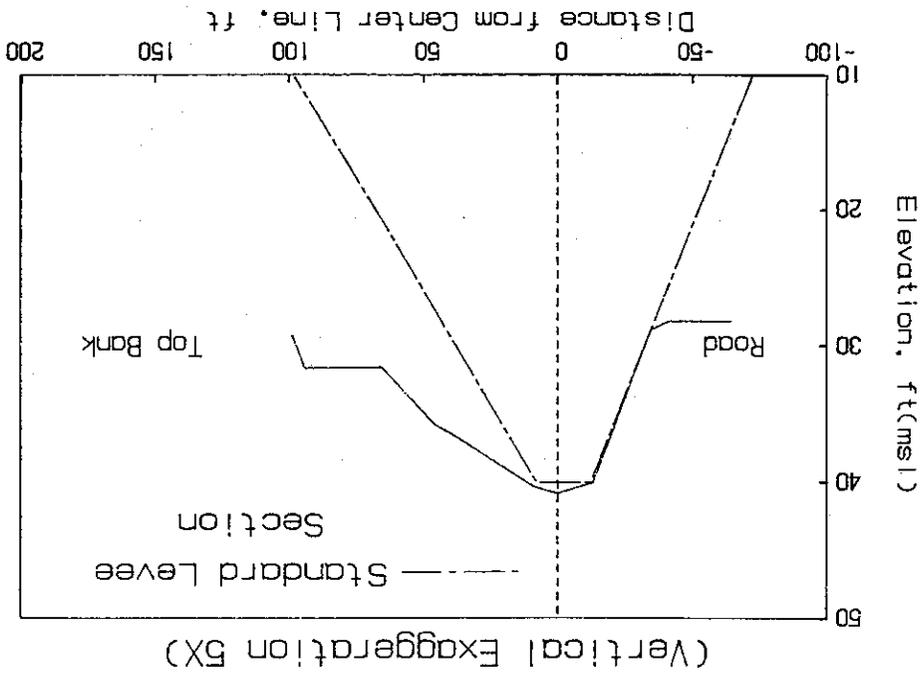
Figure 17. Levee cross-section profile, control site (site 2)

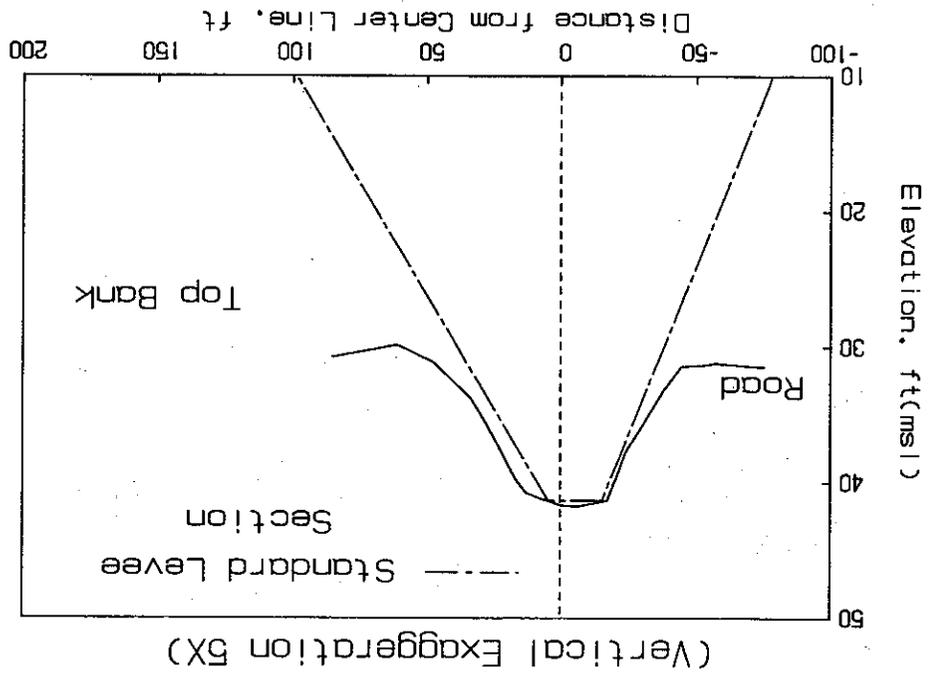
Figure 20. Levee cross-section profile, elderberry site (site 7)

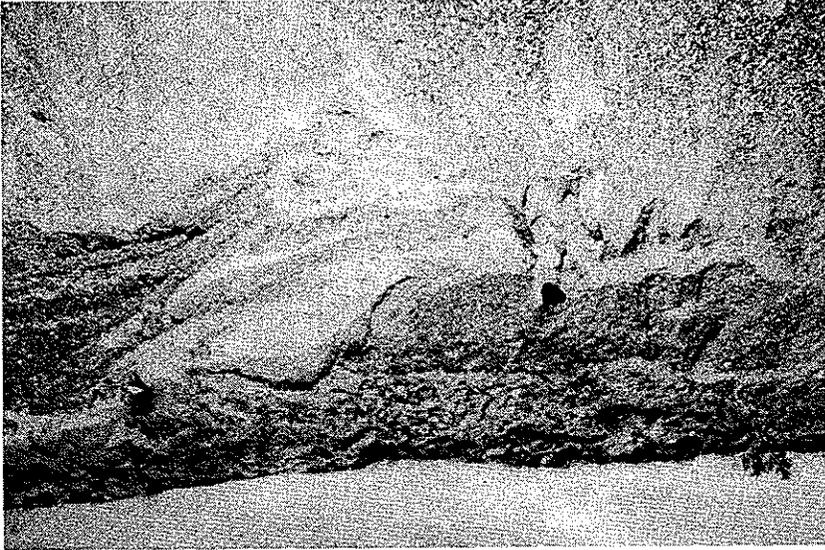
Figure 22. Example of vertical zonation or stratification on riverward levee slope caused by deposition of sediments during overbank flows

84. The levee in the study section was constructed primarily of sandy materials dredged from the river and hydraulically deposited on the bank. The levee soils consist primarily of medium to fine sands with little or no fines (silt or clay). Evidence from boreholes and trenches dug in the levee suggests that the finer materials that occasionally showed up tend to be located at depth, and in some cases may actually occur in the foundation as opposed to the levee itself. Nevertheless, small zones or inclusions of clay or silty clay can also be found in the structure. In some cases fissures or cracks in these clay inclusions are permeated with roots as shown in Figure 21. Roots exploit these zones, most likely because of greater water retention and availability in comparison to the surrounding, droughty sand. There was little evidence of any consistent vertical zonation or stratigraphic pattern. Stratification was evident in some locations on the riverward side where sediments had been deposited on the levee slope during overbank flows. Stratification was clearly delineated in this case by the presence of buried carbonaceous layers from previous levee burning. Examples of this stratification are shown in Figure 22.

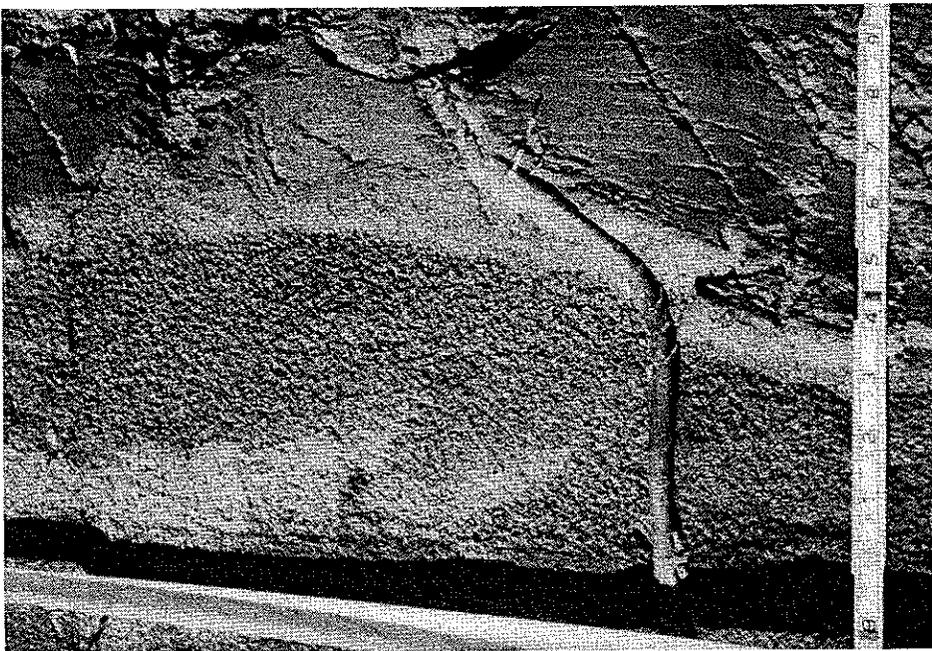
Figure 21. Fissure in large clay clod or inclusion that has been permeated by a tree root

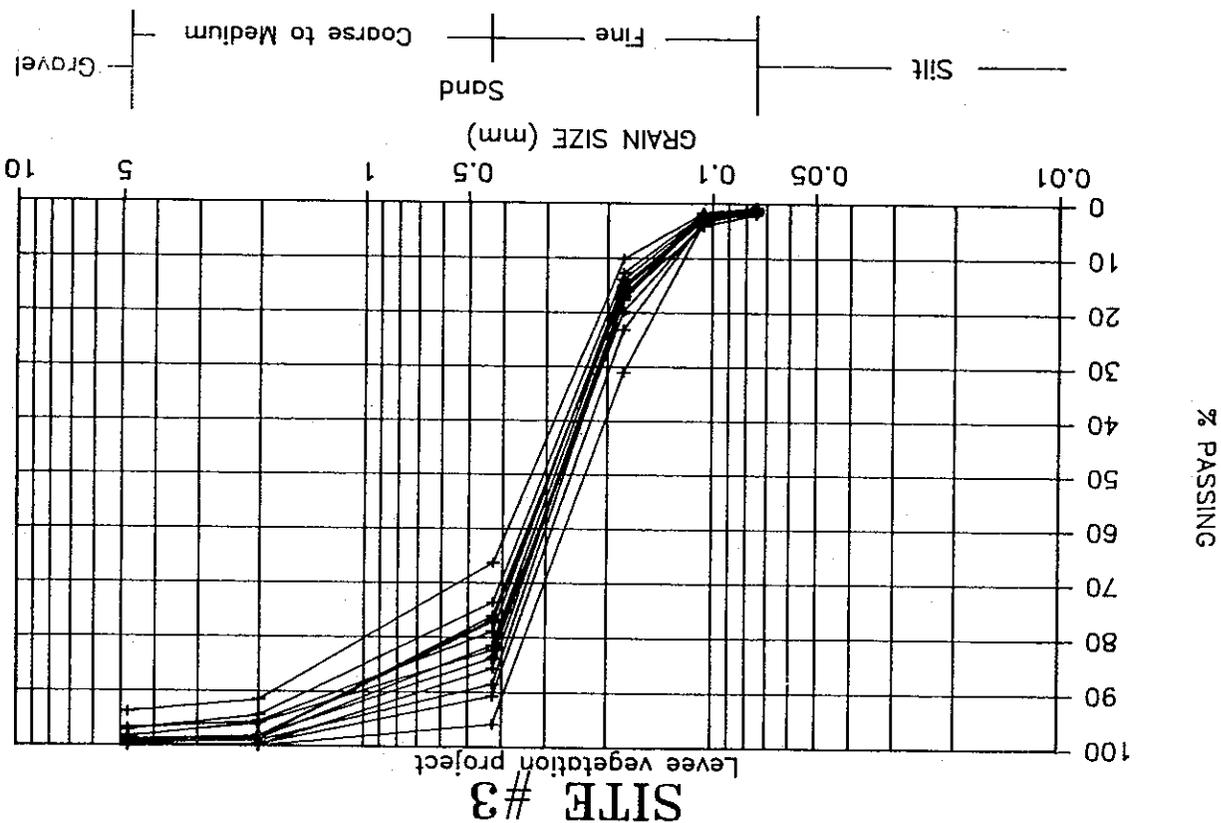
Figure 23. Grain size distribution curves for levee samples from site 3 (samples obtained from different boring locations and depths at site)

The United Soil Classification system designation for the levee soil is SP. The gradation curves shown in Figure 23 for samples from site 3 are typical.

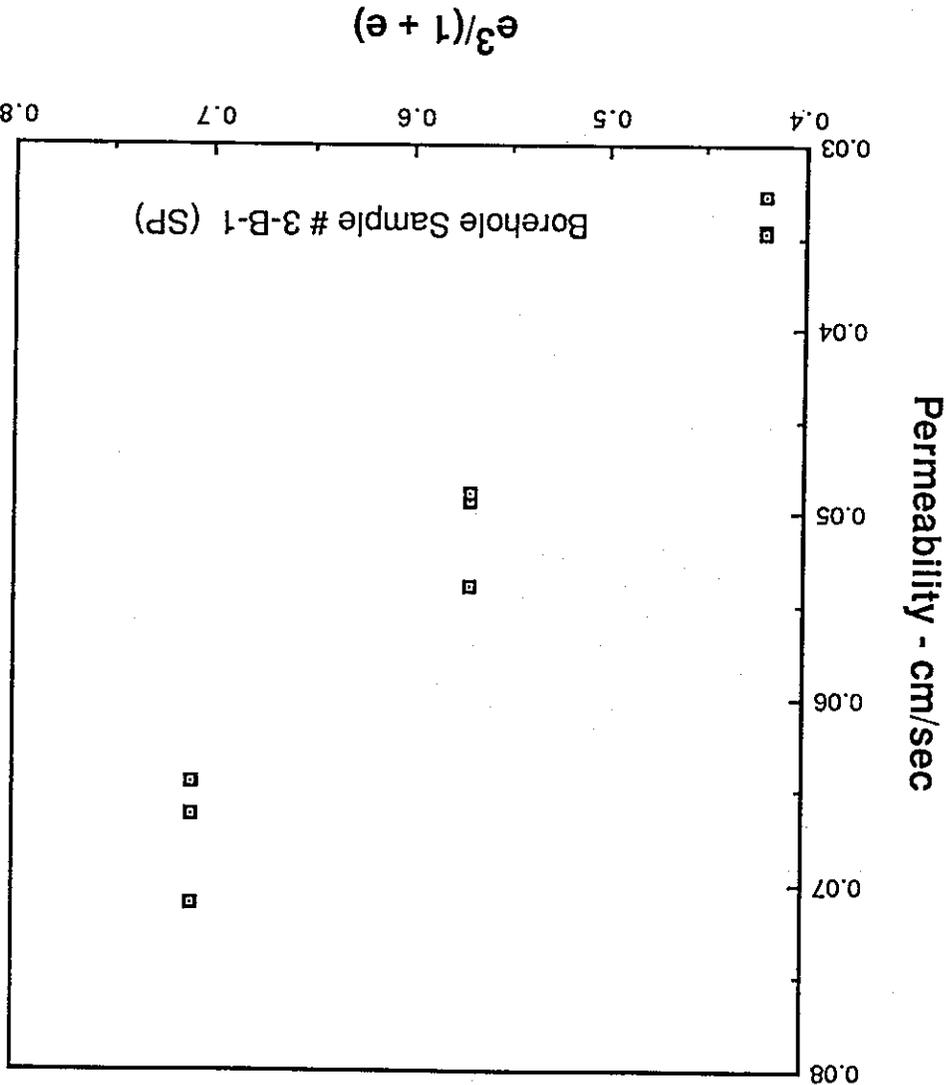
Figure 24. Typical functional relationship between permeability and void ratio for sandy levee samples

plotted in Figure 24 for one of the samples that was tested. equation which predicts a linear relation between permeability ( $K$ ) and  $(e^3/1+e)$ ; where  $e$  is the void ratio. This functional relationship is shown

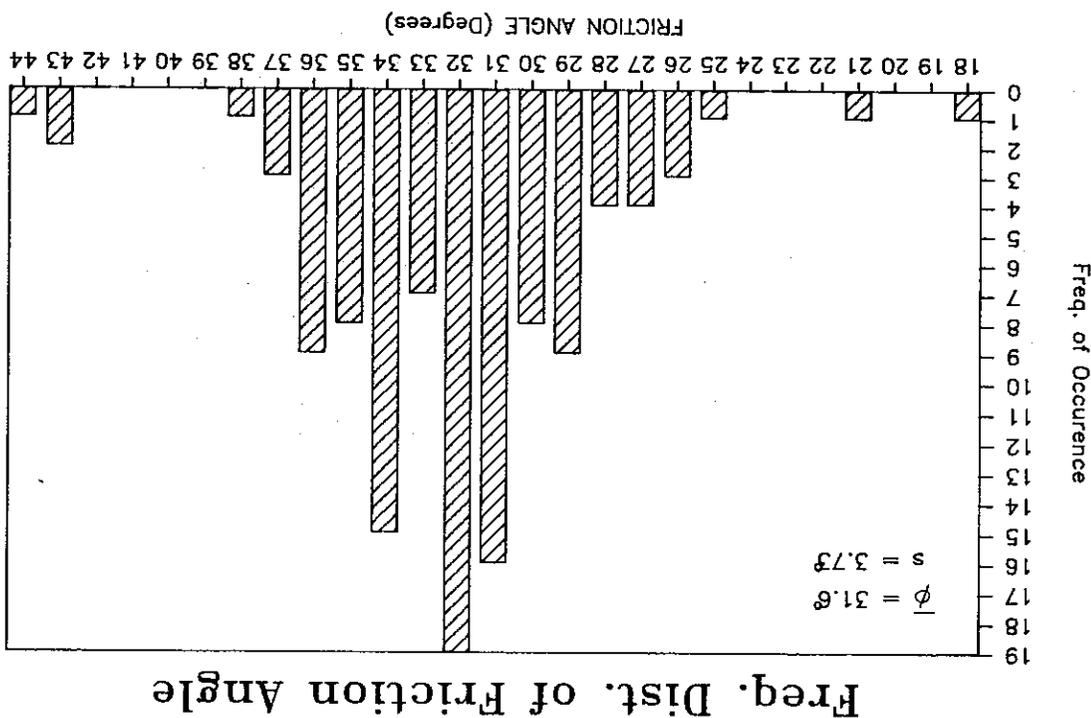
Figure 27. Frequency distribution of friction values obtained from all borehole shear test borings  
 general higher values of friction were observed where cohesion was low and vice versa. A plot of friction versus cohesion for all results (test borings) is shown in Figure 28. A linear regression analysis ( $R = 0.645$ ) of this data yielded the following relationship.

89. The frequency distribution for both the cohesion and friction values from all borings are shown in Figures 26 and 27, respectively. The average

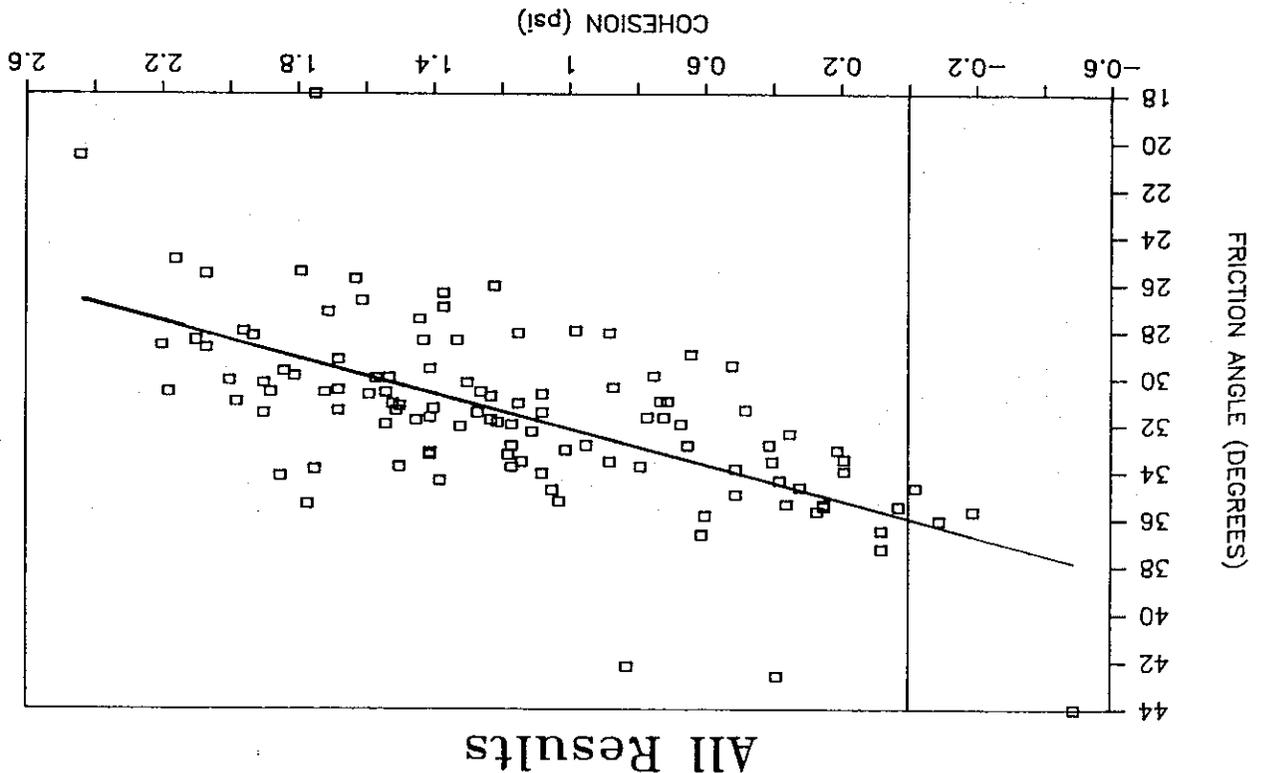
Figure 28. Friction vs. cohesion results for all test borings showing best-fit linear regression curve

where:  $\phi$  = friction angle (degrees and  $c$  = cohesion (psi)

$$\phi = 36.0 - 3.82c \quad (1)$$

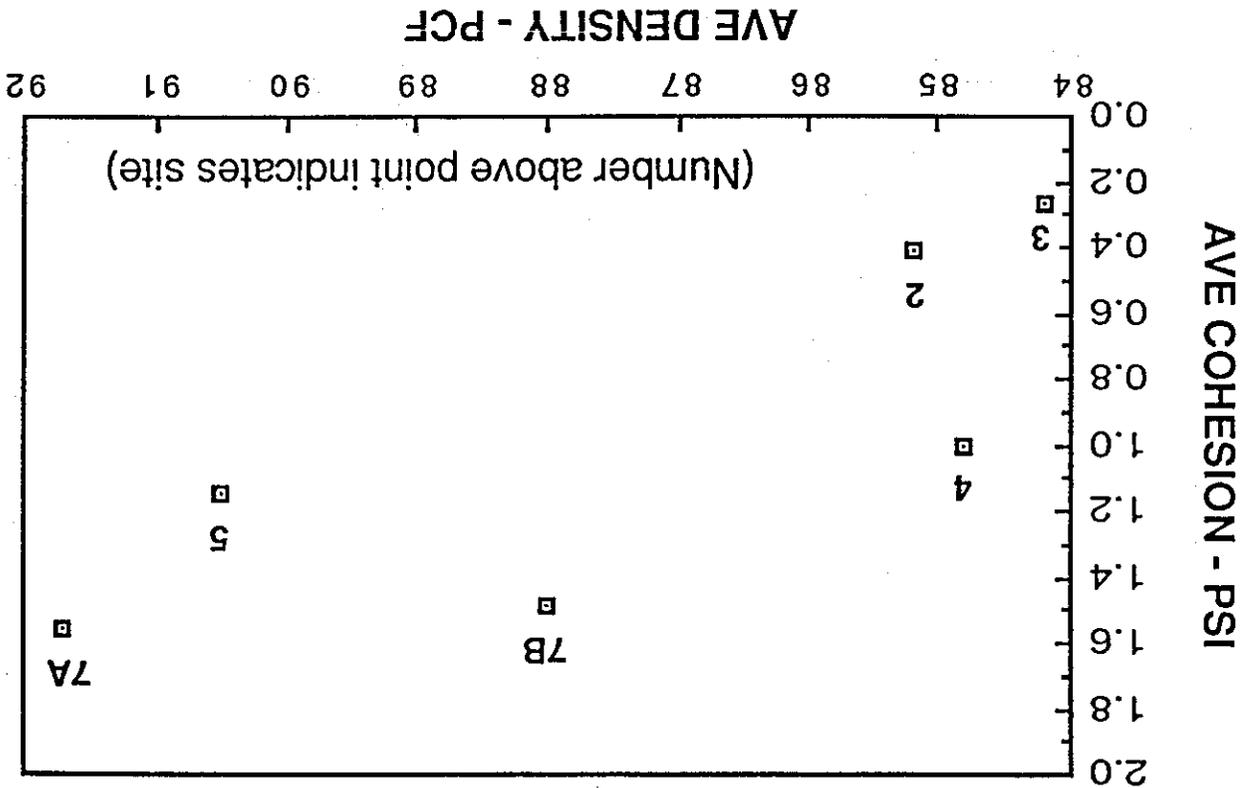
Figure 29. Average site cohesion versus average site soil density for in situ levee soils

90. High cohesion values were associated with soil samples having a higher content of fines. As noted previously, these same samples also tended to have higher densities. Not surprisingly, therefore, a correlation was also observed between average site cohesion and average site density. Cohesion increases with increasing density as shown in Figure 29. The number above each point in the plot corresponds to the site number. The sites with large amounts of fines (sites 5, 7A, and 7B) exhibit the highest cohesion and soil density, whereas sites with lesser amounts of fines (sites 2, 3, and 4) have lower cohesions and densities.

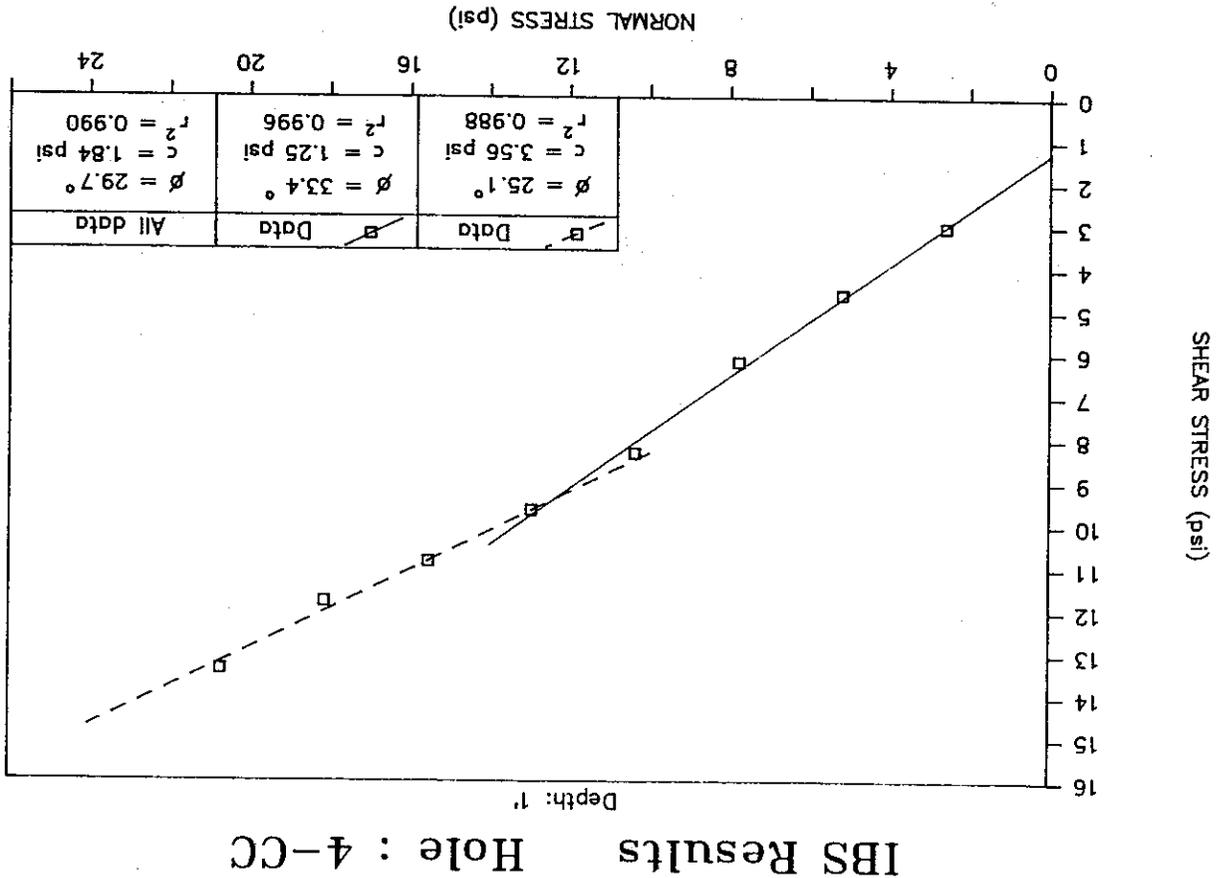
Figure 31. Bilinear failure envelope obtained in borehole shear test at site 4  
 measure of the additional shear strength or "fiber cohesion" imparted by the presence of the roots.

92. Bilinear or curved-linear failure envelopes are typical of fiber reinforced sands as demonstrated by the work of Gray and Al-Katefi (1986); Gray and Maher (1989). Their work indicated that failure envelopes become strongly bilinear, as opposed to curved-linear, as the gradation and angularity of soil particles increase. The vertical displacement of the failure envelope above the reference or unreinforced envelope can be interpreted as a

91. Some evidence of root reinforcement was observed in the failure envelopes of a few test borings using the bore hole shear device. A photograph of a test boring site illustrating the extent of root permeation around the former bore hole is shown in Figure 30. The Iowa bore hole shear device is not ideally suited or designed to detect and measure root reinforcement influences on shear strength because the roots no longer penetrate fully across the failure surface after boring and reaming a hole to accommodate the shear head. Nevertheless, root/fiber reinforcement effects still manifested themselves in the form of bilinear or curved-linear failure envelopes in some instances, as illustrated in Figure 31. A distinct bilinear failure envelope was observed at a depth of 1 ft at this location (site 4).
