4. TITLE AND SUBTITLE  The Effects of Vegetation on the Structural Integrity of Sandy Levees	5. FUNDING NUMBERS  WU 32374
--	------------------------------------

8. PERFORMING ORGANIZATION REPORT NUMBER  Technical Report REMR-EI-5	9. SPONSORING/MONITORING AGENCY NAME(S) AND ADDRESS(ES)  US Army Corps of Engineers, Washington, DC 20314-1000
---	--

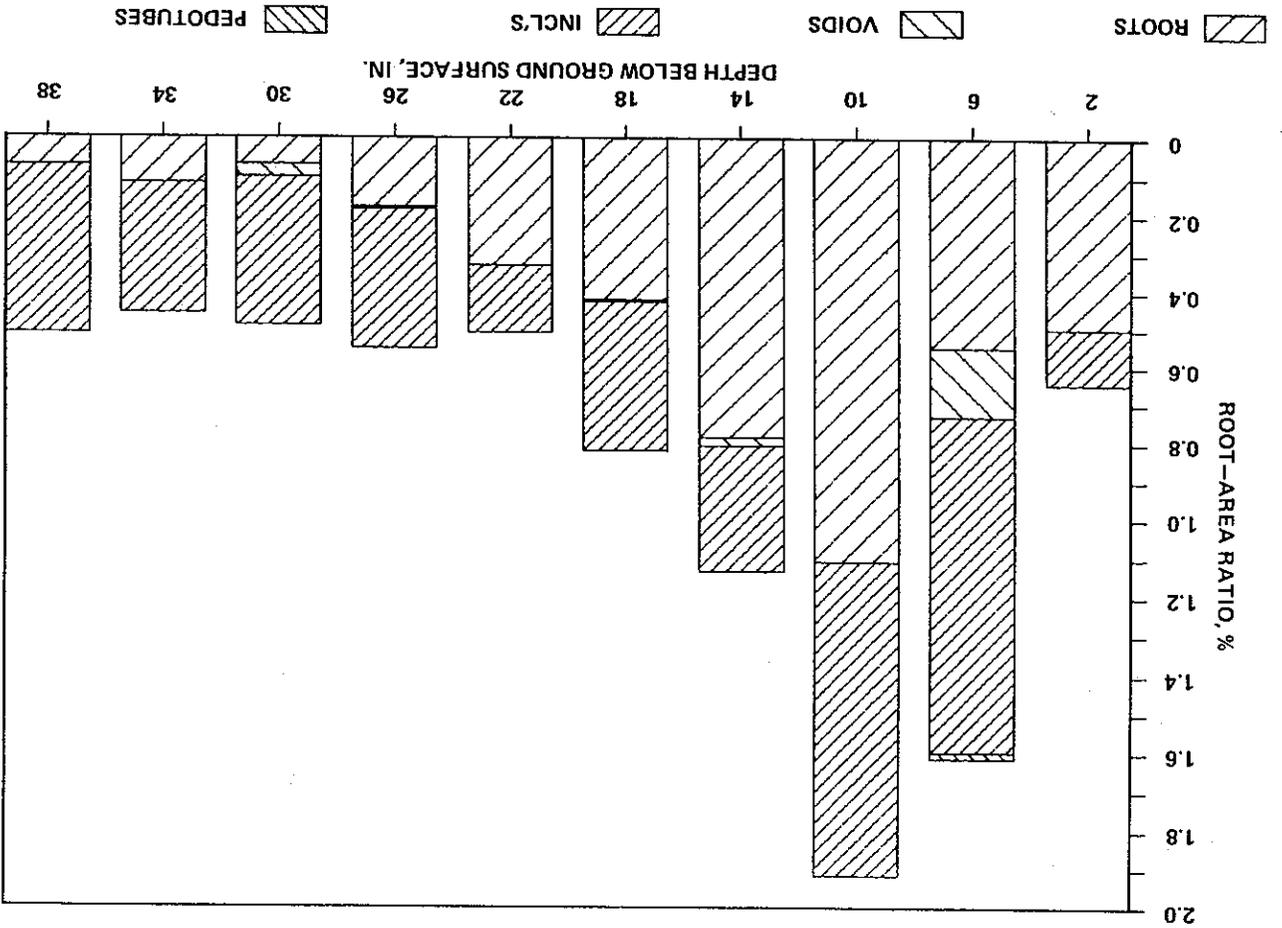
Figure 32. Total area ratio vs. depth, perpendicular trench, elderberry site (site 7)

trench in the perpendicular trench arm at the elderberry site is shown in histogram for all features and depths as a function of position along the histograms for the other sites are collected in Appendix A. An area ratio elderberry site (site 7) are shown in Figures 32 and 33. Total area ratio showing the area ratios for different features as a function of depth at the typical histograms for the perpendicular and parallel trenches, respectively, the trench face or cross-sectional area occupied by a particular feature.

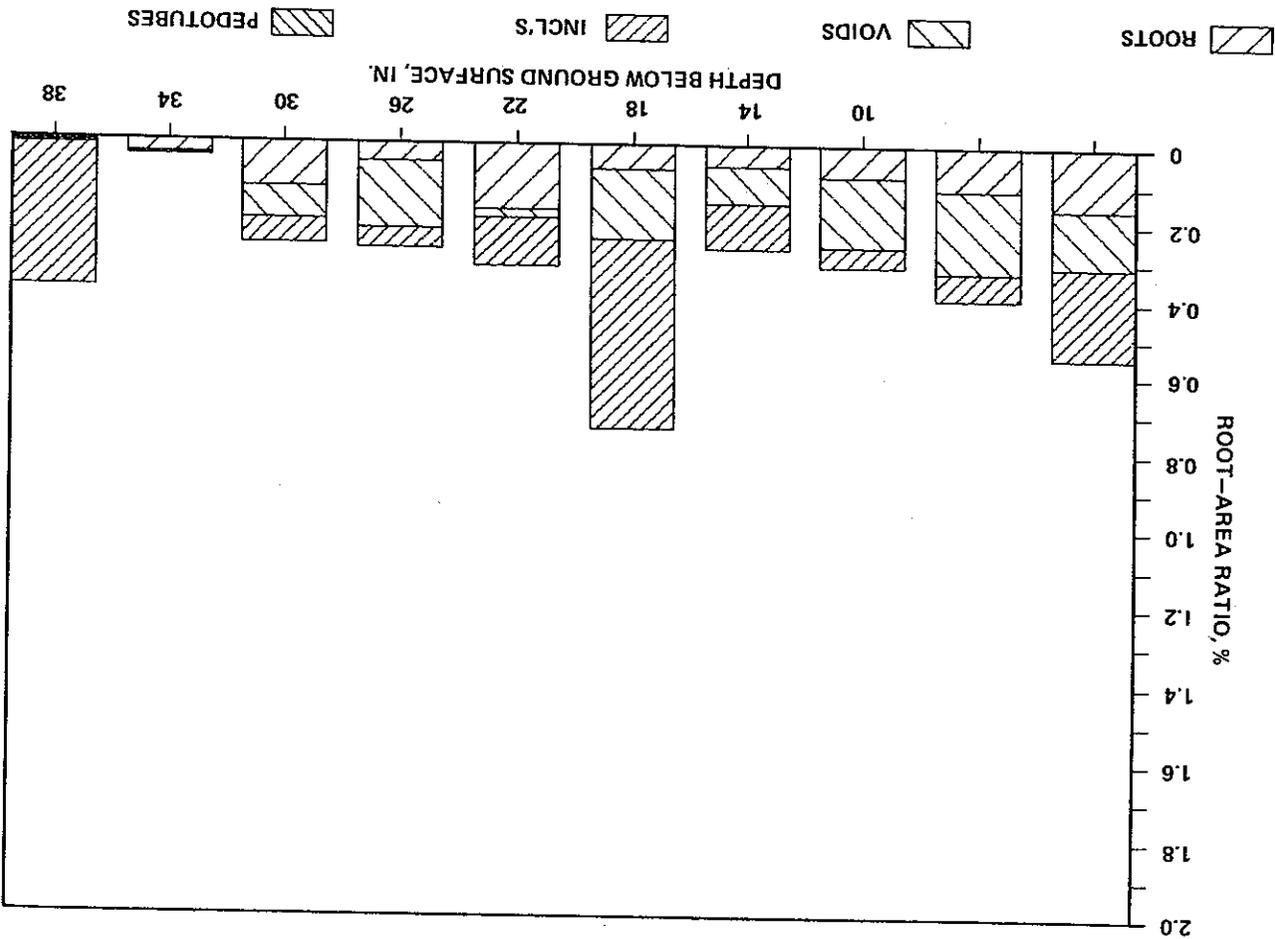
Figure 33. Total area ratio vs. depth, parallel trench, elderberry site (site 7)

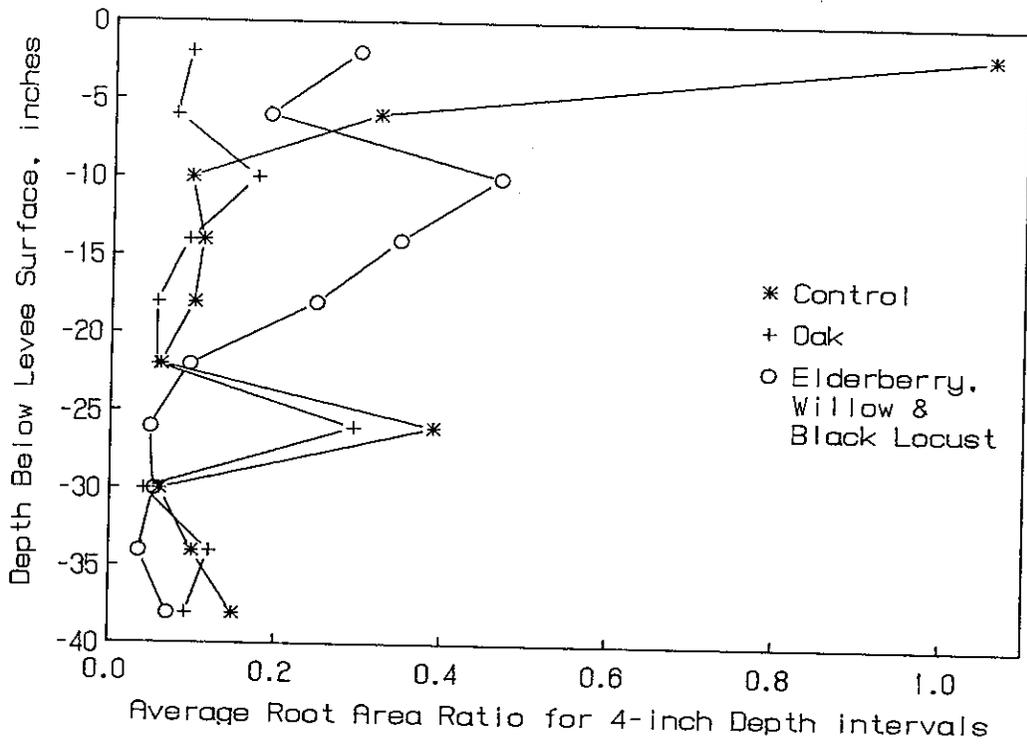
Figure 35. Average RAR profiles for control, oak and elderberry/willow/black locust trench sites

Figure 35 for the control, oak, and elderberry/willow/black locust sites. trend is shown in Figures 35 through 37. Average RAR versus depth is shown in 99. The RARs tended to decrease with depth in nearly every case. This

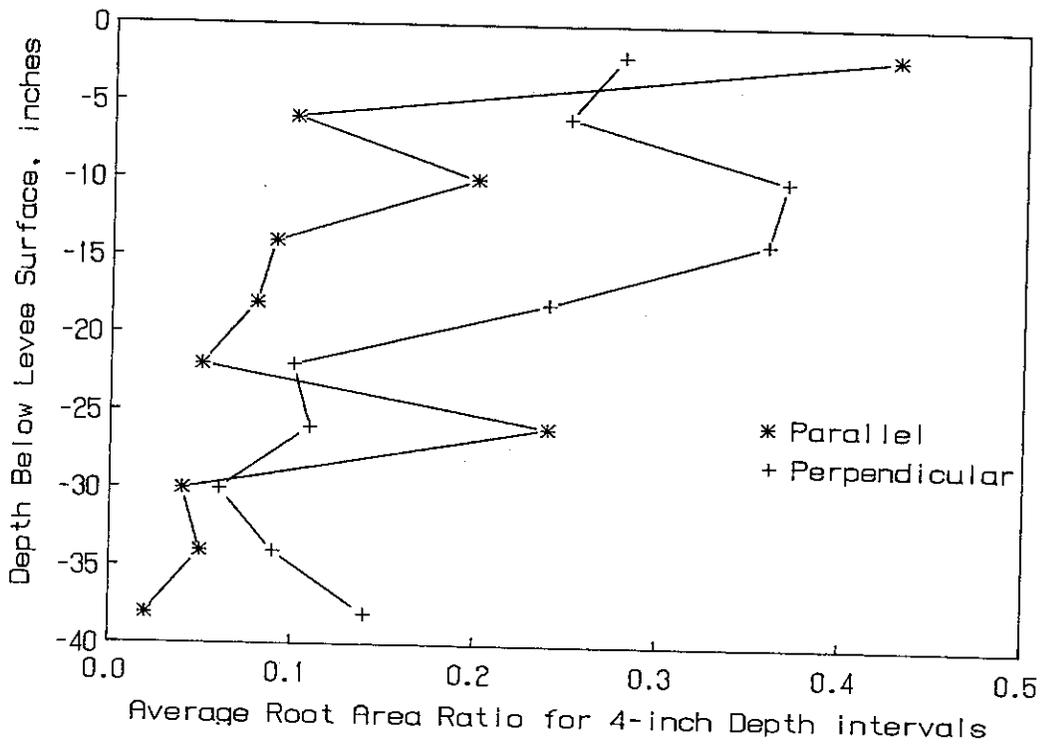
Figure 36. Average RAR profiles for parallel and perpendicular trenches, all sites, arithmetic scale

Figures 36 and 37 show RAR-depth profiles for all sites (species) plotted on arithmetic and logarithmic scales, respectively. Average RARs decreased to less than 0.1 percent in all cases at depths greater than 40 in. These root distributions and concentrations are consistent with trends and values reported in the horticultural literature. A plot of RAR versus depth for the elderberry site at the parallel and perpendicular mapping trenches is shown in Figure 38. Root concentrations decreased approximately exponentially with depth at the perpendicular trench which passed close to the centers of the stems, whereas root concentrations tended to decrease linearly with depth in the parallel trench which was located at the drip line of the bushes. These root distributions were used later to estimate likely rooting contributions to shear strength.

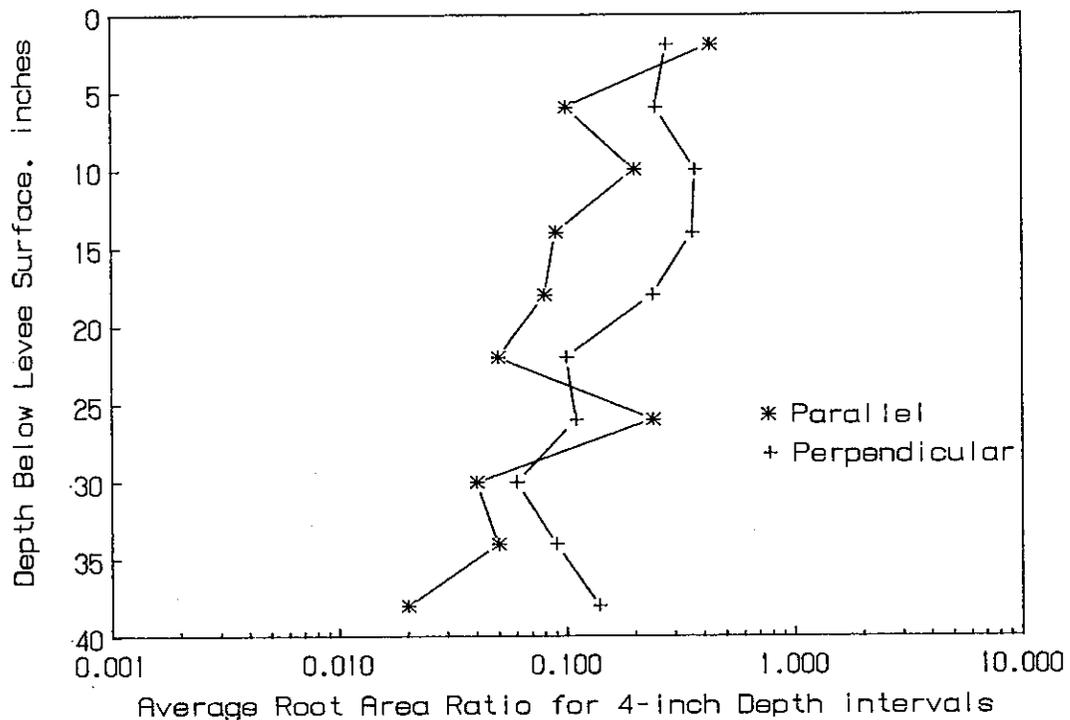
Figure 37. Average RAR profiles for parallel and perpendicular trenches, all sites, logarithmic scale

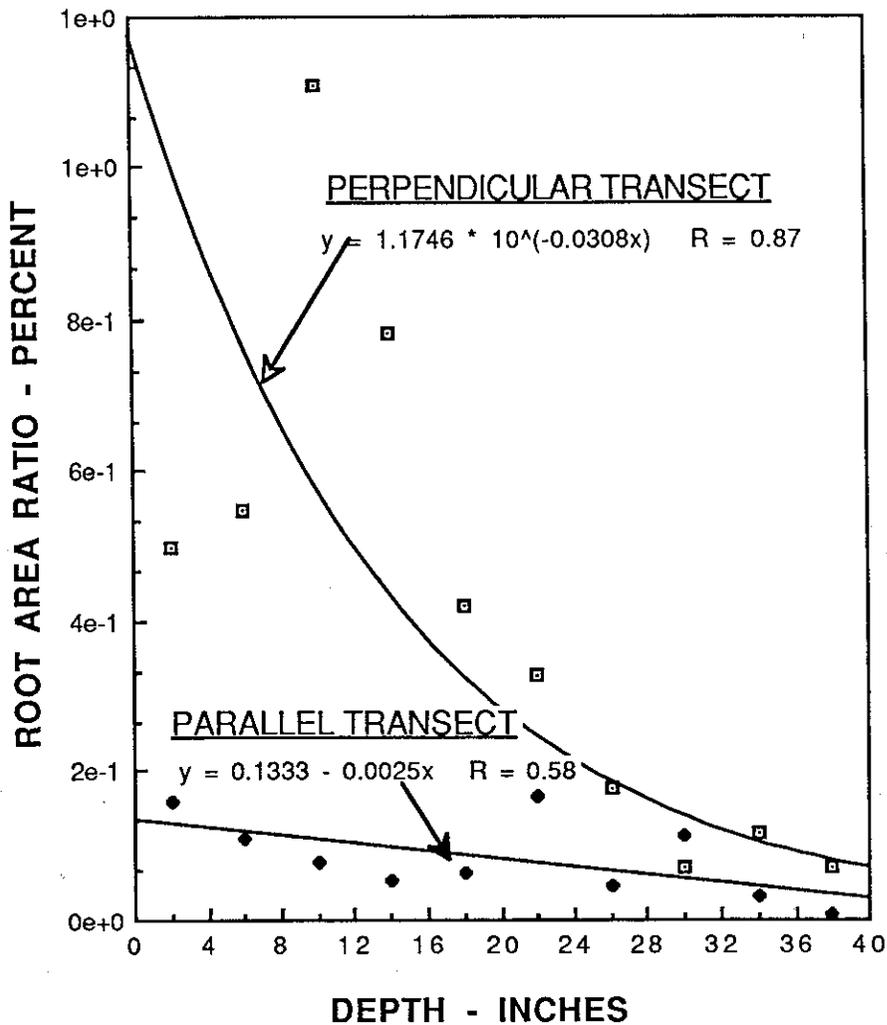
Figure 38. Functional relationship between RAR and depth in perpendicular and parallel transects, respectively, elderberry site (site 7)

141. RAR-versus-depth curves shown in Figure 38 for the elderberry site were used to estimate the likely root cohesion ( $c_R$ ) as a function of depth.

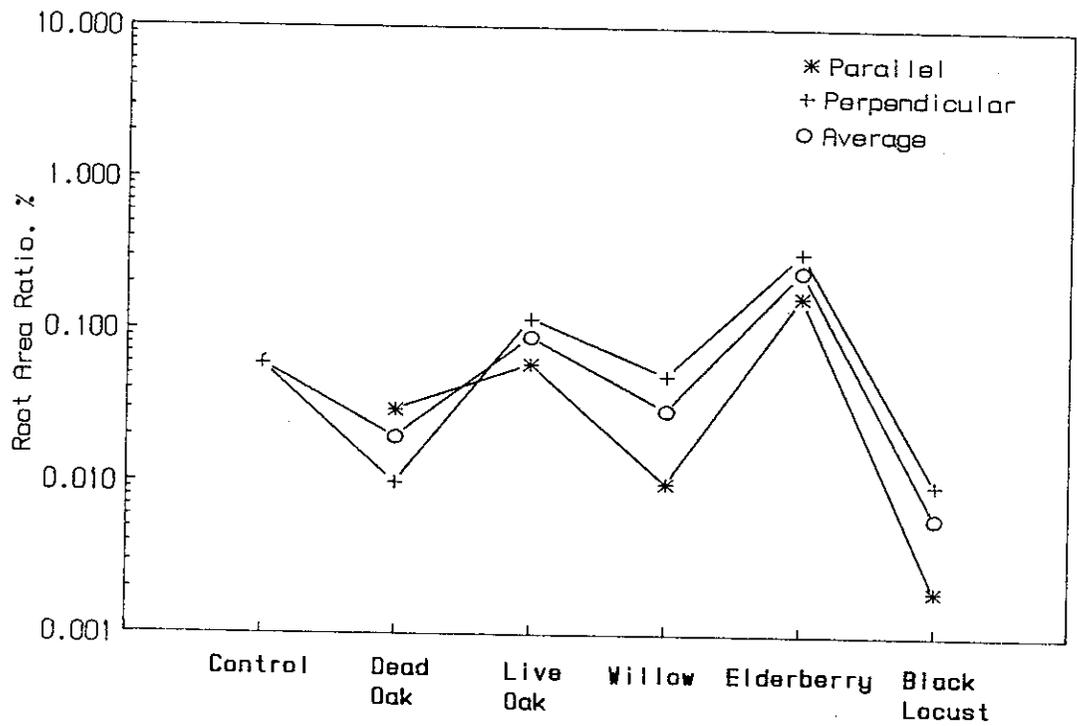
Figure 40. The RAR versus species for 20- to 24-in. depth interval

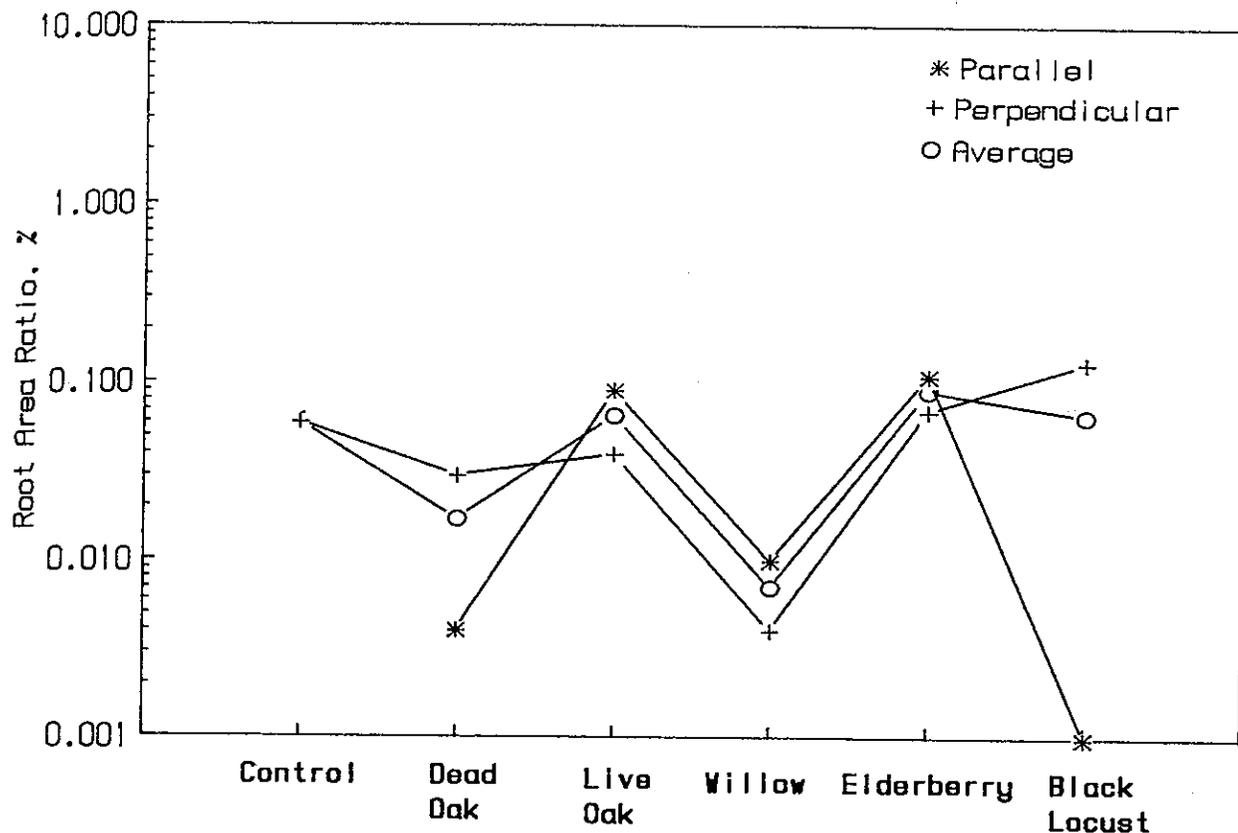
Figure 41. The RAR versus species for 28- to 32-in. depth interval trees growing in a colluvial layer of soil on a steep, slide-prone slope. They hand-excavated the root systems and measured root areas in horizontal planes as a function of depth. Their root area ratio profiles were very similar to those obtained in the present study. This finding suggests that root distributions obtained by the profile-wall method should provide reasonable estimates of root area ratios (on horizontal surfaces) with depth as well. Further study is required on this point, however, in view of the root structure revealed during the excavation of the dead oak stump.

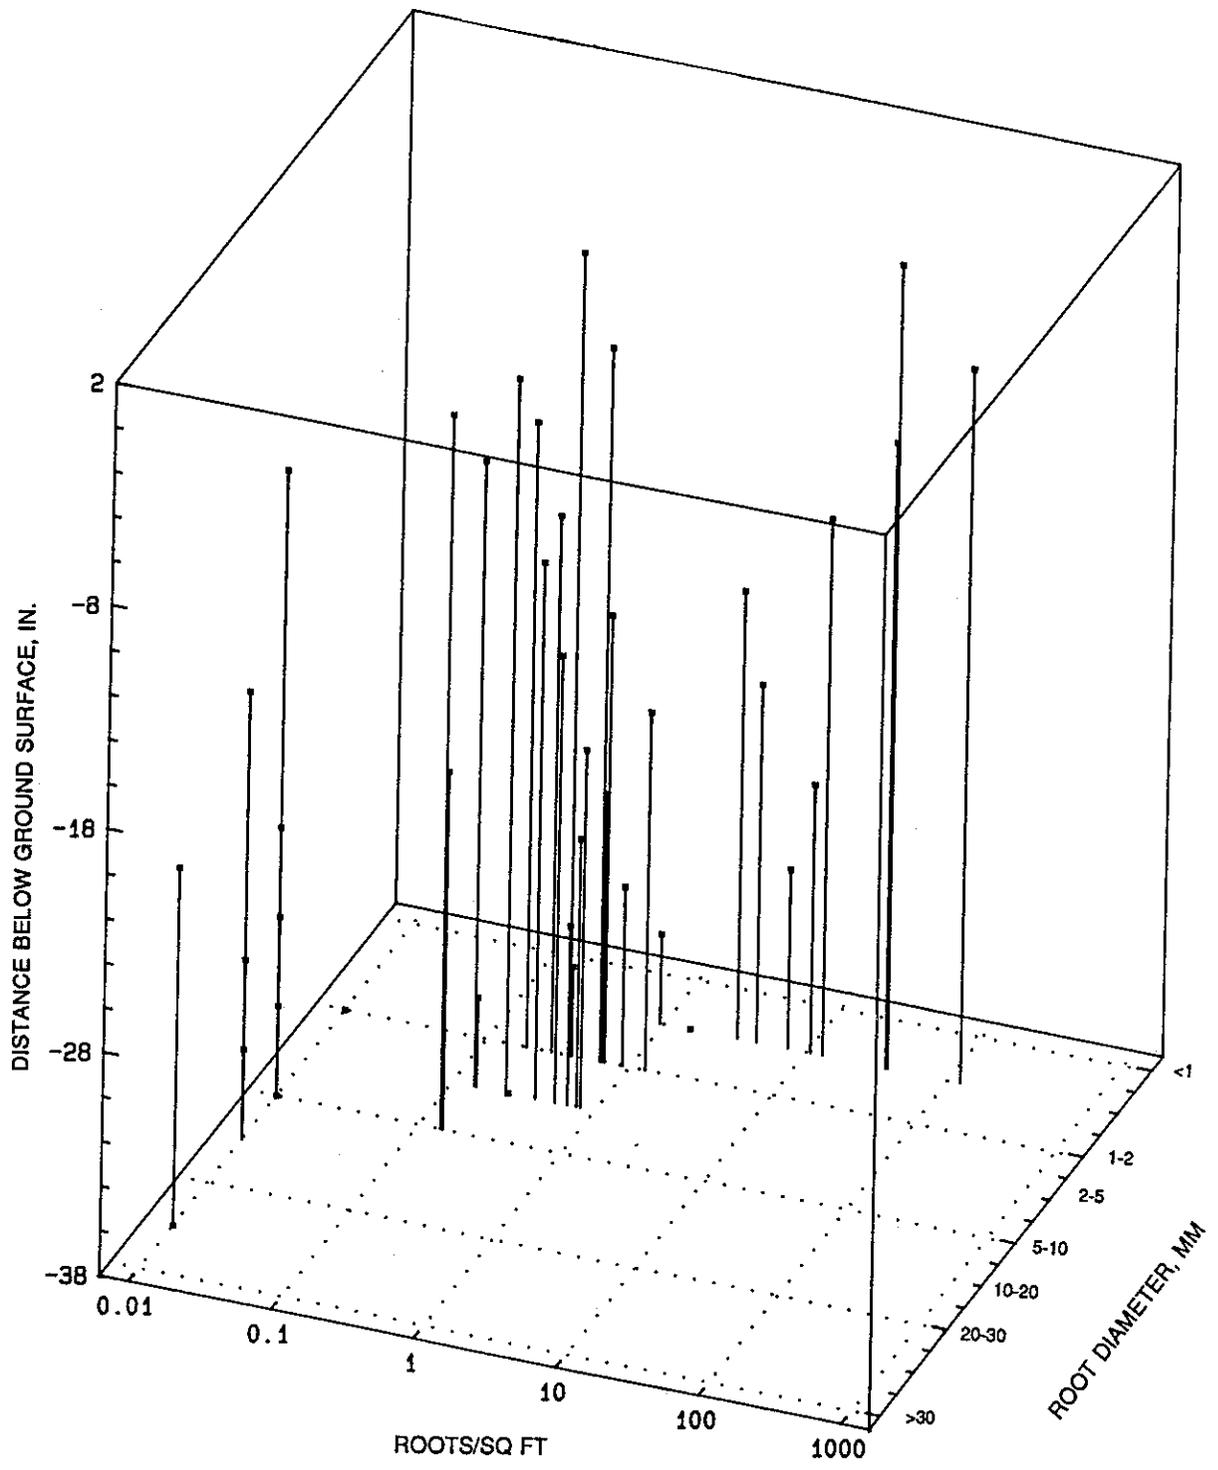
Figure 42. Root size frequency distribution, parallel trench, live oak site (site 4)

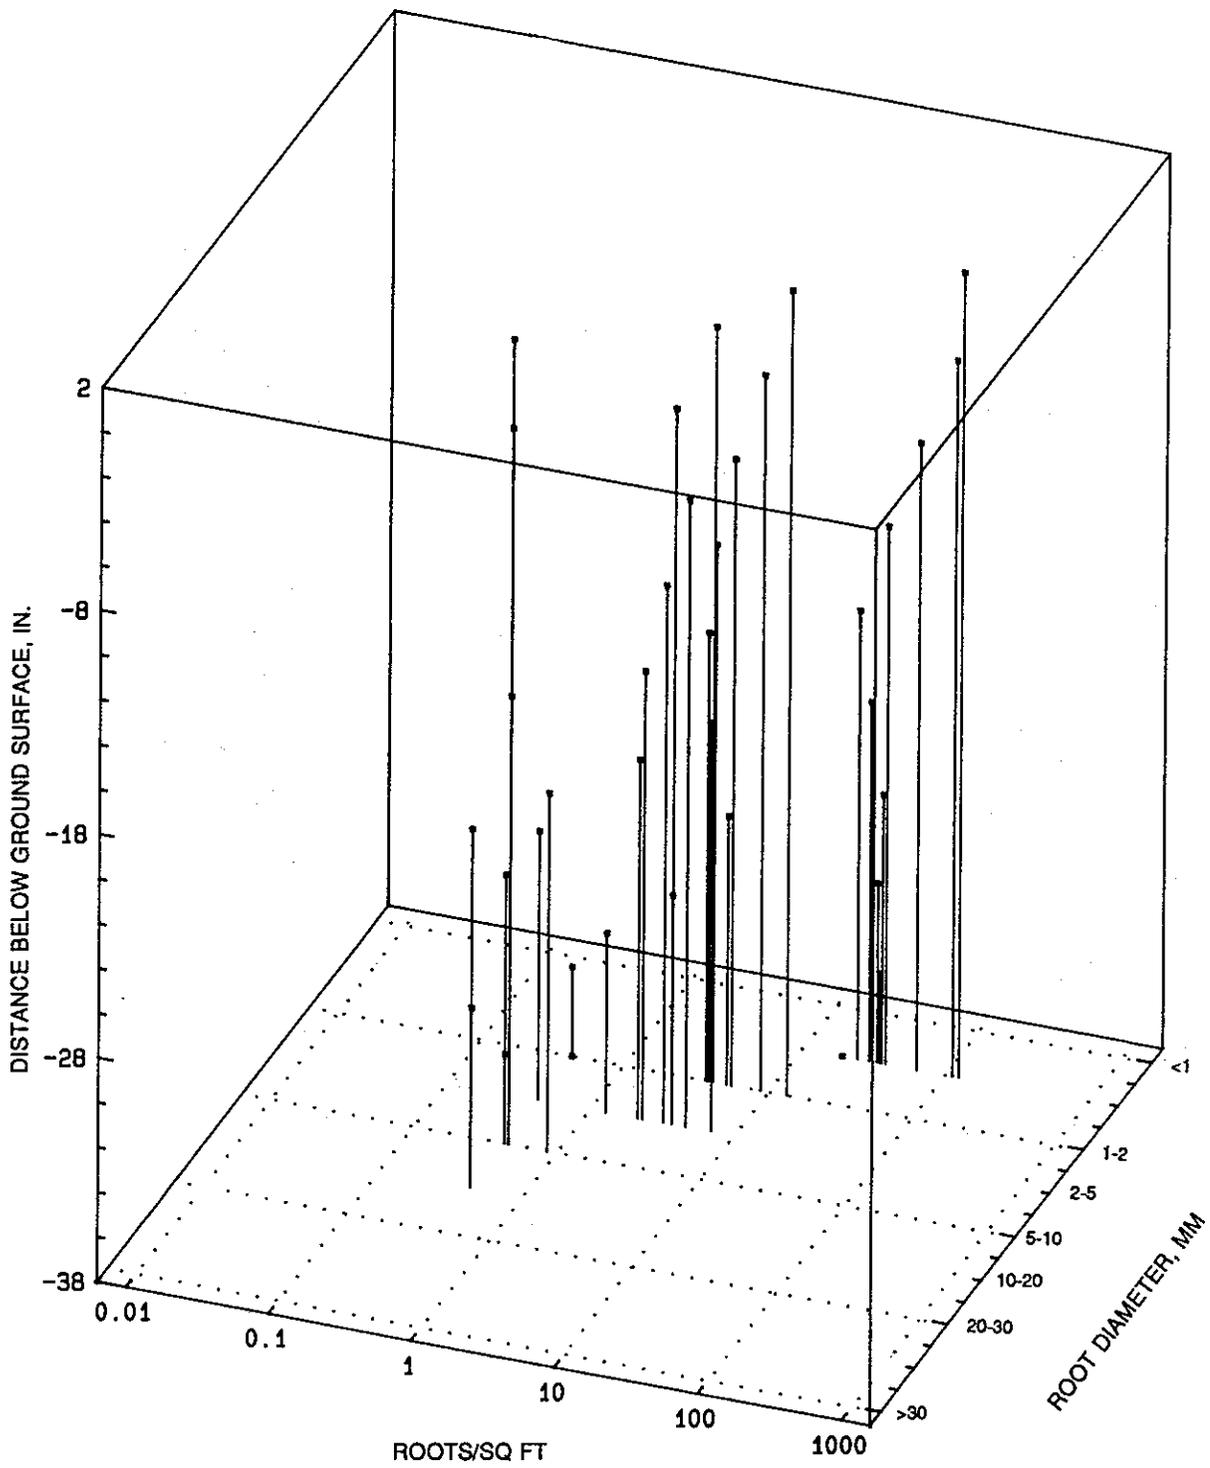
Figure 43. Root size frequency distribution, parallel trench, elderberry site (site 7)

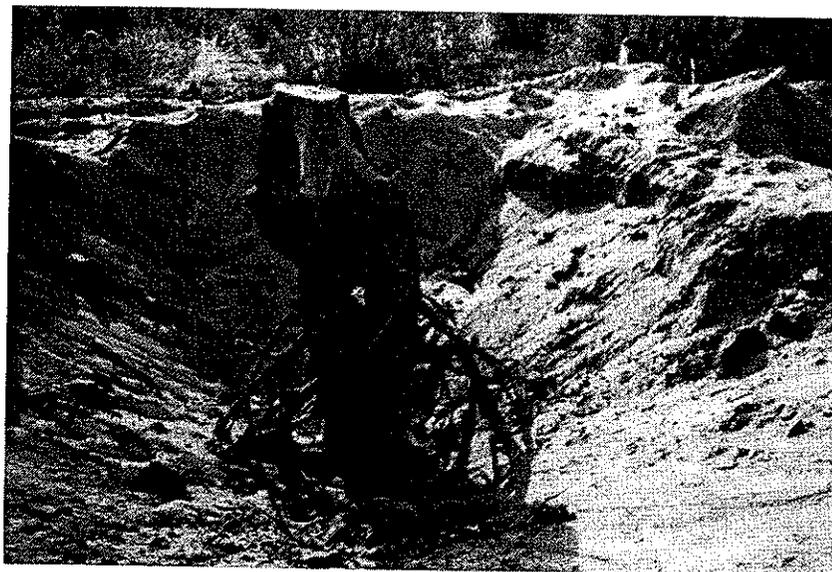
Figure 44. Photograph showing root structure and architecture of dead oak stump excavated in sandy levee, site 2

103. The root architecture of the oak was characterized by a massive, central tap root and a series of lateral roots radiating from the main tap root at a depth below the ground surface of approximately 0.6 to 1.2 m. A photograph of the excavated stump is shown in Figure 44. The most interesting and significant feature of the laterals was the angle at which they radiated away from the central tap root with respect to the ground surface. Most of these lateral roots angled down sharply rather than growing out in a quasi-horizontal attitude characteristic of lateral roots. This structure explains in part the paucity of roots exposed in the vertical mapping faces of the trenches around the oak trees at their drip lines. This structure is also consistent with the adaptability of the oaks to the levee environment and extreme droughtiness of the sandy soils that comprise the levee. The lateral

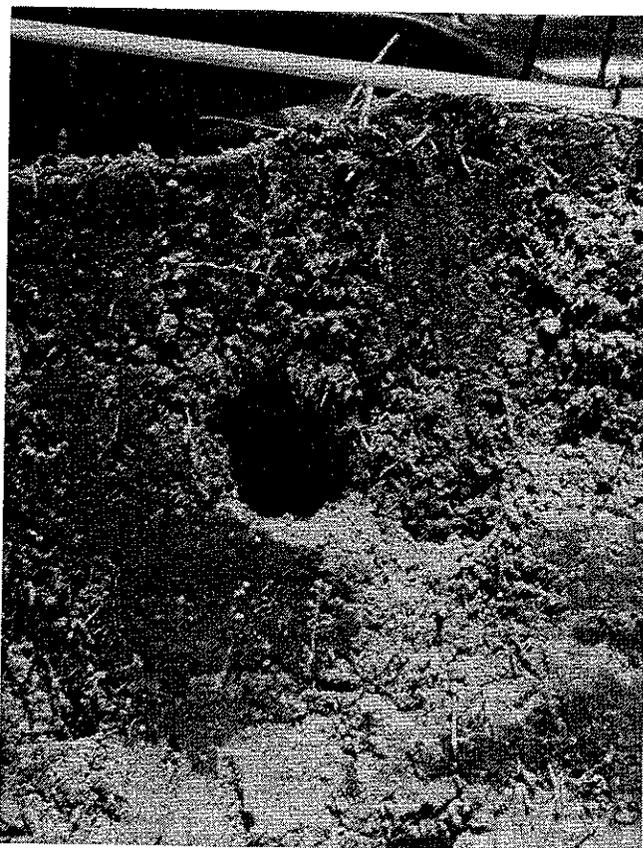
Figure 45. Photograph of ground squirrel burrows exposed in trench face at live oak site (site 4)

105. Void and pedotubule distribution. Voids and pedotubules that were exposed in the trench faces were also mapped along with roots. Unlike intact roots, open voids or conduits in a levee represent a clear and immediate danger from the point of view of a piping or internal erosion failure. Voids or holes created by burrowing rodents were easily identified in the trench faces by their size, shape, and form. An example of a ground squirrel burrow exposed in the trench face at site 4 is shown in Figure 45. These burrow holes occurred at all depths. A burrow hole located at the bottom of the

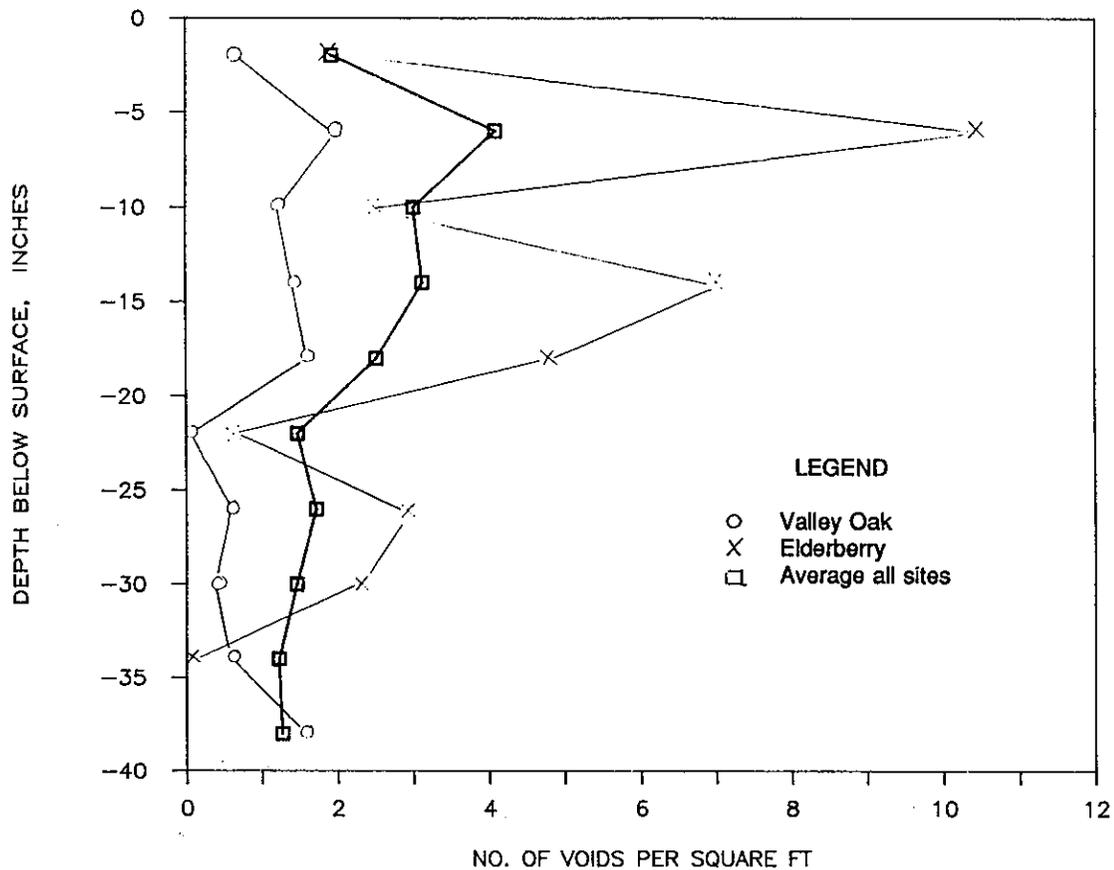
Figure 48. Void density versus depth for various trench sites

107. Void versus depth profiles were plotted for each site. The void density versus depth is shown plotted in Figure 48 for the elderberry and live oak sites. The average void count for all sites is also plotted on Figure 48.

The number of voids per square foot reaches a maximum at a depth of 6 in. and then decreases with depth to some minimum value. The number of voids per square foot tends to exceed the average at the elderberry site, and drops below the average at the live oak site. This finding can be explained as follows: voids at the elderberry site are smaller and more numerous as a result of insect activity, whereas the voids at the live oak site tend to be larger and less numerous as a result of animal (ground squirrel) burrowing. An examination of the total area ratio profiles--which include void area ratios--reveals that the live oak site had a total or combined void area ratio of 4.7 percent versus 1.3 percent for the elderberry site. This finding also supports the position that voids are less numerous but much larger on average at the oak site compared to the elderberry site.

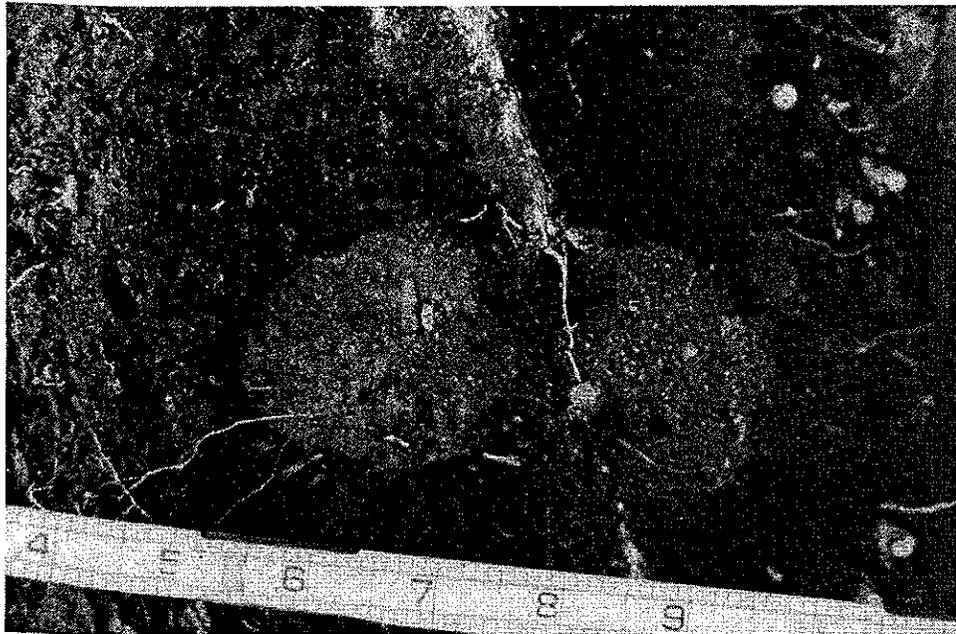
Figure 49. Example of pedotubule (No. 1) exposed in the perpendicular trench face at the live oak site (site 4)

as the squirrel burrows also observed in the same trench face. The pedotubules could be distinguished visually from the surrounding soil by differences in color and texture as shown in Figure 49. The soil from these pedotubules was analyzed further to determine if other soil properties might serve to distinguish them as well. One pedotubule (No. 1) was located approximately 9 m from the levee crest at an approximate depth of 2.2 ft, and the other (No. 2) at a depth of 0.5 ft approximately 13.5 m from the crest.

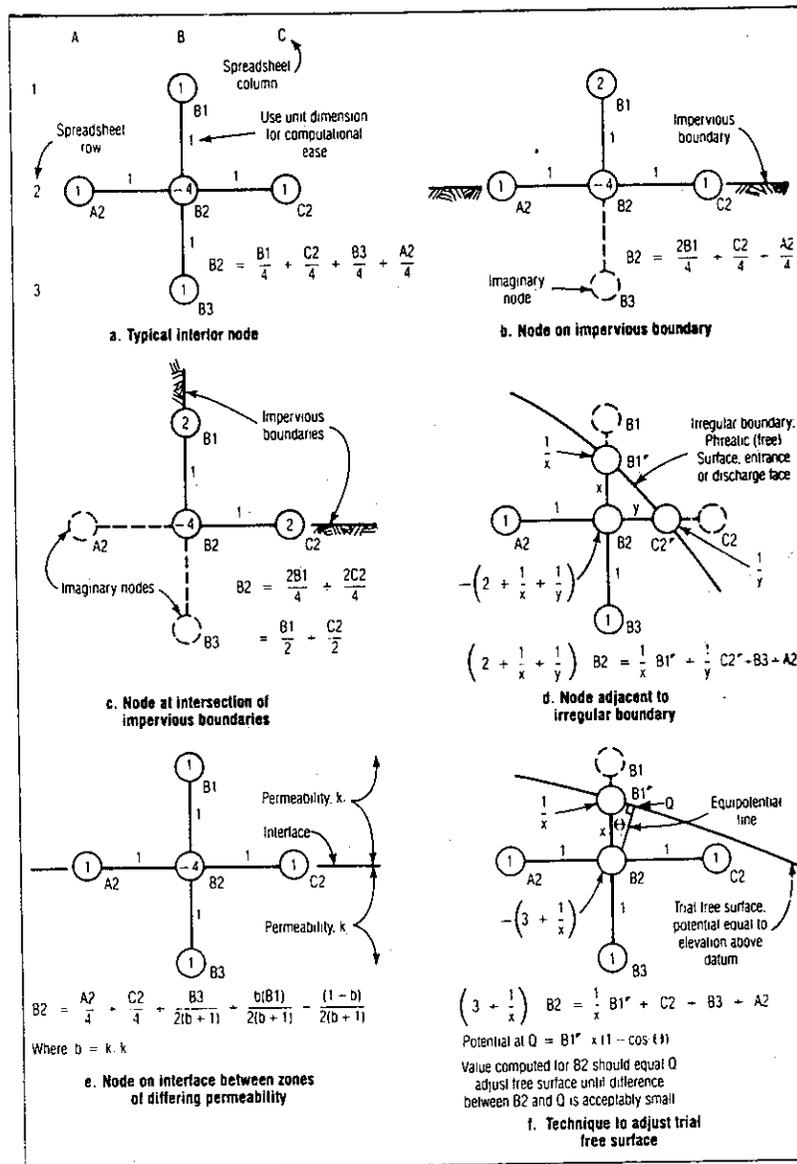
Figure 50. Summary of typical hydraulic head relationships for interior nodes, nodes adjacent to or on a boundary, and nodes on an interface between materials of different permeability (after Kleiner, 1985)

115. Steady state seepage flow through an earthen levee must satisfy the equation governing the distribution of hydraulic potential, viz., the Laplace equation, at every point. The finite difference method essentially consists of subdividing the flow region into a series of nodes or grid points and determining the appropriate finite difference equation for the hydraulic head at each point. The head at each point can be expressed in terms of the heads at surrounding or adjoining nodal points. Typical nodal relationships or rules for calculating the head at interior nodes, nodes adjacent to or on a boundary, and nodes on an interface between material of different permeability, are summarized in Figure 50.

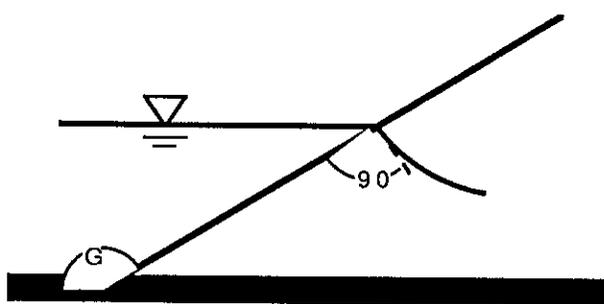
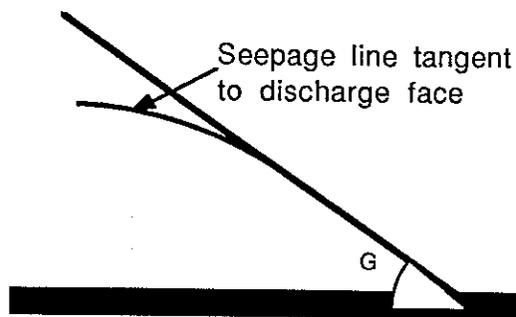
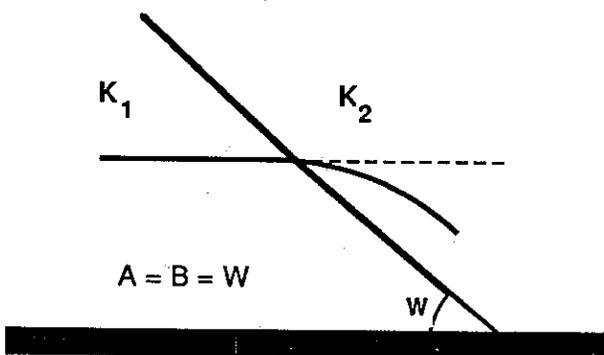
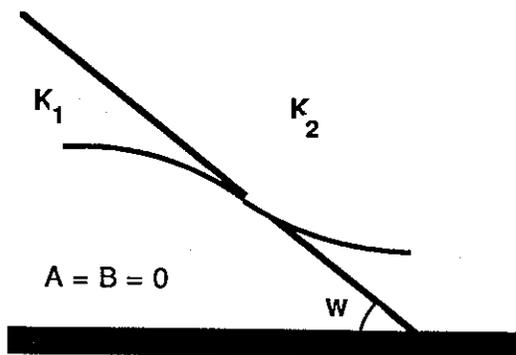
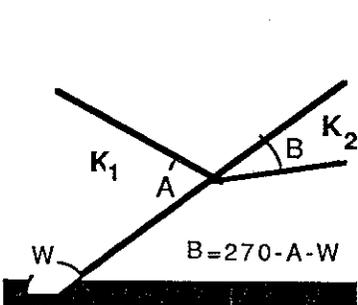
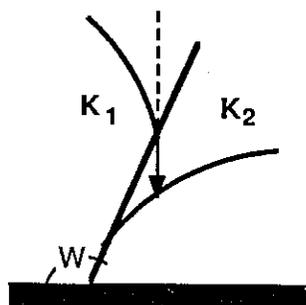
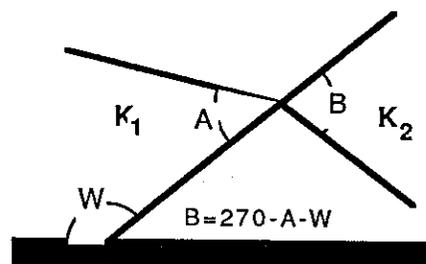
Entrance Condition ( $G > 90$ )

Exit Condition ( $G < 90$ )

Figure 51. Entrance, discharge, and transfer conditions for phreatic surface during seepage flow through a levee

117. The orientation of the phreatic surface in unconfined seepage through an embankment or levee depends upon a number of factors. The influence of entrance, discharge, and interface transfer conditions relevant to seepage flow through a levee are summarized in Figure 51.

118. The effect of a permeability discontinuity upon the change in direction of phreatic surface at the interface depends upon both the permeability ratio ( $K_1/K_2$ ) and the orientation of the interface ( $W$ ) as shown in Figure 51. The direction of the line of seepage must satisfy the Forcheimer relationship, viz.,

where: A and B are angles of incidence and departure, respectively, of the seepage line with respect to the interface. In addition to the Forcheimer relationship, the direction of the line of seepage must also satisfy the condition  $B = 270 - A - W$  for the cases noted in Figure 51.

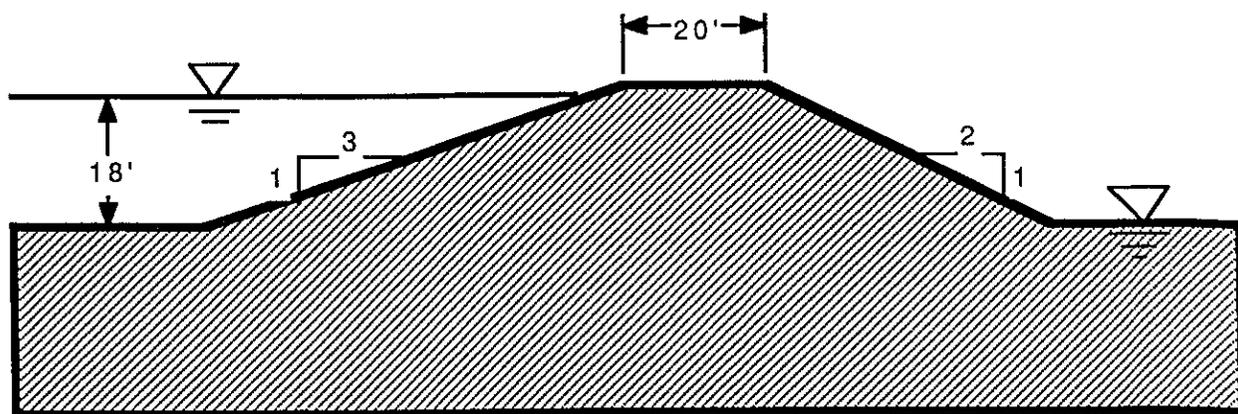
Figure 52. Standardized geometry adopted for seepage and stability analyses. Levee dimensions (height) are less important if the main purpose of the seepage analysis is to compare behavior with and without a modified surface layer or skin.

119. Standardized levee geometry. A standardized levee profile or geometry was adopted for the seepage analyses, as shown in Figure 52. The same side slopes and crest width specified in the standard levee sections shown in Figures 17 through 20 were retained for the seepage analyses. The embankment height was set at 20 ft. A 20-ft levee height with the use of 1-ft nodal spacings facilitated calculations in the seepage simulation. The actual

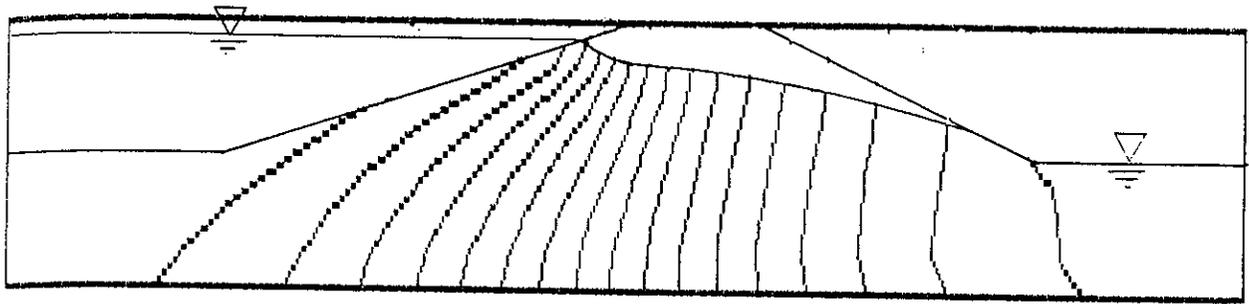
Figure 53. Equipotential lines and hydraulic head distribution for a homogeneous levee cross section

122. The spreadsheet output was converted to a data file that was used as the input to a contour or isopotential plotting program. The resulting equipotential map is shown in Figure 53 together with the location of the phreatic surface and the free water surface.

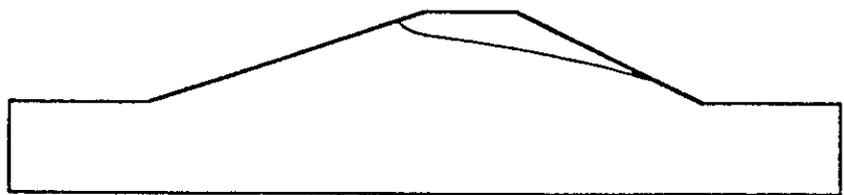
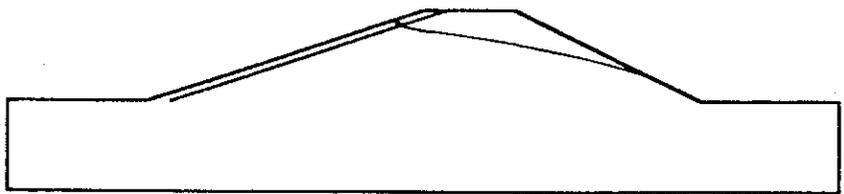
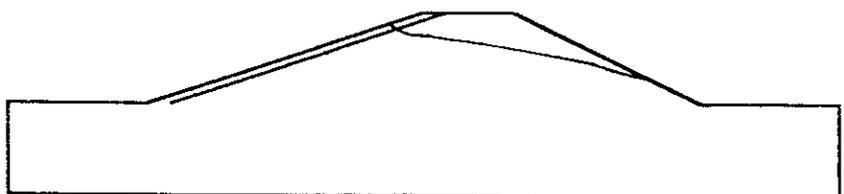
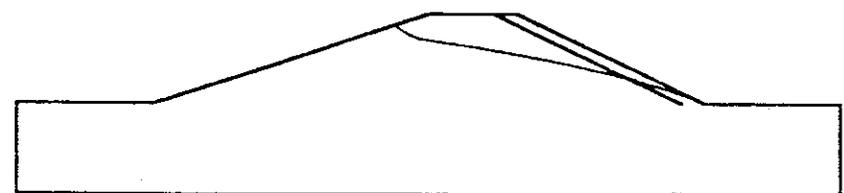
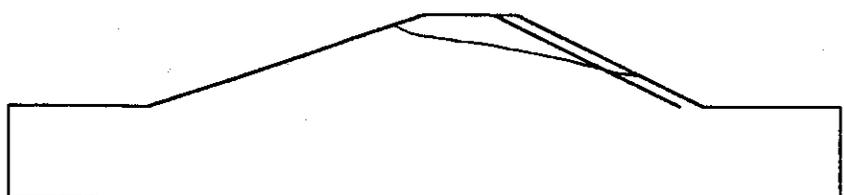
a) levee with constant permeability ,  $k_2$

b) levee with a 1-ft layer of permeability ,  $k_1$  and  $k_1 / k_2 = 10$

c) levee with a 1-ft layer of permeability ,  $k_1$  and  $k_1 / k_2 = 0.1$

d) levee with 1-ft layer of permeability ,  $k_1$  and  $k_1 / k_2 = 10$

e) levee with 1-ft layer of permeability ,  $k_1$  and  $k_1 / k_2 = 0.1$

Figure 54. Schematic illustration showing influence of a modified surface permeability on the line of seepage

124. The first task was to determine the influence of a surface layer or skin on the location of the phreatic surface as shown schematically in Figure 54. This was accomplished by following the transfer condition rules summarized earlier in Figure 51. The "skin" was assumed to be either more or less permeable than the core by a factor of 10. The subsequent influence on the location and orientation of the phreatic surface as a result of this permeability contrast is depicted schematically in Figure 55.

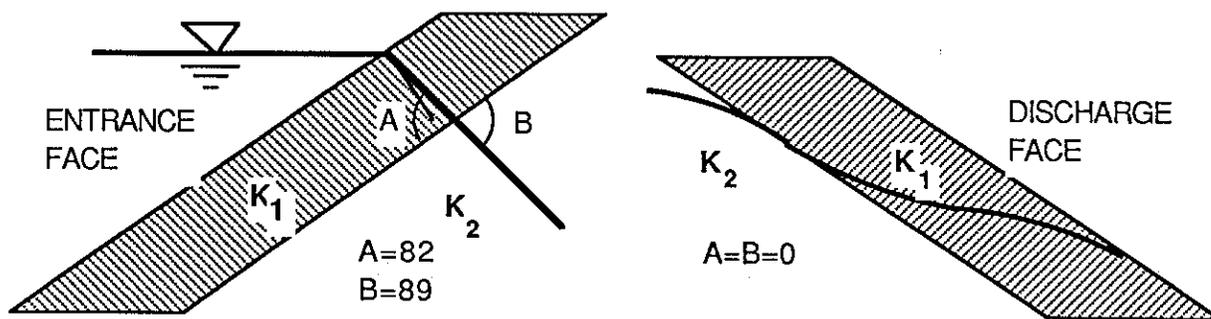
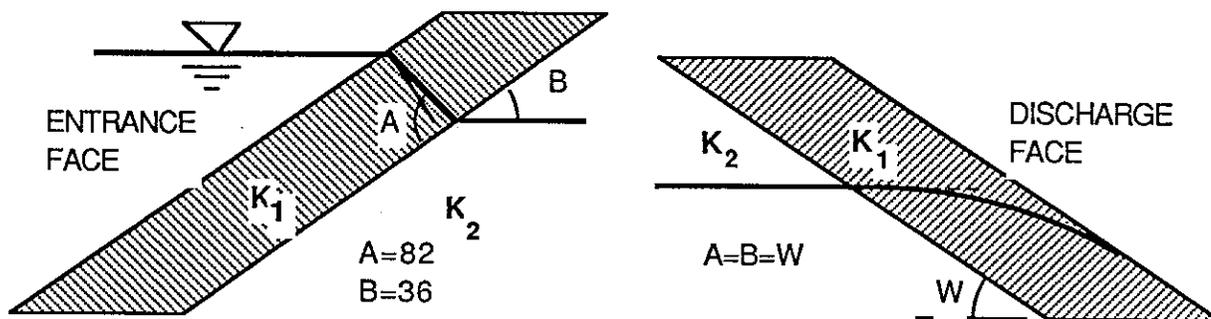
(A) MORE PERMEABLE "SKIN" ( $K_1 = 10 K_2$ )

(B) LESS PERMEABLE "SKIN" ( $K_1 = 0.1 K_2$ )

Figure 55. Influence of permeability contrast between facing or "skin" and core of levee on line of seepage

125. The location of the phreatic surface is not greatly influenced by a modified surface on the upstream slope. Nor are the consequences of the change very significant. This is not the case, however, on the downstream side. A less permeable layer elevates the phreatic surface and increases the area of discharge on the downstream face whereas a more permeable layer depresses the phreatic surface and lowers the emergence point relative to the homogeneous case. A detailed view showing the influence of a permeability contrast between a surface layer and core at the upstream and downstream faces, respectively, is presented in Figure 55.

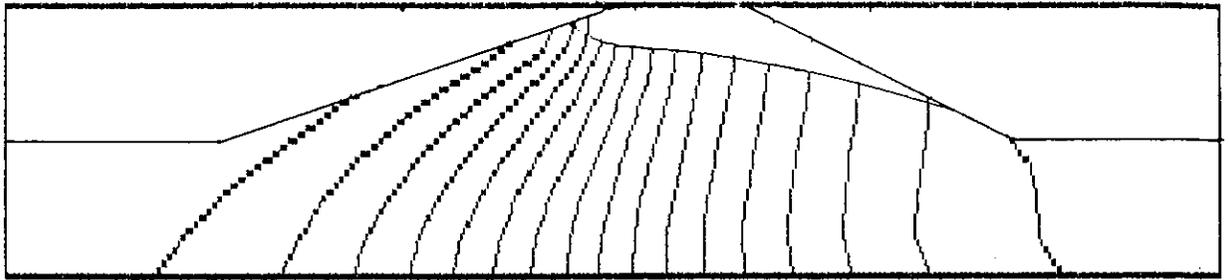
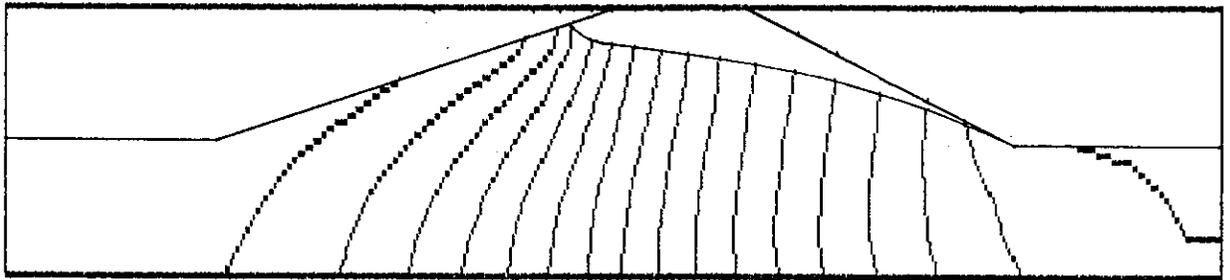
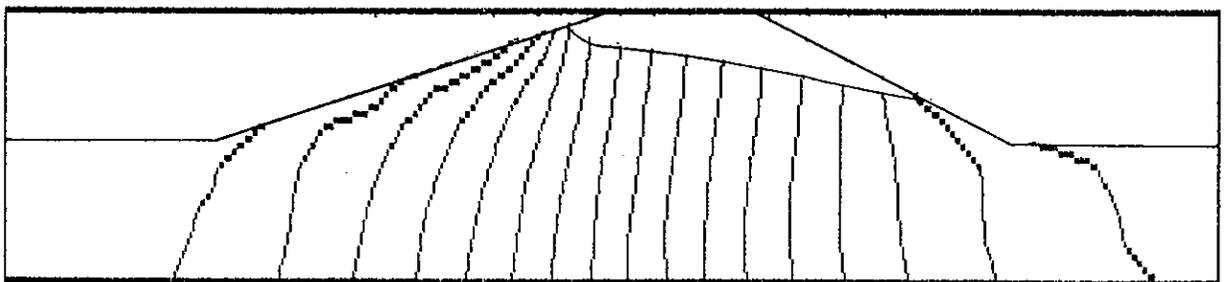
HOMOGENEOUS LEVEE

MORE PERMEABLE SKIN ( $K_1 = 10 \times K_2$ )

LESS PERMEABLE SKIN ( $K_1 = 0.1 \times K_2$ )

Figure 56. Equipotential lines and hydraulic head distribution for homogenous levee and levees with a surface layer having a different permeability on the landward face

Figure 56. The following tentative conclusions can be drawn from the results of the comparison shown in Figure 56:

- a. A less permeable skin elevates the phreatic surface and increases the discharge area or seepage zone on the downstream face.
- b. A less permeable skin results in considerably higher exit gradients (closely spaced equipotential lines) at the discharge face near the toe.

127. Some distortion of the equipotential lines resulted from the relative coarseness of the grid or nodal spacing used in the spreadsheet analysis. A nodal spacing of 1 ft was used in the present study. The fidelity of the equipotential lines and hydraulic head distribution could be improved by using
