4. TITLE AND SUBTITLE  The Effects of Vegetation on the Structural Integrity of Sandy Levees	5. FUNDING NUMBERS  WU 32374
--	------------------------------------

8. PERFORMING ORGANIZATION REPORT NUMBER  Technical Report REMR-EI-5	9. SPONSORING/MONITORING AGENCY NAME(S) AND ADDRESS(ES)  US Army Corps of Engineers, Washington, DC 20314-1000
---	--

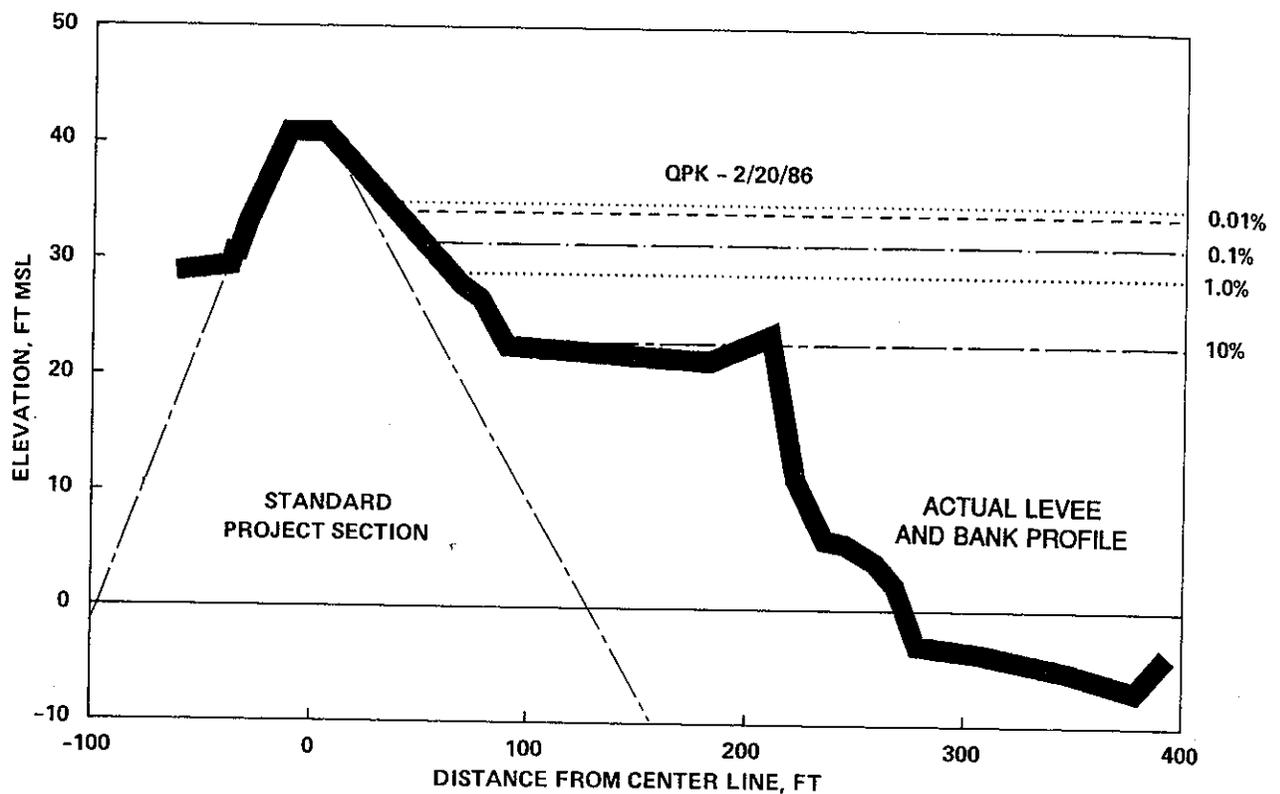
Figure 57. Typical flood-duration record for a levee site, Sacramento River channel levee (percentages represent the amount of time during the 1986 winter period during which these stages were equalled or exceeded, based on daily discharge values and supplemented by hourly values for the 1986 flood above 0.1 percent)

129. Flood stage duration records for the reach of levee in question along the Sacramento River indicate that (a) the peak flood levels have not risen more than 6-7 ft above the base of the levee, and (b) the duration of the near peak levels is not more than a few hours. A typical flood stage duration record is shown in Figure 57.

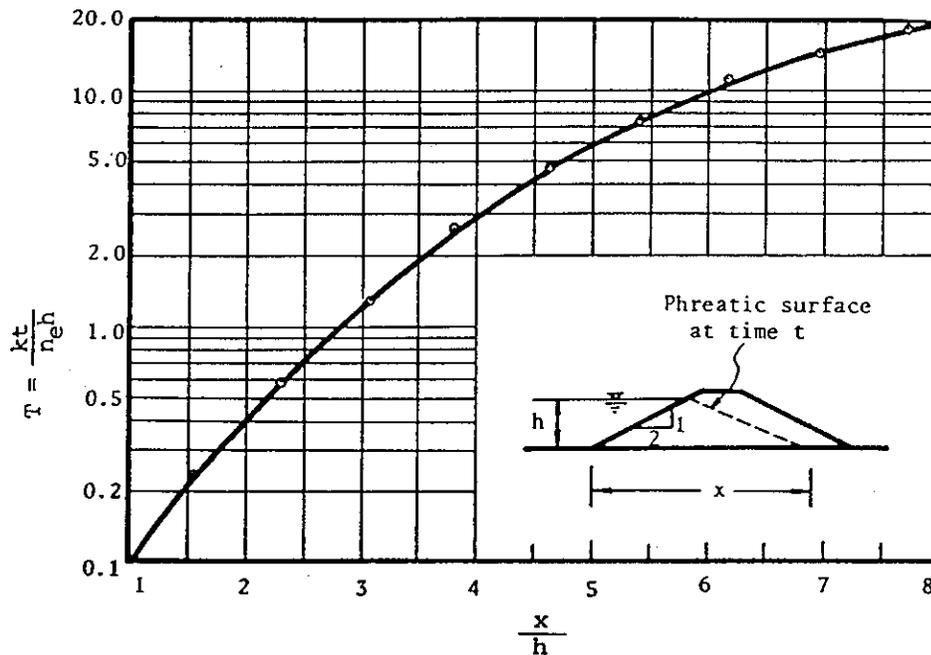
Figure 58. Plot of dimensionless time (T) versus dimensionless distance (x/h) for determining location of transient phreatic surface (from Huang 1986)

130. Huang (1986) has presented a simple method for locating the unsteady state or transient phreatic surfaces in an earth dam or levee. The phreatic surface progresses over time from the upstream to downstream face, with the upper end fixed at the pool (free water) elevation and the lower end moving along the base of the levee. Huang derived an equation to predict the distance (x) from the heel of the levee as a function of time (t). A plot of dimensionless distance (x/h) versus dimensionless time (T) is shown in Figure 58. The dimensionless time T is defined as follows:

131. At any given time,  $t$ , the distance  $x$  can be determined from Figure 58 and the phreatic surface located. The relationship in Figure 58 is, strictly speaking, only valid for cases involving an upstream slope of 2:1 and an impervious horizontal base. Flatter slopes can be handled using a procedure described by Huang, and the presence of a permeable foundation beneath the levee leads to conservative estimates.

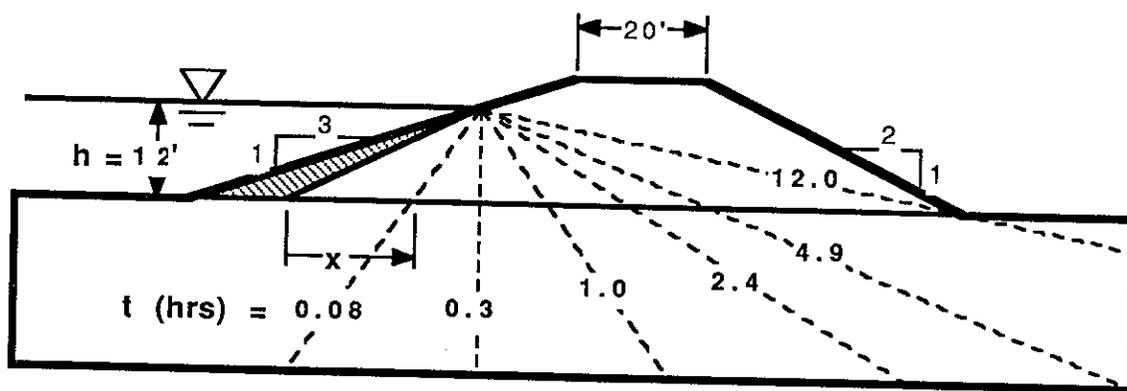
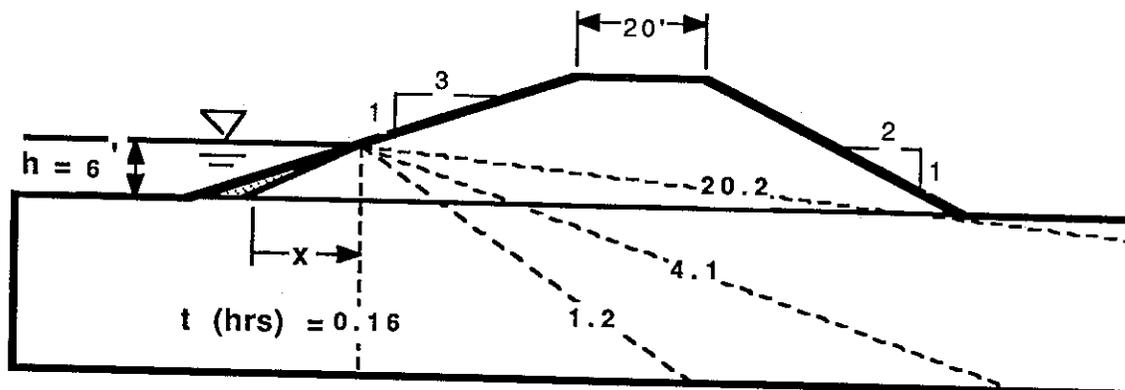
(A) HIGH FLOOD STAGE - 12 FT ABOVE BASE OF LEVEE

(A) LOW FLOOD STAGE - 6 FT ABOVE BASE OF LEVEE

Figure 59. Development of transient phreatic surfaces with time in a sandy levee for two different flood stage elevations (assumed permeability = 0.05 cm/sec)

132. Huang's method was used to plot the location of the transient phreatic surfaces for both a "low" (6-ft) and "high" (12-ft) flood stage. The results are shown in Figure 59. The time required for the phreatic surface to reach the toe of the levee under a low and high flood, respectively, are approximately 20 and 12 hr. Accordingly, not only are actual, maximum FWLs less than those assumed in the analyses described herein, they are also of

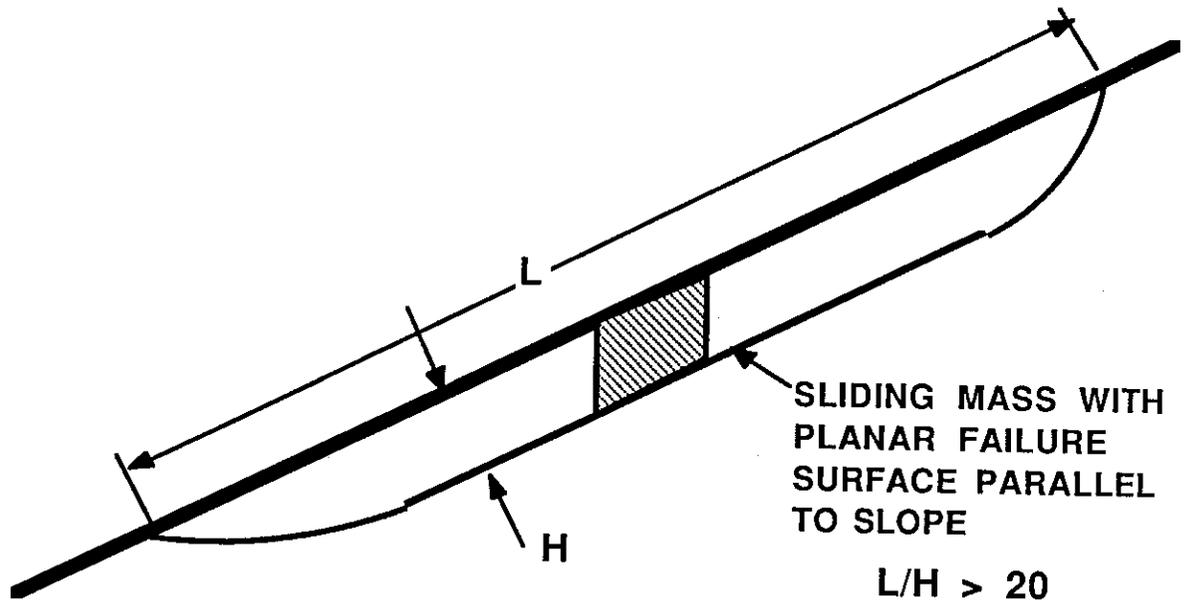
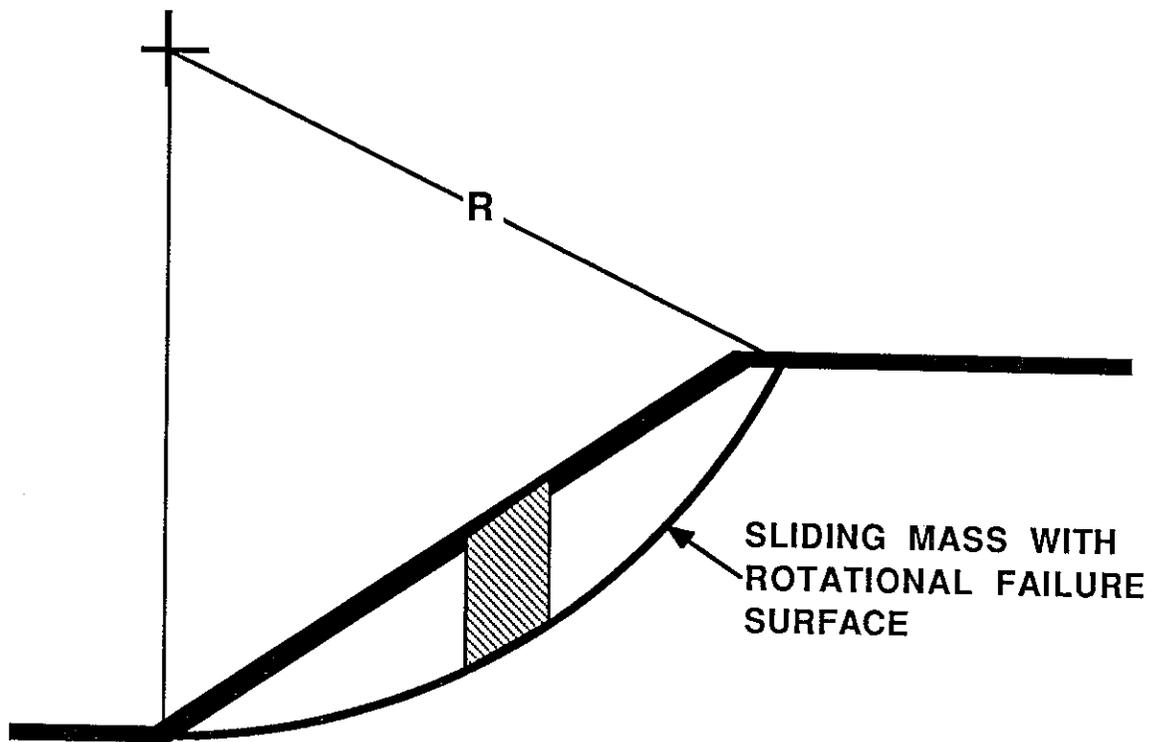
(A) INFINITE SLOPE MODEL

(B) CIRCULAR ARC FAILURE MODEL

Figure 60. Slope failure models for mass stability analysis  
((a) = infinite slope model; (b) = circular arc model)

137. Both types of failure models, infinite slope and circular arc, are depicted schematically in Figure 60. In the case of a levee embankment or dam, both the upstream and downstream slopes are vulnerable to a mass stability failure. The upstream slope can fail as a result of rapid drawdown, e.g., a rapidly subsiding flood crest, and the downstream slope as a result of steady seepage (either parallel to or emerging from the face of the levee).

model is no longer valid. This analysis assumes that the length of the sliding mass is large relative to its thickness ( $L > 20 H$ ) as shown in Figure 60. For a 15-ft-high sandy levee, this criteria translates to a thickness of 1.7 and 2.4 (or vertical depth to the sliding plane of 1.9 and 2.5) for 2:1 and 3:1 slopes, respectively. At sufficiently large depths ( $H > 4$  ft) the root concentrations and reinforcement will decrease to zero. At these depths the sliding mass will not have the dimensions or aspect ratio required by the infinite slope model. When this condition is no longer observed, then another type of analysis, either a circular arc or log spiral failure analysis, should be used as well.

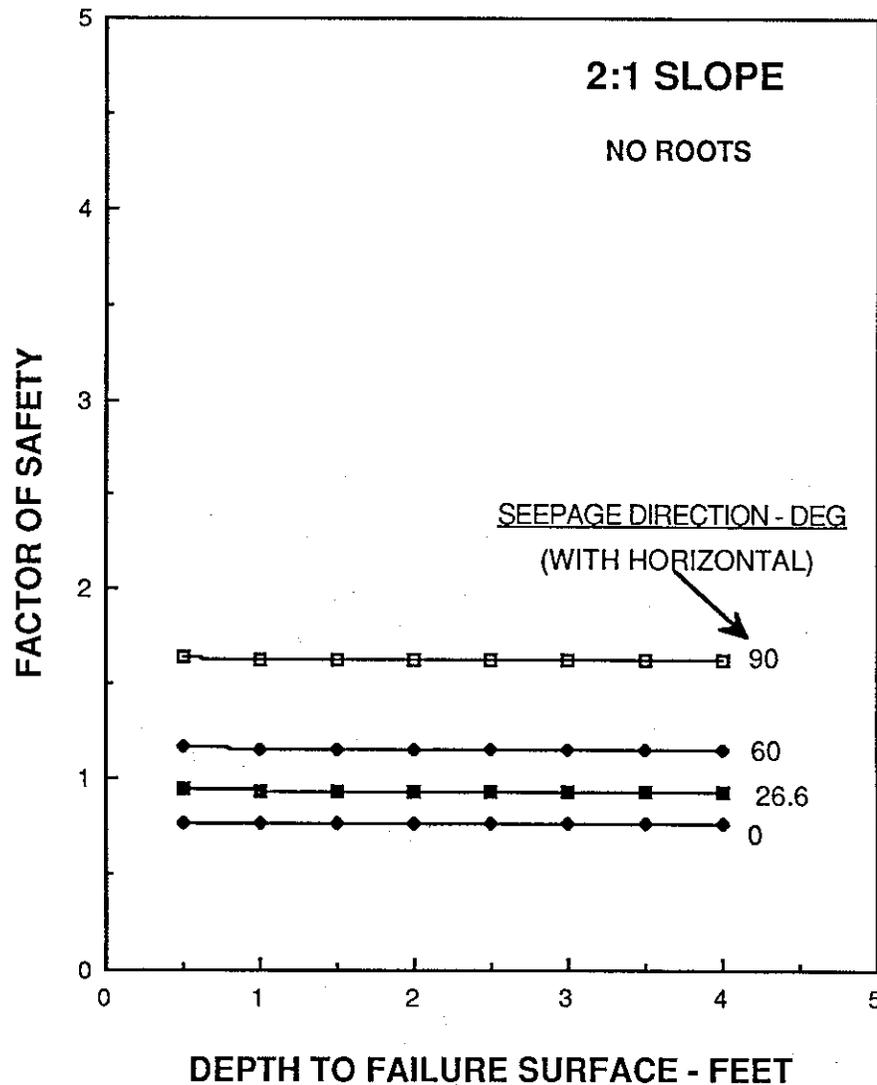
Figure 61. Infinite slope analysis of saturated (2:1) downstream slope of levee without roots (friction angle =  $36^\circ$ )

145. Results from the spreadsheet analyses are presented graphically in Figures 61 through 64 for the case of soil friction angle equal to  $36^\circ$ . Factor of safety is plotted as a function of depth and seepage direction for the case of no root cohesion ( $c_R = 0$ ) for the 2:1 and 3:1 slope, respectively, in Figures 61 and 62. The factor of safety drops below one when the seepage either parallels or emerges from the slope face for the 2:1 slope. The corresponding factor of safety for the case of low root concentrations is plotted in Figures 63 and 64. The factor of safety exceeds unity for all depths and seepage directions in this case (except for low seepage angle directions in the 2:1 slope).

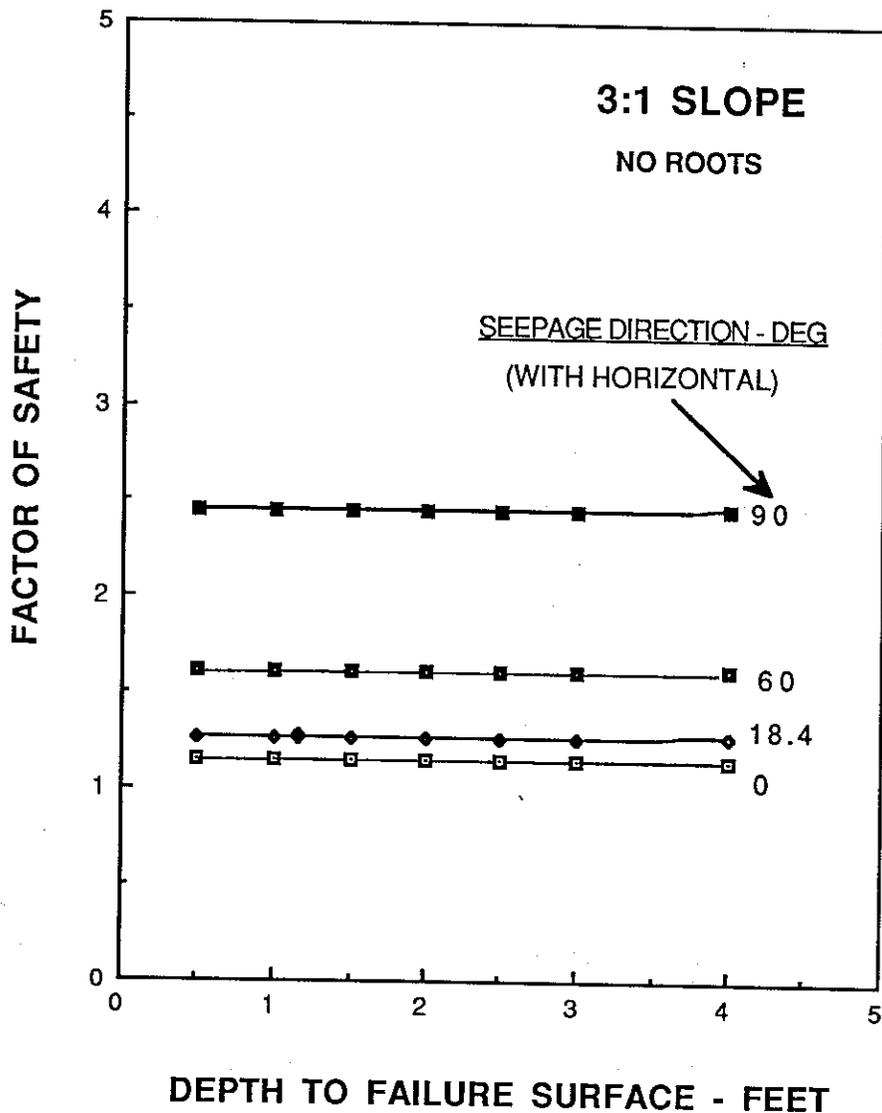
Figure 62. Infinite slope analysis of saturated (3:1) downstream slope of levee without roots (friction angle = 36°)

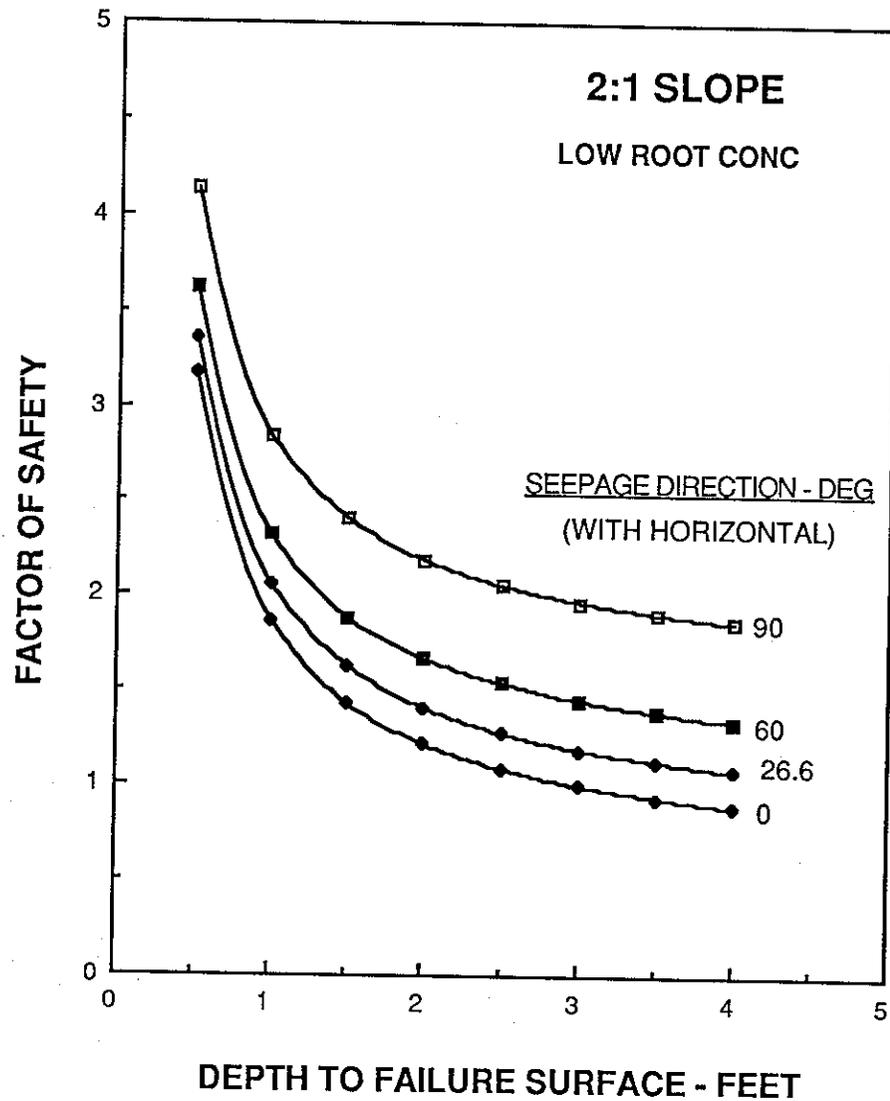
Figure 63. Infinite slope analysis of saturated (2:1) downstream slope of levee with roots (friction angle = 36°)

146. The results show that both the seepage direction ( $\theta$ ) and presence of root cohesion ( $c_R$ ) have a significant effect on the factor of safety. Even a small amount of root cohesion can increase the factor of safety substantially. This influence is very pronounced at shallow depths where root concentrations are highest and reinforcement effects, therefore, greatest. In this regard grass roots appear to be just as effective as tree and shrub (woody) roots because of their high concentration at shallow depths. The RARs measured at the control site, for example, exceeded all other sites at depths under 6 in. (see Figures 35 and 36) because of the abundance of grasses and herbaceous ground cover at this location. In the presence of root cohesion, even for low root concentrations, the factor of safety exceeds unity at all depths up to 2.0 ft even for worst case scenario conditions of low friction angle ( $\phi = 28^\circ$ ) and seepage emerging from the slope ( $\theta = 0^\circ$ ).

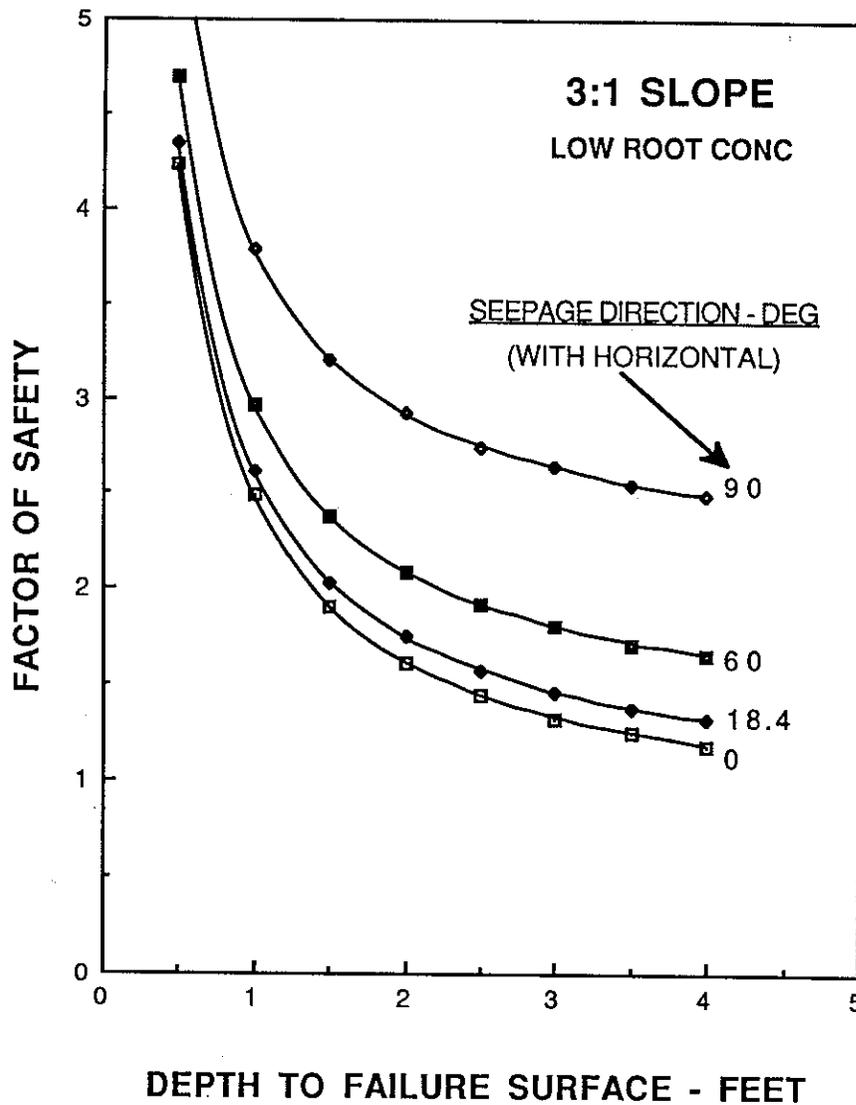
Figure 64. Infinite slope analysis of saturated (3:1) downstream slope of levee with roots (friction angle = 36°)

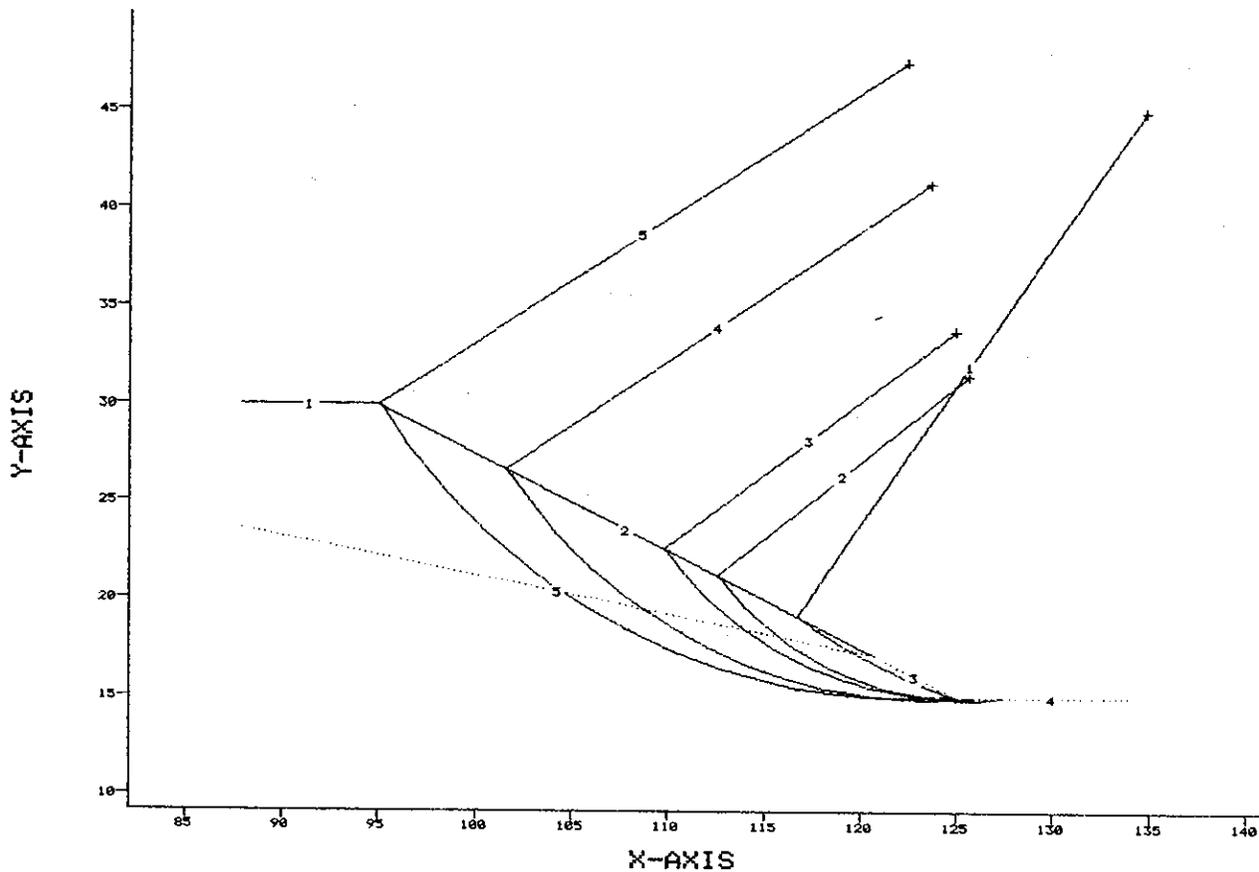
No. 1	X= 134.7	Y= 45	R= 31.5	FS= 0.65
No. 2	X= 125.6	Y= 31.5	R= 16.6	FS= 0.79
No. 3	X= 124.9	Y= 33.8	R= 18.8	FS= 0.86
No. 4	X= 123.6	Y= 41.3	R= 26.4	FS= 0.98
No. 5	X= 122.4	Y= 47.5	R= 32.5	FS= 1.04

Figure 65. Circular arc stability analysis of (2:1) landward slope of levee under steady seepage conditions. No roots are present (friction angle = 30°)

153. The factor of safety was computed for several trial circles for both steady seepage (2:1 slope) and sudden drawdown (3:1 slope) conditions, respectively, as shown in Figures 65 and 66. Successively deeper circles passing through the toe (or heel) were selected. The most critical circles were the shallow ones in both cases.

155. Results of the circular arc analysis show that in the unreinforced (no root) case, the critical failure circle ( $F < 1$ ) is quite shallow. The presence of roots, even at low concentration, completely reverses this trend. Now the shallow circles (where root concentrations are highest) have the highest factor of safety, whereas the deeper circles are relatively unaffected. Since the deeper circles are not critical in the first place ( $F > 1$ ), the influence of plant roots is less important.

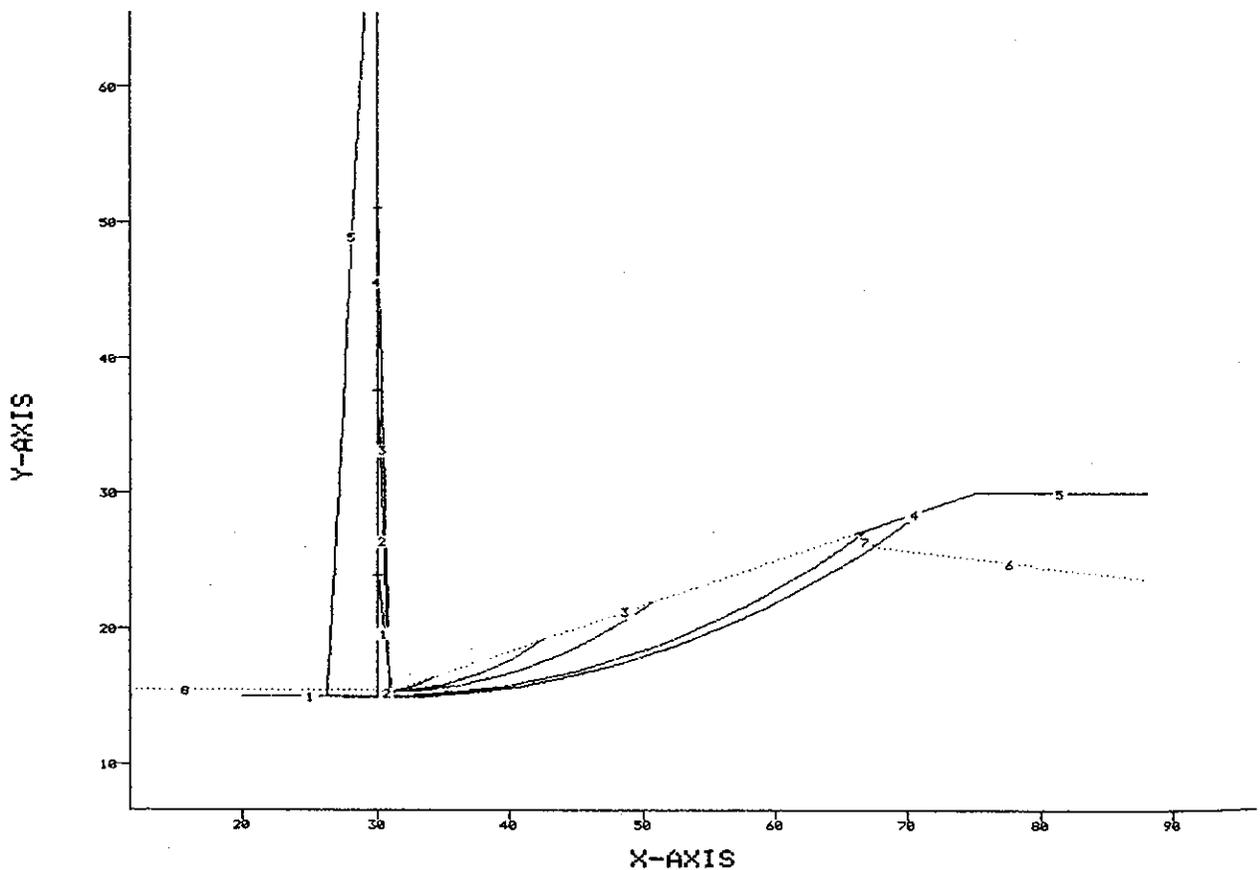
No. 1	X= 30	Y= 23.9	R= 8.6	FS= 0.72
No. 2	X= 30	Y= 37.6	R= 22.3	FS= 0.72
No. 3	X= 30	Y= 51.1	R= 35.8	FS= 0.73
No. 4	X= 30	Y= 76.4	R= 61.4	FS= 0.74
No. 5	X= 30	Y= 83	R= 68.1	FS= 0.77

Figure 66. Circular arc stability analysis of (3:1) riverward slope of levee under sudden drawdown conditions. No roots are present (friction angle =  $30^\circ$ )

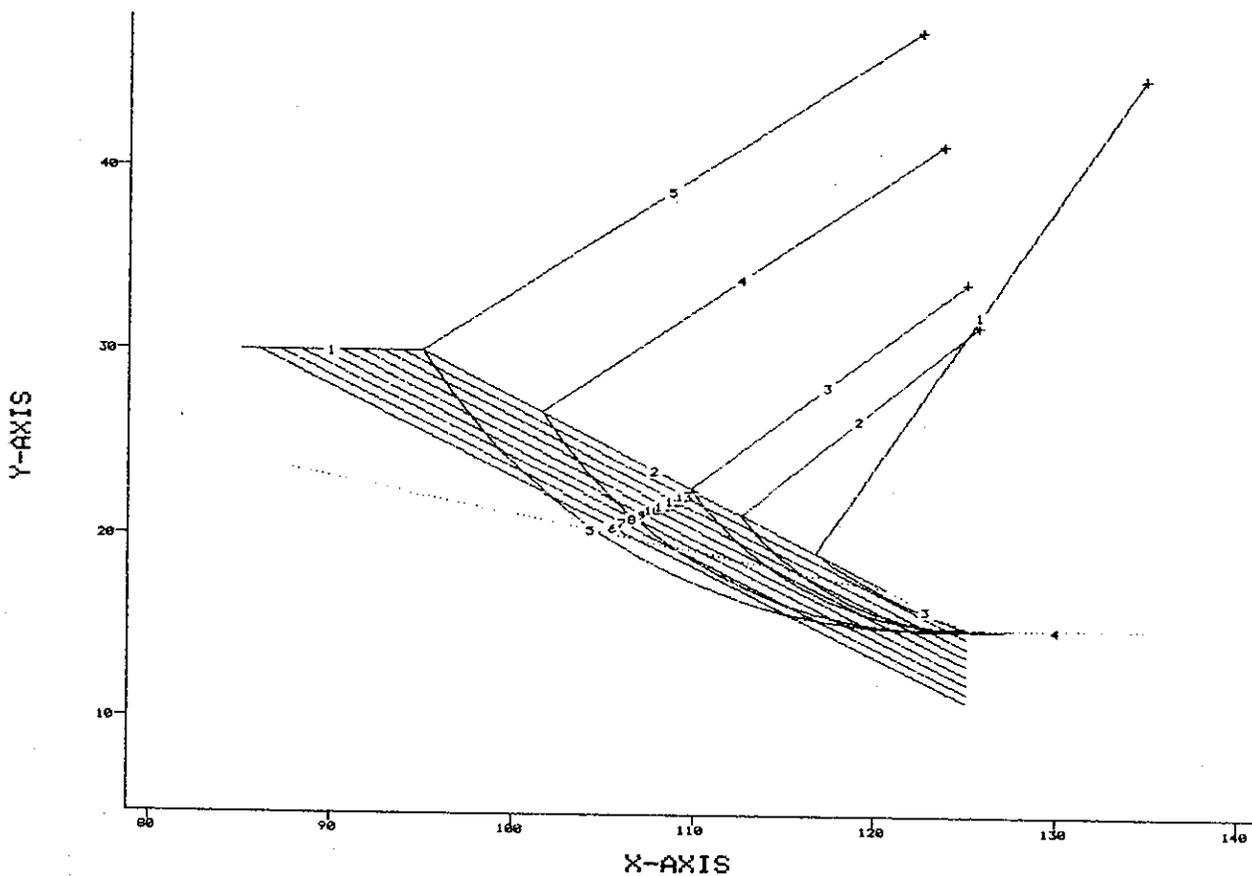
No. 1	X= 134.7	Y= 45	R= 31.5	FS= 5.57
No. 2	X= 125.6	Y= 31.5	R= 16.6	FS= 1.75
No. 3	X= 124.9	Y= 33.8	R= 18.8	FS= 1.54
No. 4	X= 123.6	Y= 41.3	R= 26.4	FS= 1.23
No. 5	X= 122.4	Y= 47.5	R= 32.5	FS= 1.16

Figure 67. Circular arc stability analysis of (2:1) landward slope of levee under steady seepage conditions. Low root concentration (friction angle = 30°)

154. The influence of root cohesion was investigated by assigning a cohesion value as a function of depth as described in the previous section. Results of safety factor calculations for the steady seepage and sudden drawdown cases are shown graphically in Figures 67 and 68, respectively, for the same failure circles used previously in Figures 65 and 66. The thin soil layers (6 in. thick) shown in the cross-section diagram of the slope represent soils with different cohesion based on a "low" root concentration in the soil.

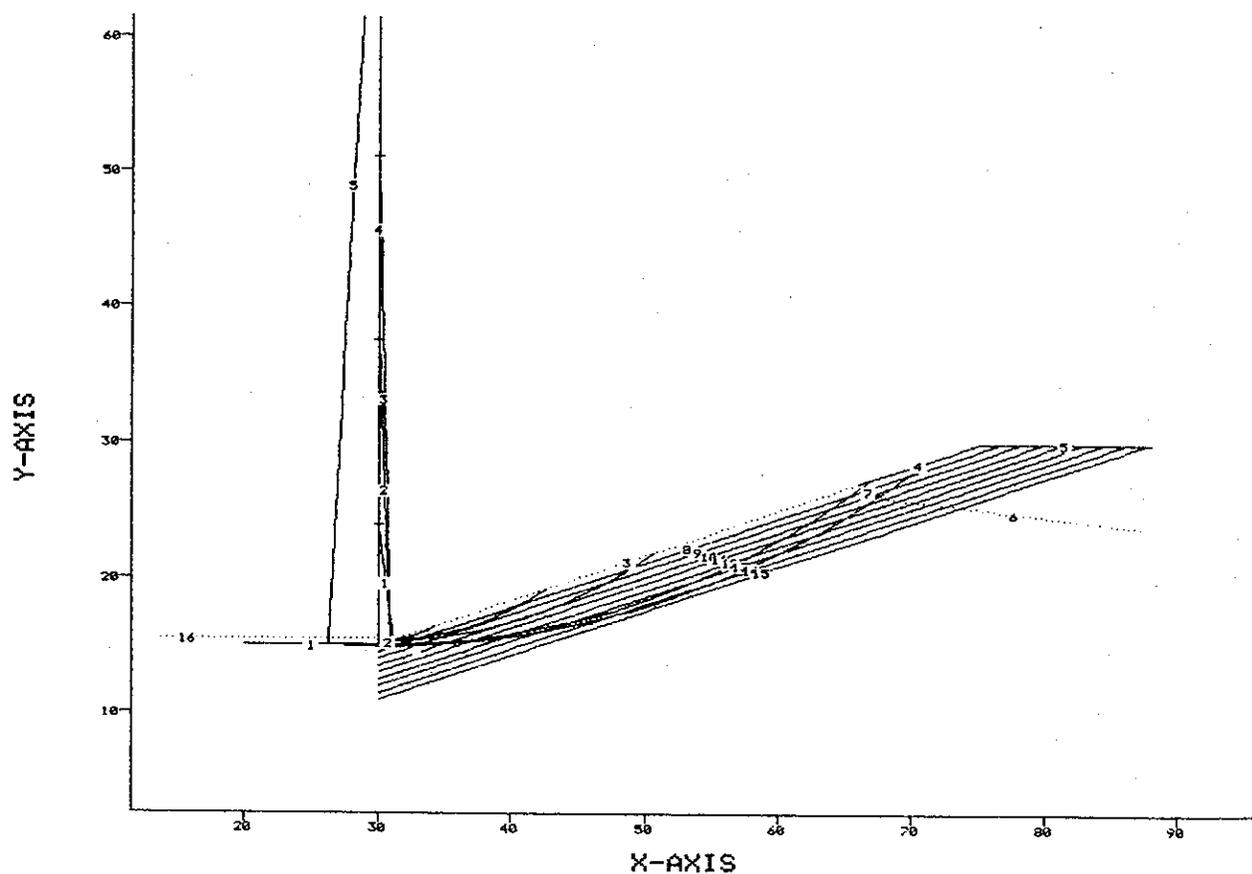
No. 1	X= 30	Y= 23.9	R= 8.6	FS= 16.5
No. 2	X= 30	Y= 37.6	R= 22.3	FS= 3.40
No. 3	X= 30	Y= 51.1	R= 35.8	FS= 2.01
No. 4	X= 30	Y= 76.4	R= 61.4	FS= 1.16
No. 5	X= 30	Y= 83	R= 68.1	FS= 1.10

Figure 68. Circular arc stability analysis of (3:1) riverward slope of levee under sudden drawdown conditions. Low root concentration (friction angle = 30°)

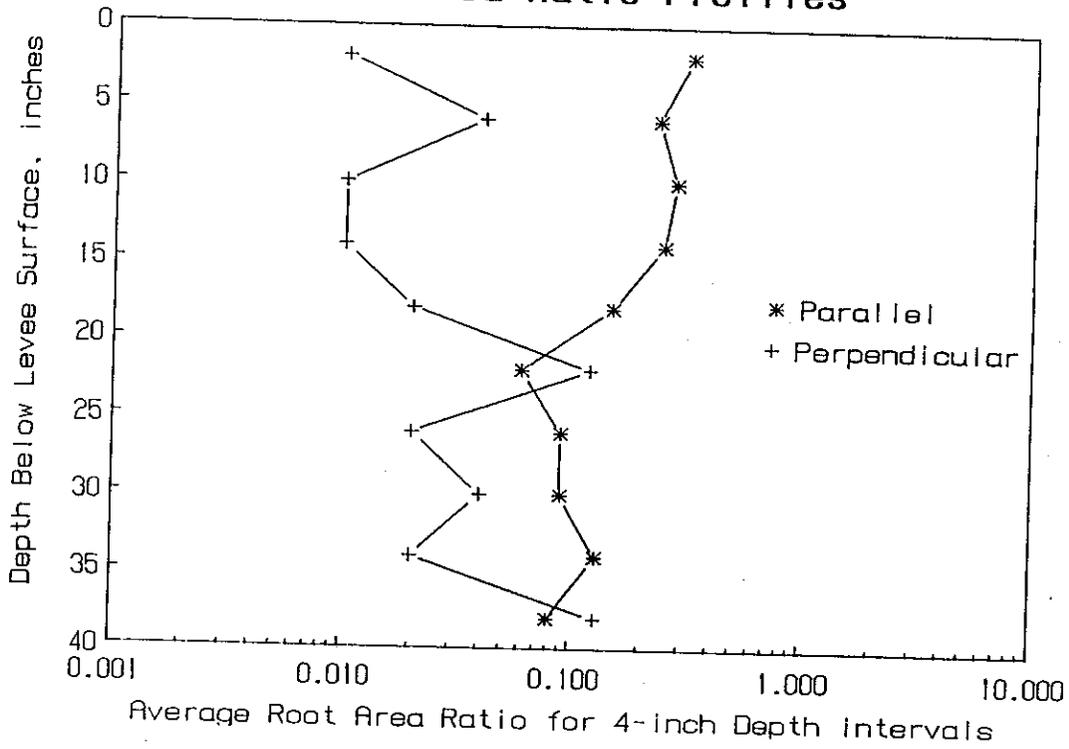
## Sacramento River Levee: Live Oak Root Area Ratio Profiles

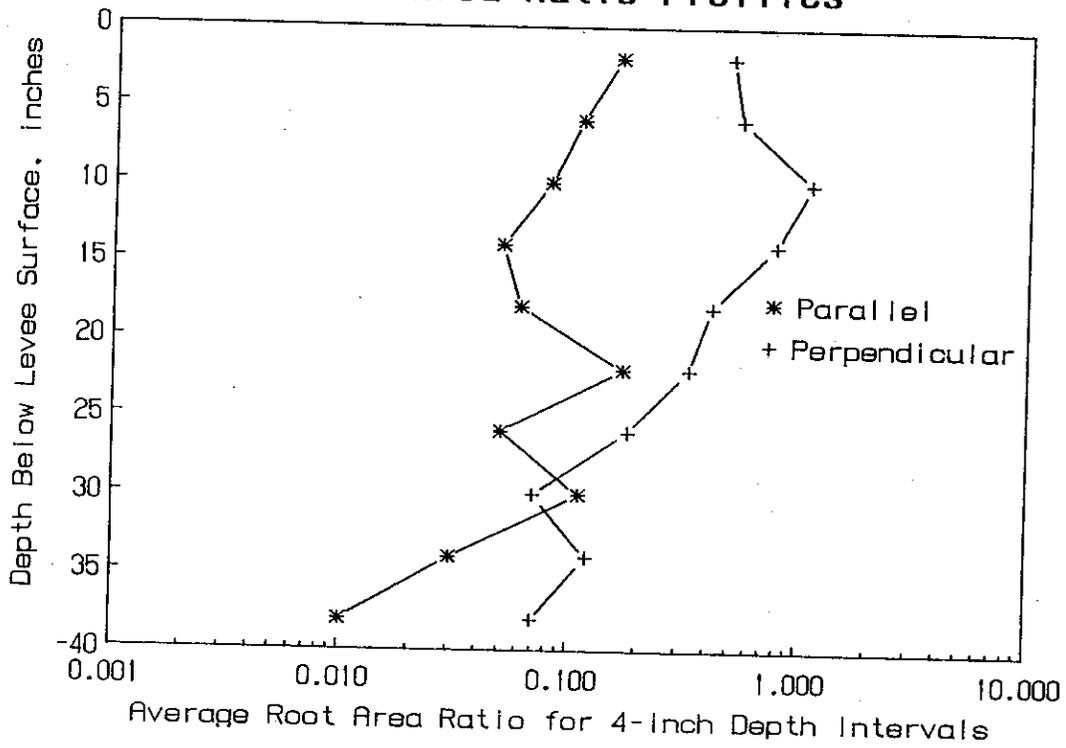
## Sacramento River Levee: Elderberry Root Area Ratio Profiles

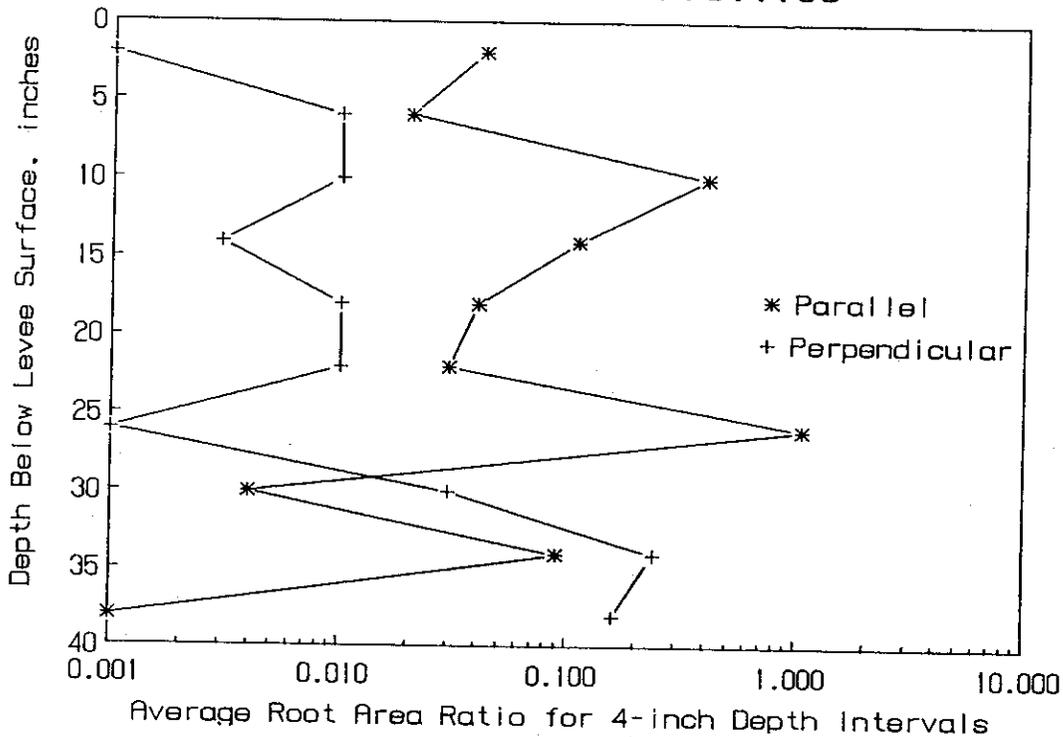
## Sacramento River Levee: Dead Oak Root Area Ratio Profiles

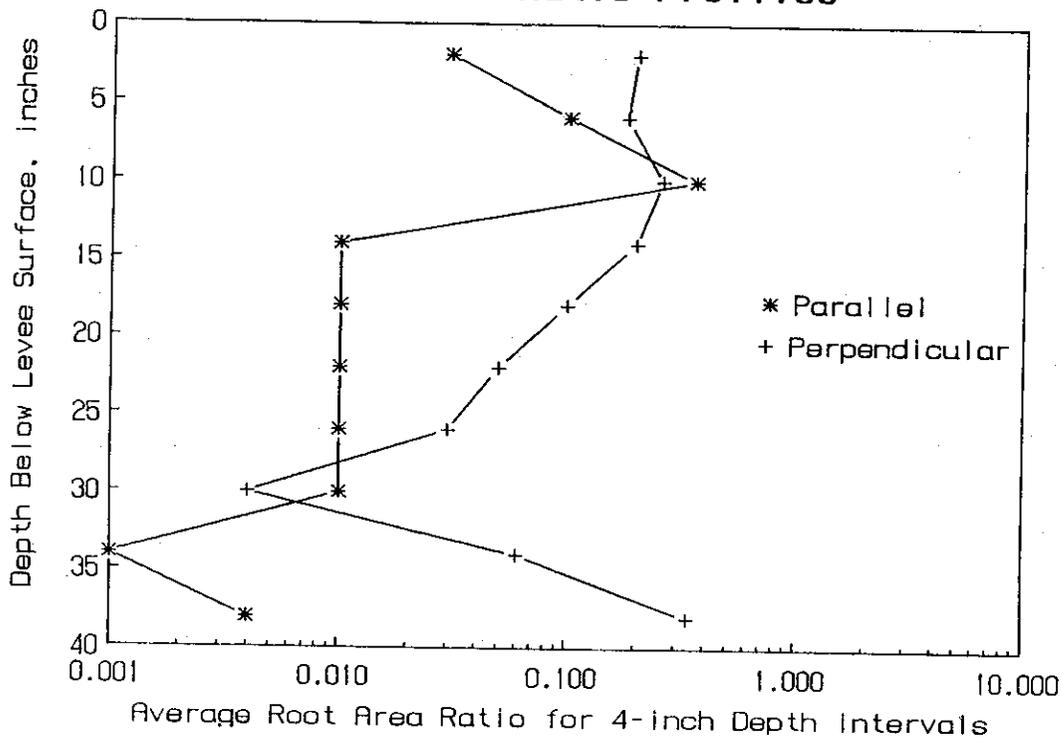
## Sacramento River Levee: Willow Root Area Ratio Profiles

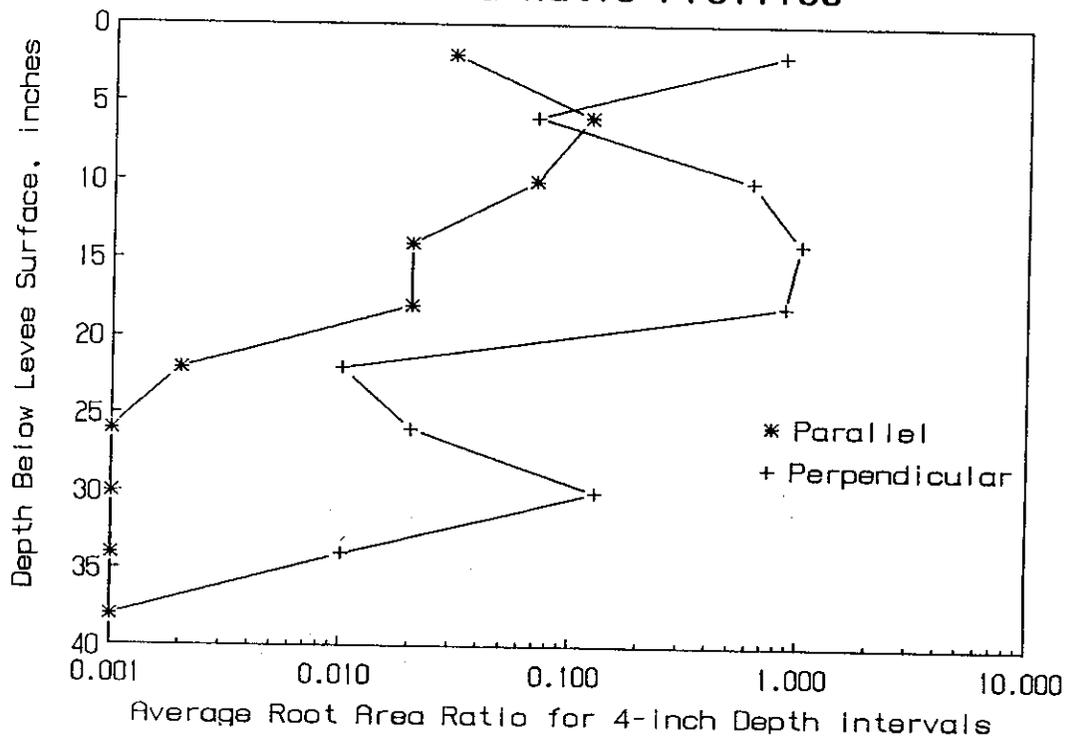
## Sacramento River Levee: Black Locust Root Area Ratio Profiles

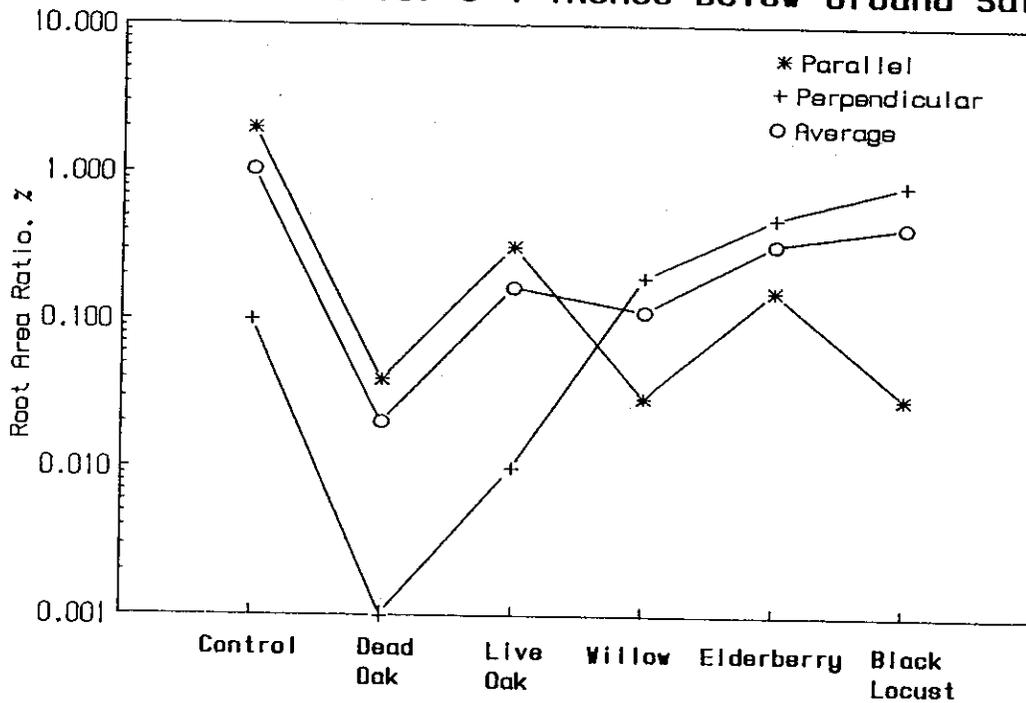
## Sacramento River Levee Root Area Ratio for 0-4 inches Below Ground Surface

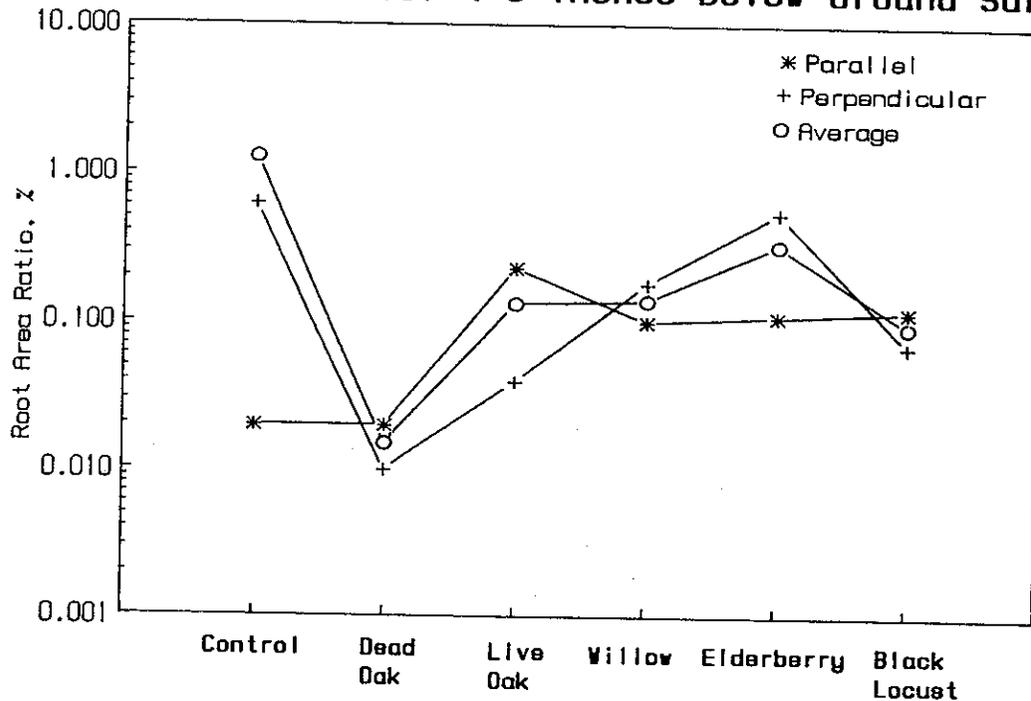
## Sacramento River Levee

Root Area Ratio for 4-8 inches Below Ground Surface

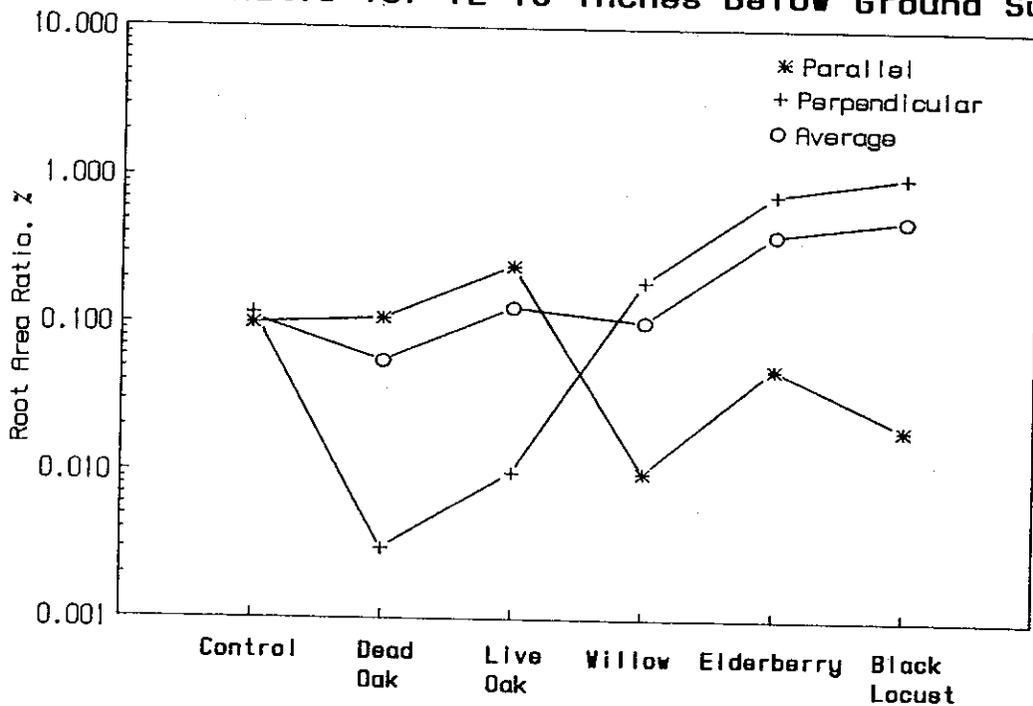
## Sacramento River Levee

Root Area Ratio for 12-16 inches Below Ground Surface

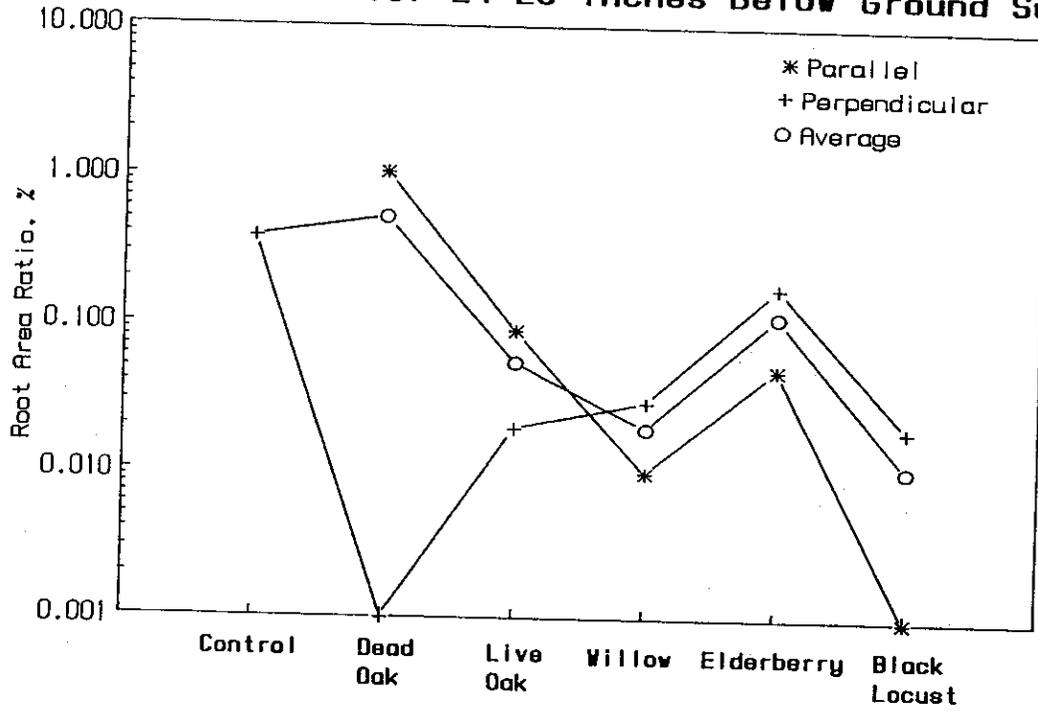
## Sacramento River Levee

Root Area Ratio for 24-28 inches Below Ground Surface

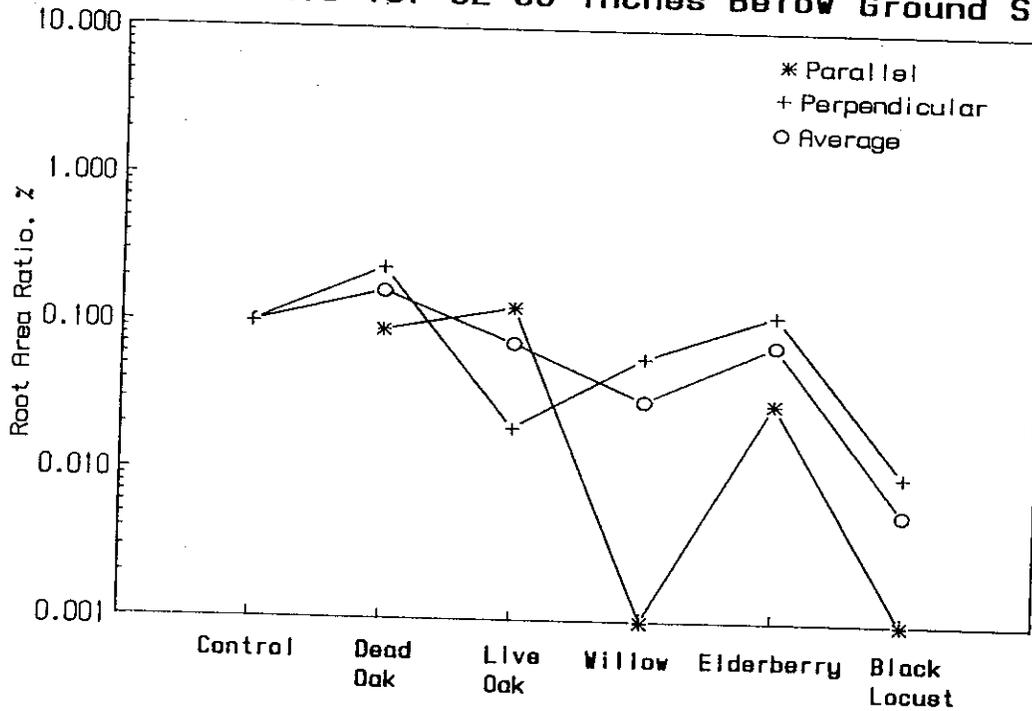
## Sacramento River Levee

Root Area Ratio for 32-36 inches Below Ground Surface
