4. TITLE AND SUBTITLE  The Effects of Vegetation on the Structural Integrity of Sandy Levees	5. FUNDING NUMBERS  WU 32374
--	------------------------------------

8. PERFORMING ORGANIZATION REPORT NUMBER  Technical Report REMR-EI-5	9. SPONSORING/MONITORING AGENCY NAME(S) AND ADDRESS(ES)  US Army Corps of Engineers, Washington, DC 20314-1000
---	--

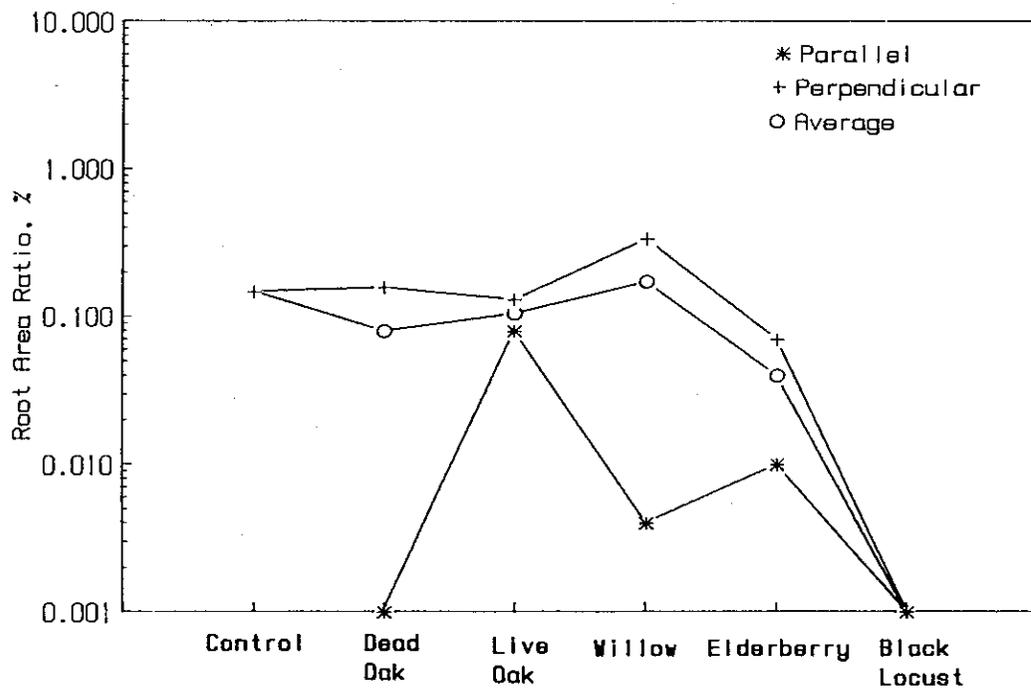
# Sacramento River Levee

Root Area Ratio for 36-40 inches Below Ground Surface

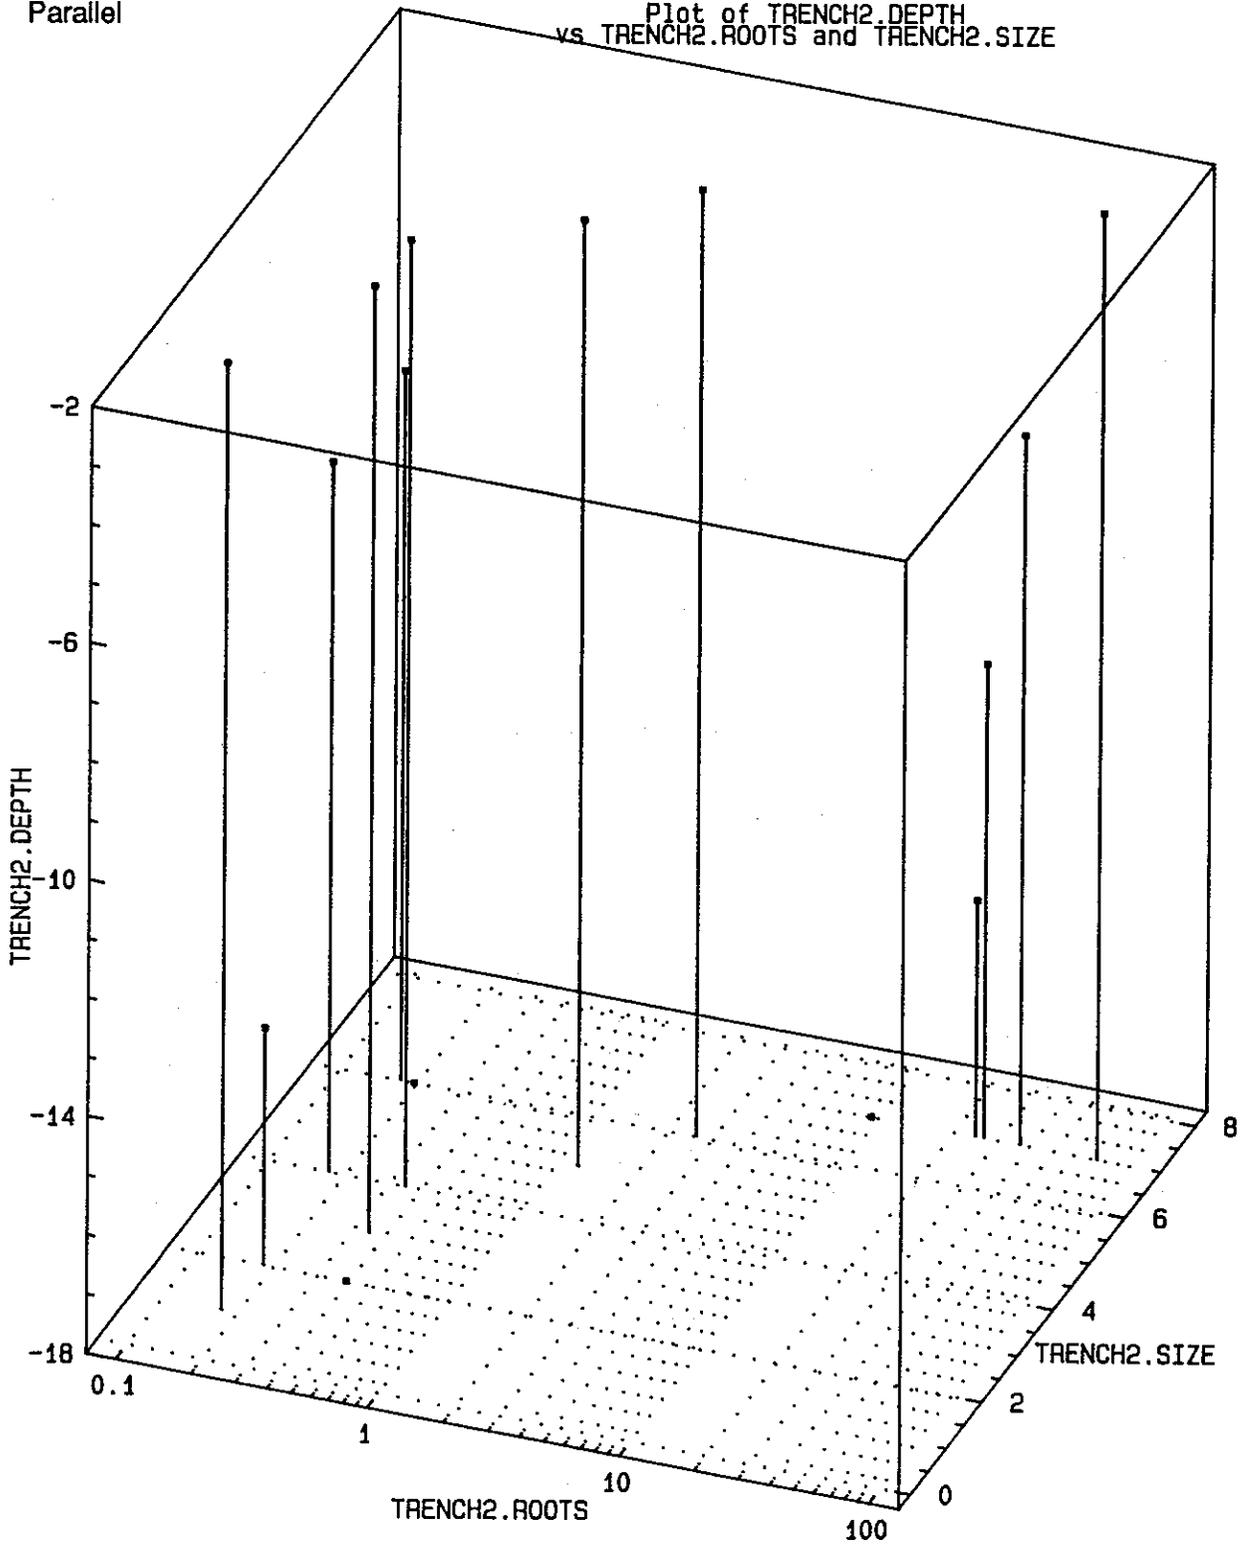
Site 2  
Parallel

Plot of TRENCH2.DEPTH  
vs TRENCH2.ROOTS and TRENCH2.SIZE

Z (vertical) axis--depth below surface in inches times -1. The upper limit of +2 was set by the automatic scaling routine in the plot software--there has been some trouble with the software when attempts are made to manually set the scales. Note that all plots have Z axes scaled from +2 to -38, except site 2 (parallel) and site 3 (perpendicular).

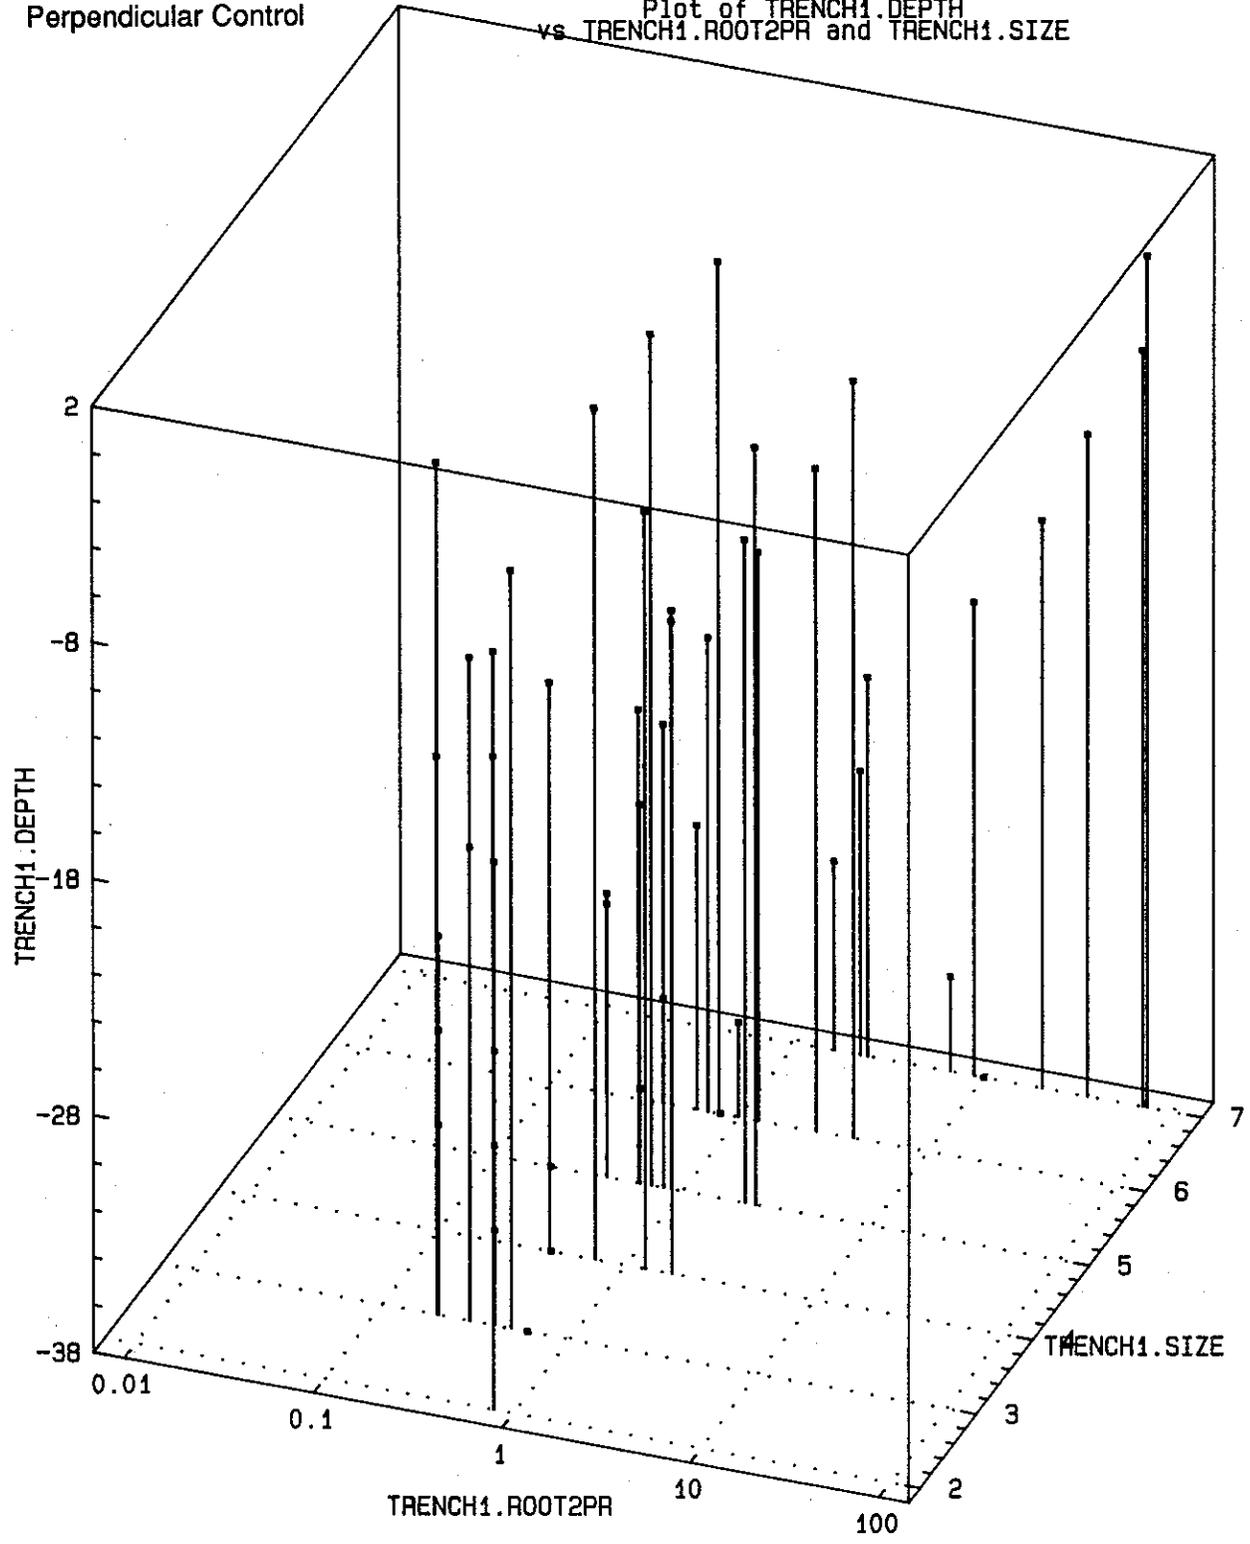
Site 2  
Perpendicular Control

Plot of TRENCH1.DEPTH  
vs TRENCH1.ROOT2PR and TRENCH1.SIZE

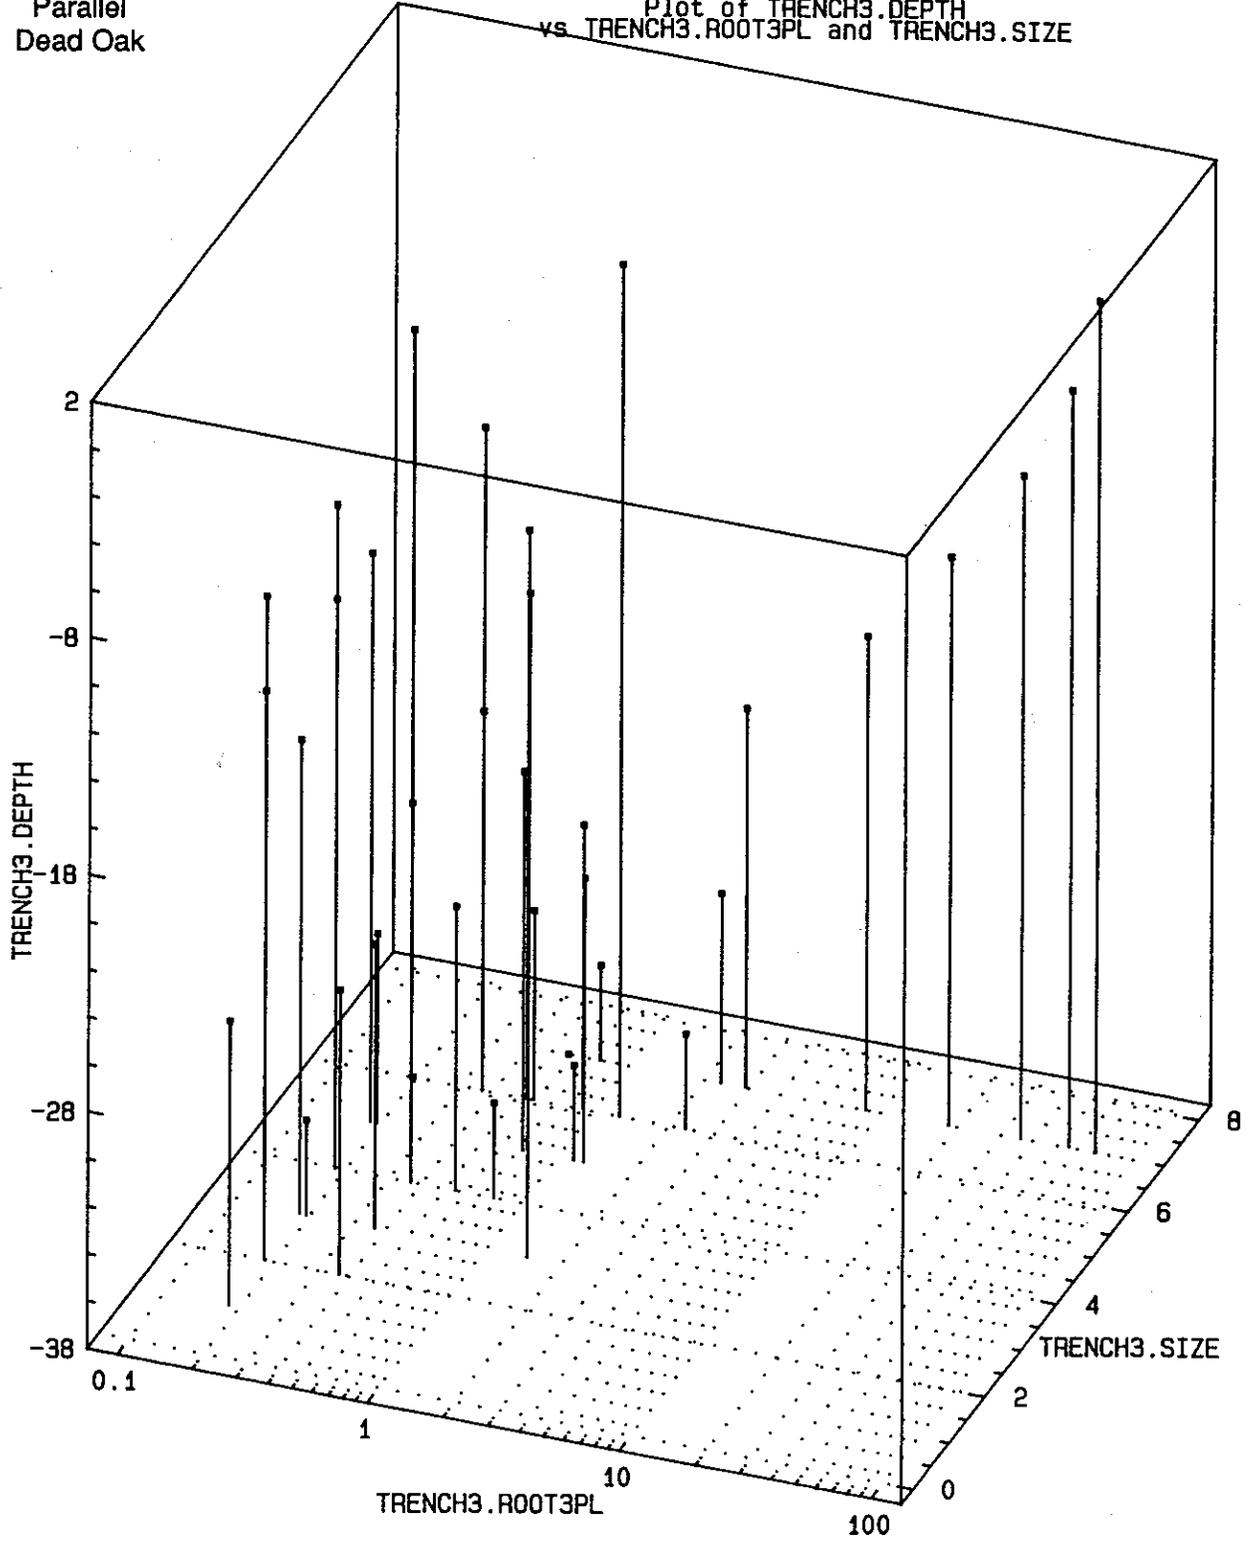
Site 3  
Parallel  
Dead Oak

Plot of TRENCH3.DEPTH  
vs TRENCH3.ROOT3PL and TRENCH3.SIZE

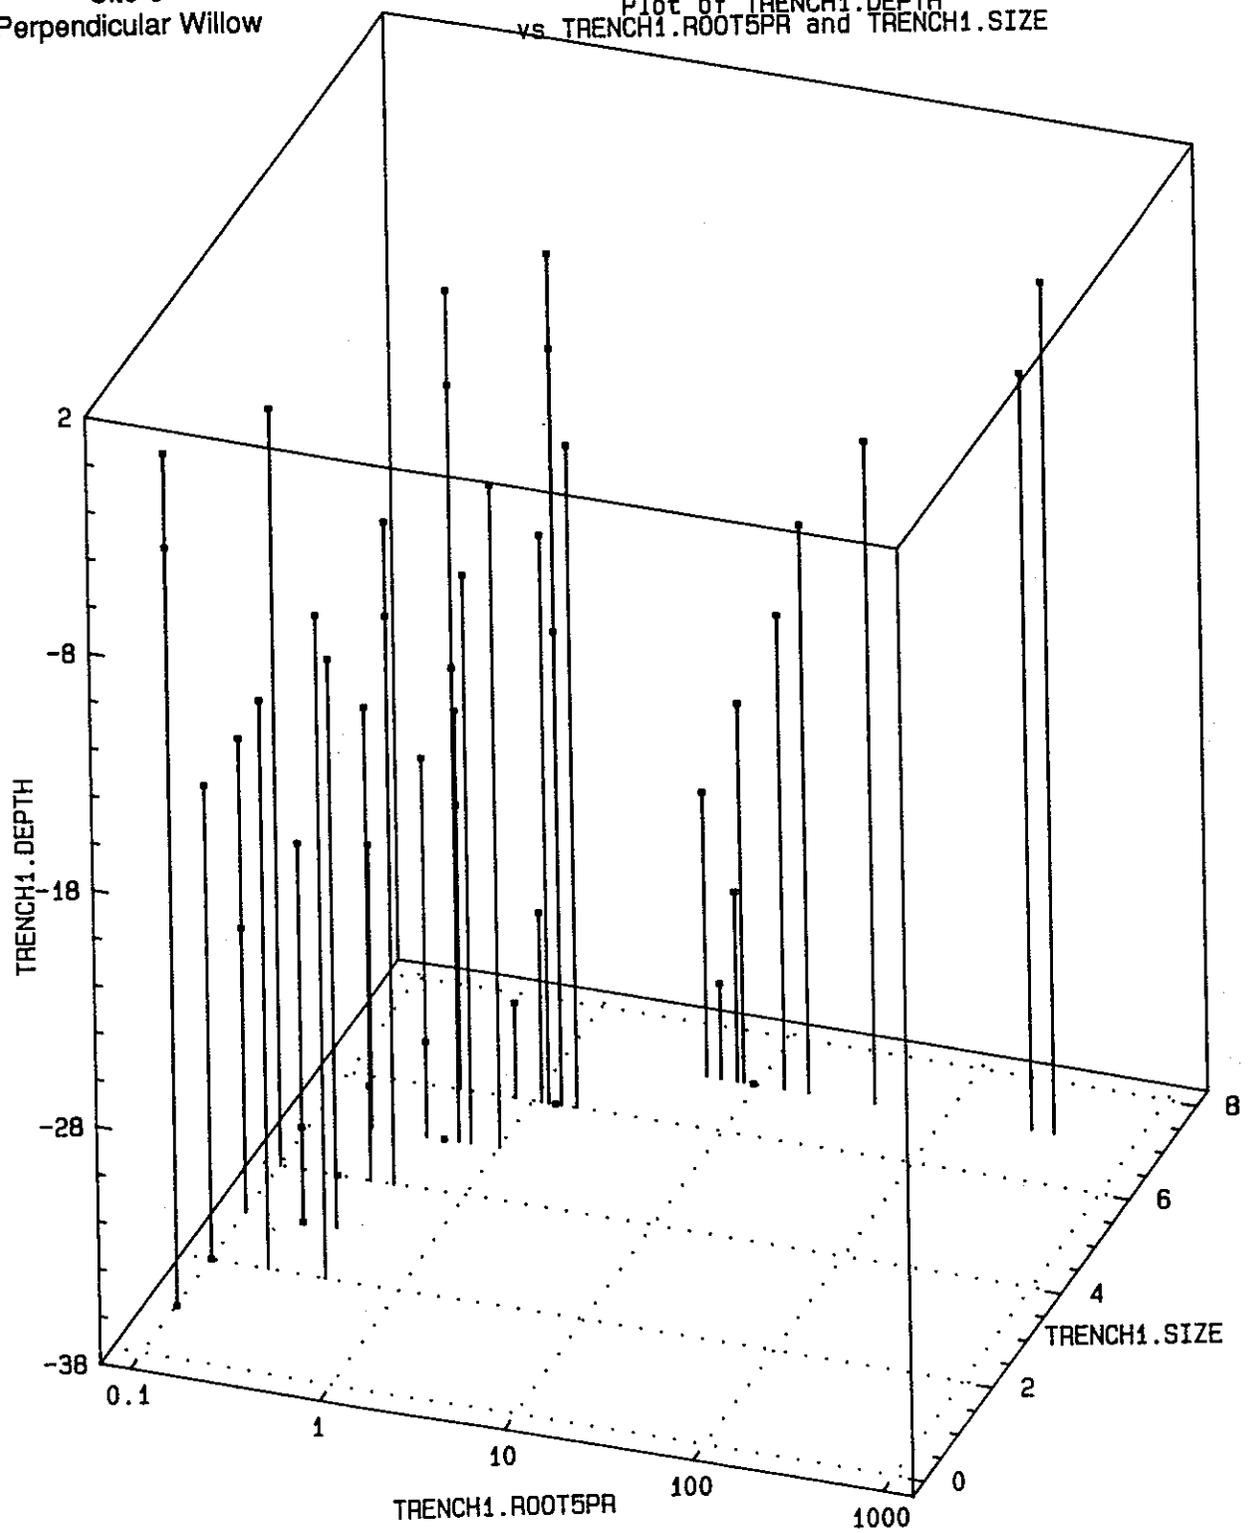
Site 5  
Perpendicular Willow

Plot of TRENCH1.DEPTH  
vs TRENCH1.ROOT5PR and TRENCH1.SIZE

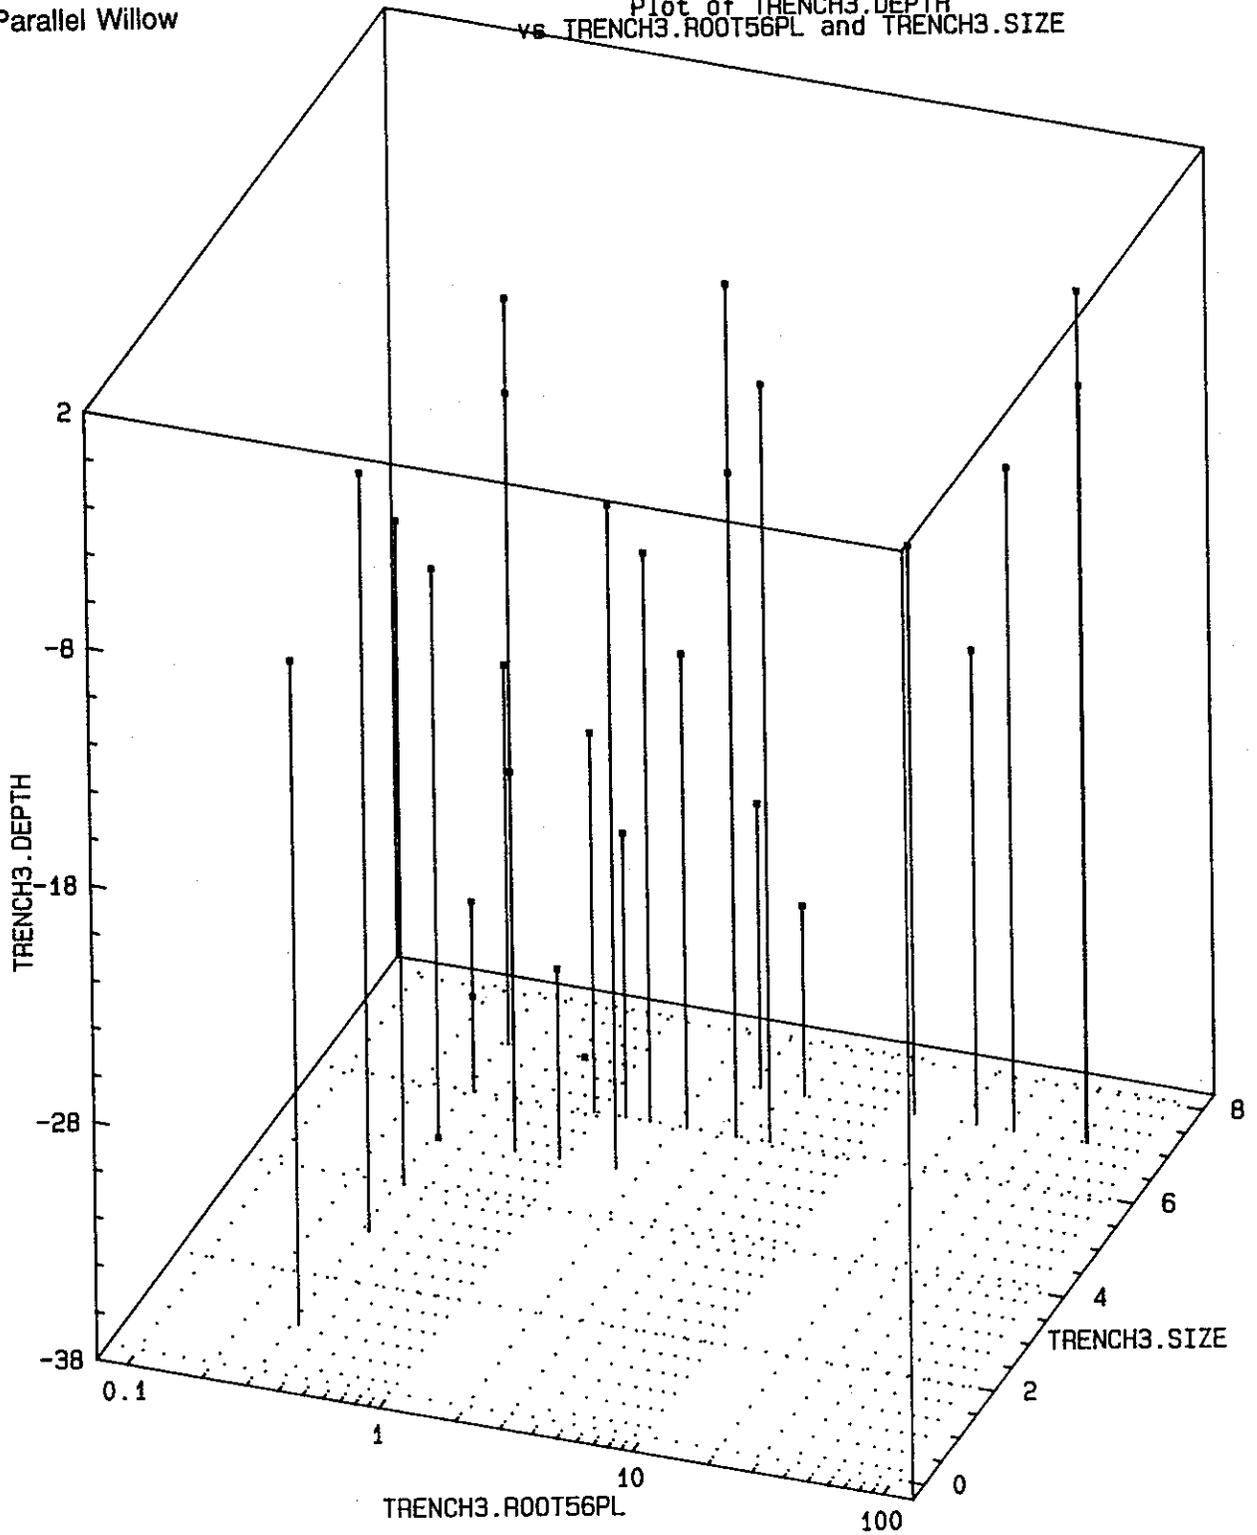
Site 5  
Parallel Willow

Plot of TRENCH3.DEPH  
vs TRENCH3.ROOT56PL and TRENCH3.SIZE

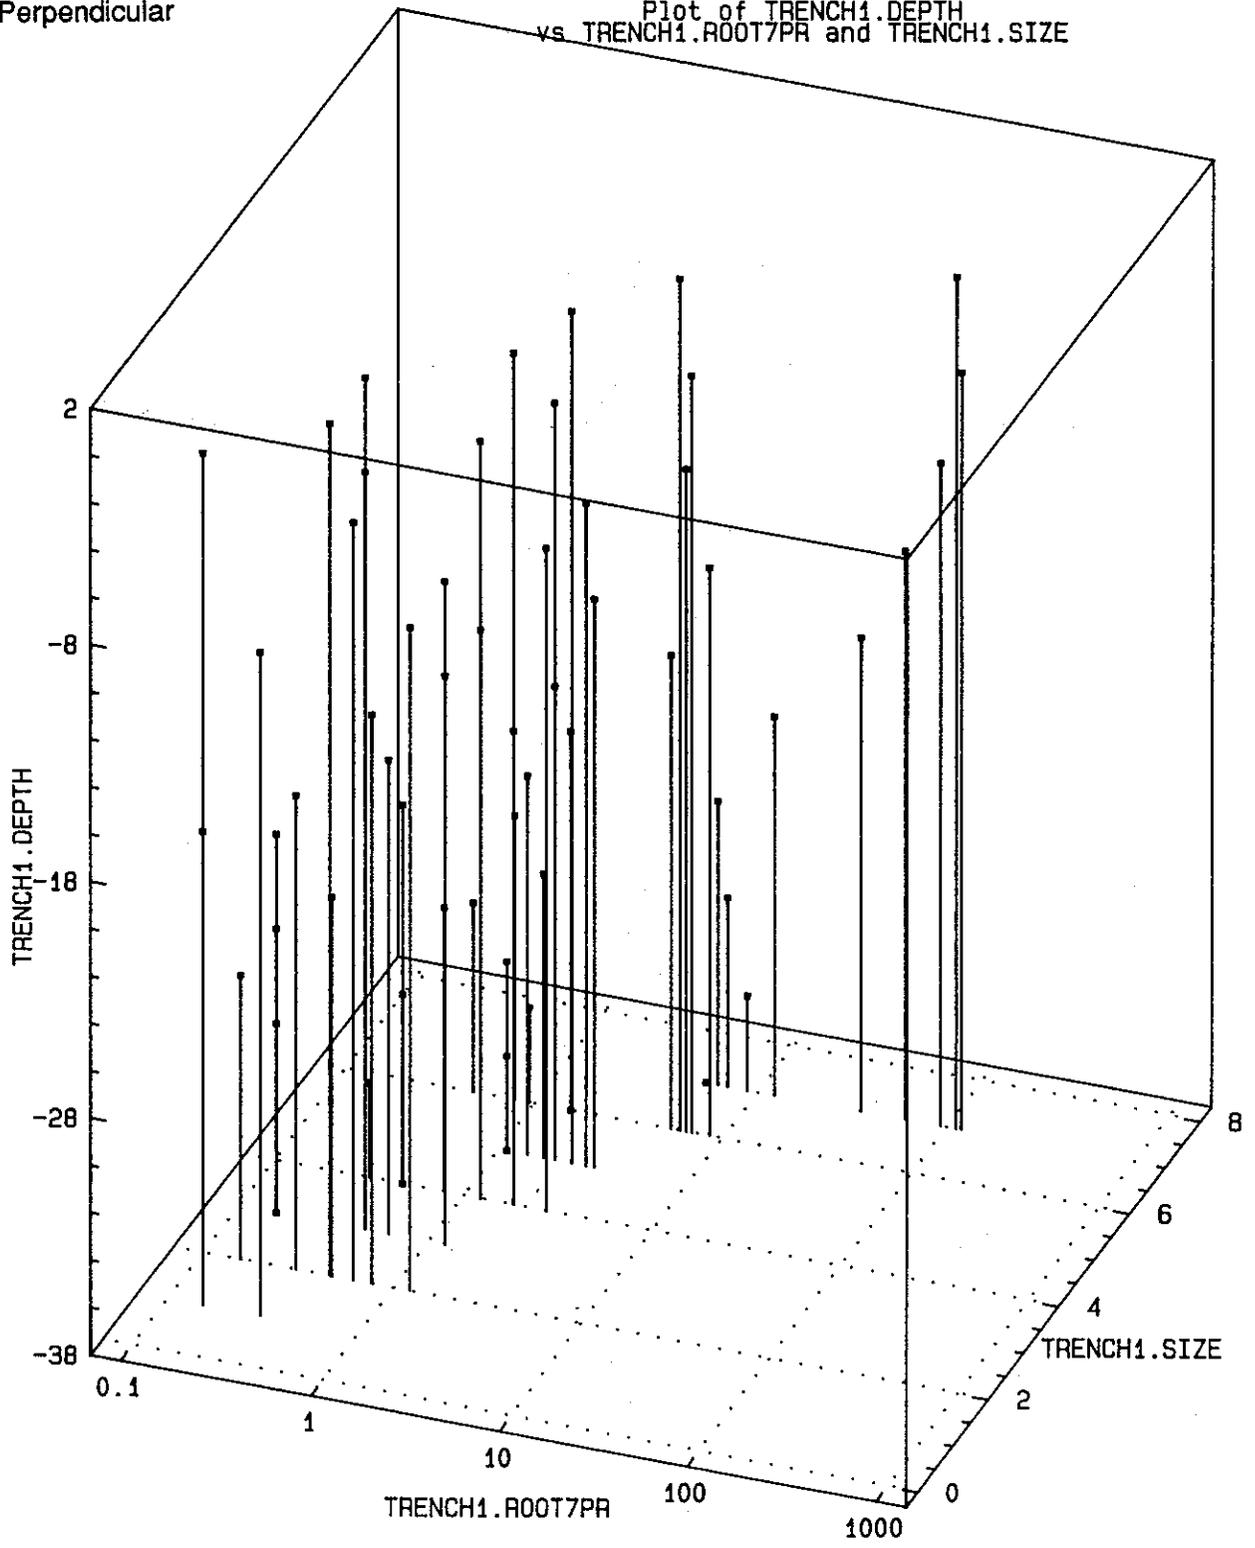
Site 7  
Perpendicular

Plot of TRENCH1.DEPTH  
vs TRENCH1.ROOT7PR and TRENCH1.SIZE

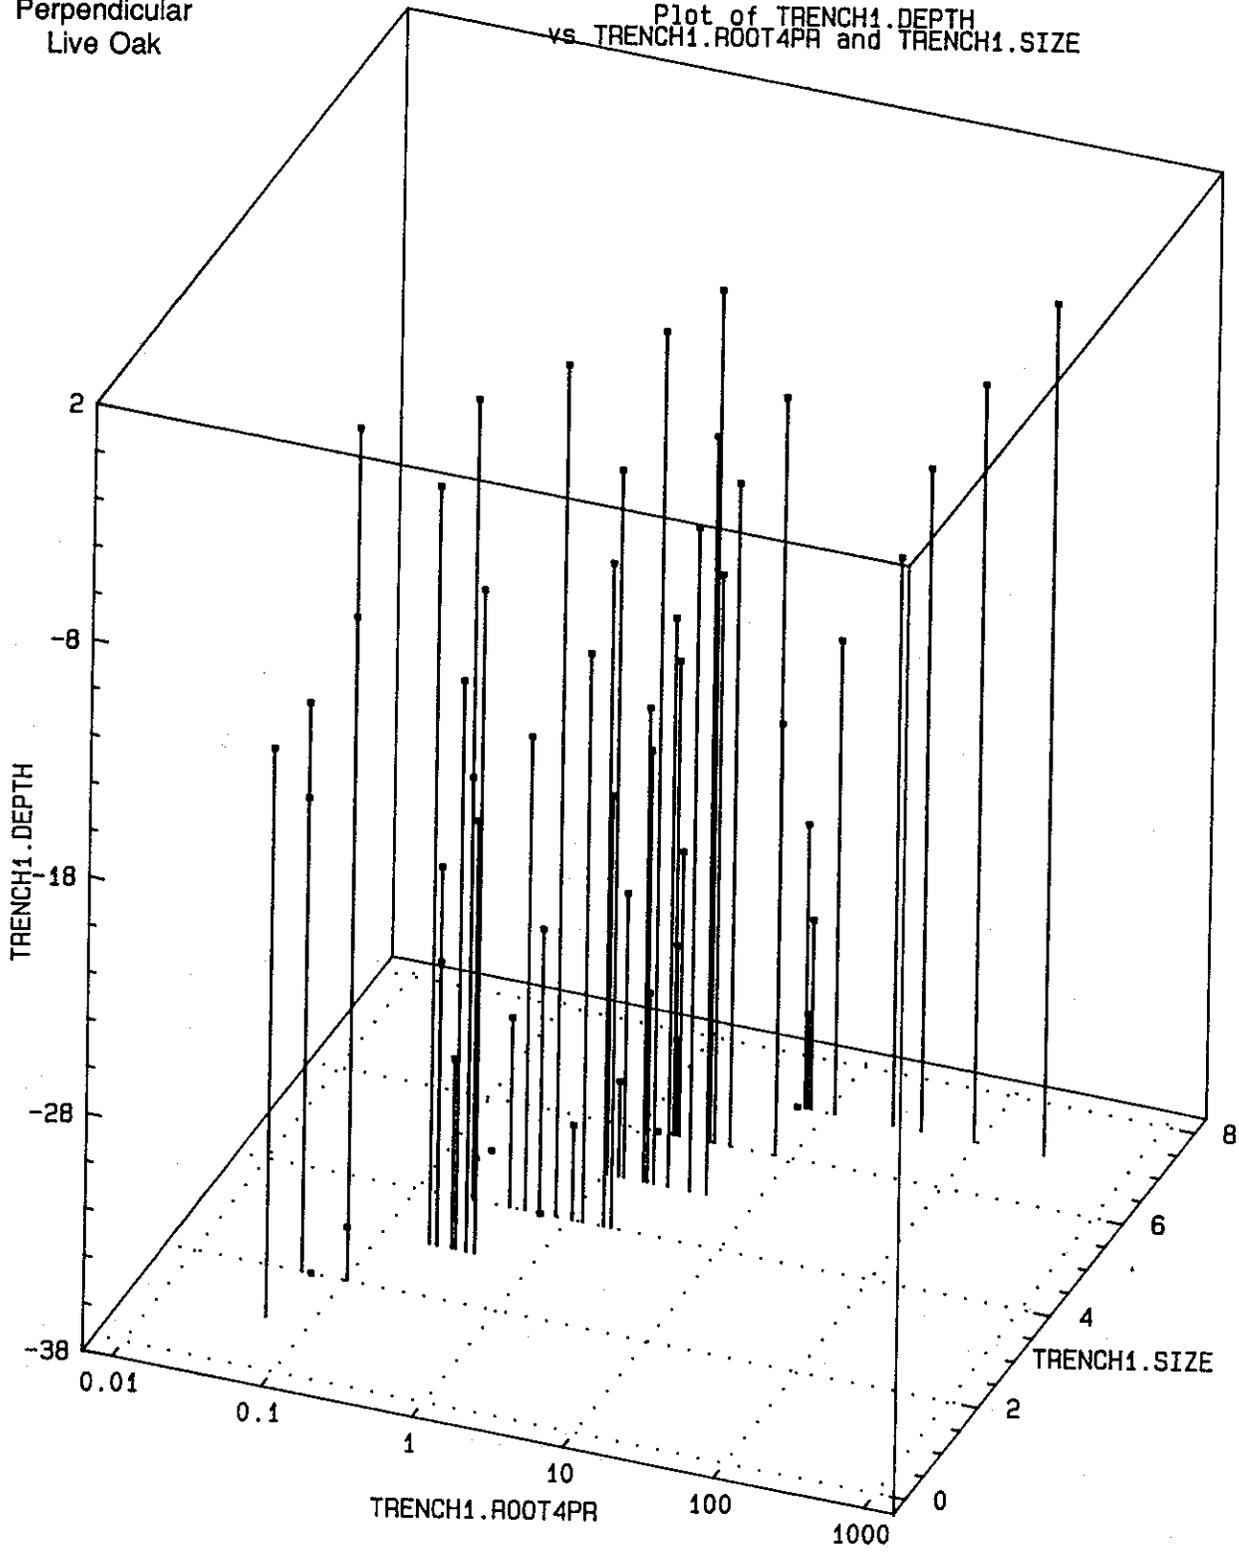
Site 4  
Perpendicular  
Live Oak

Plot of TRENCH1.DEPTH  
vs TRENCH1.ROOT4PR and TRENCH1.SIZE

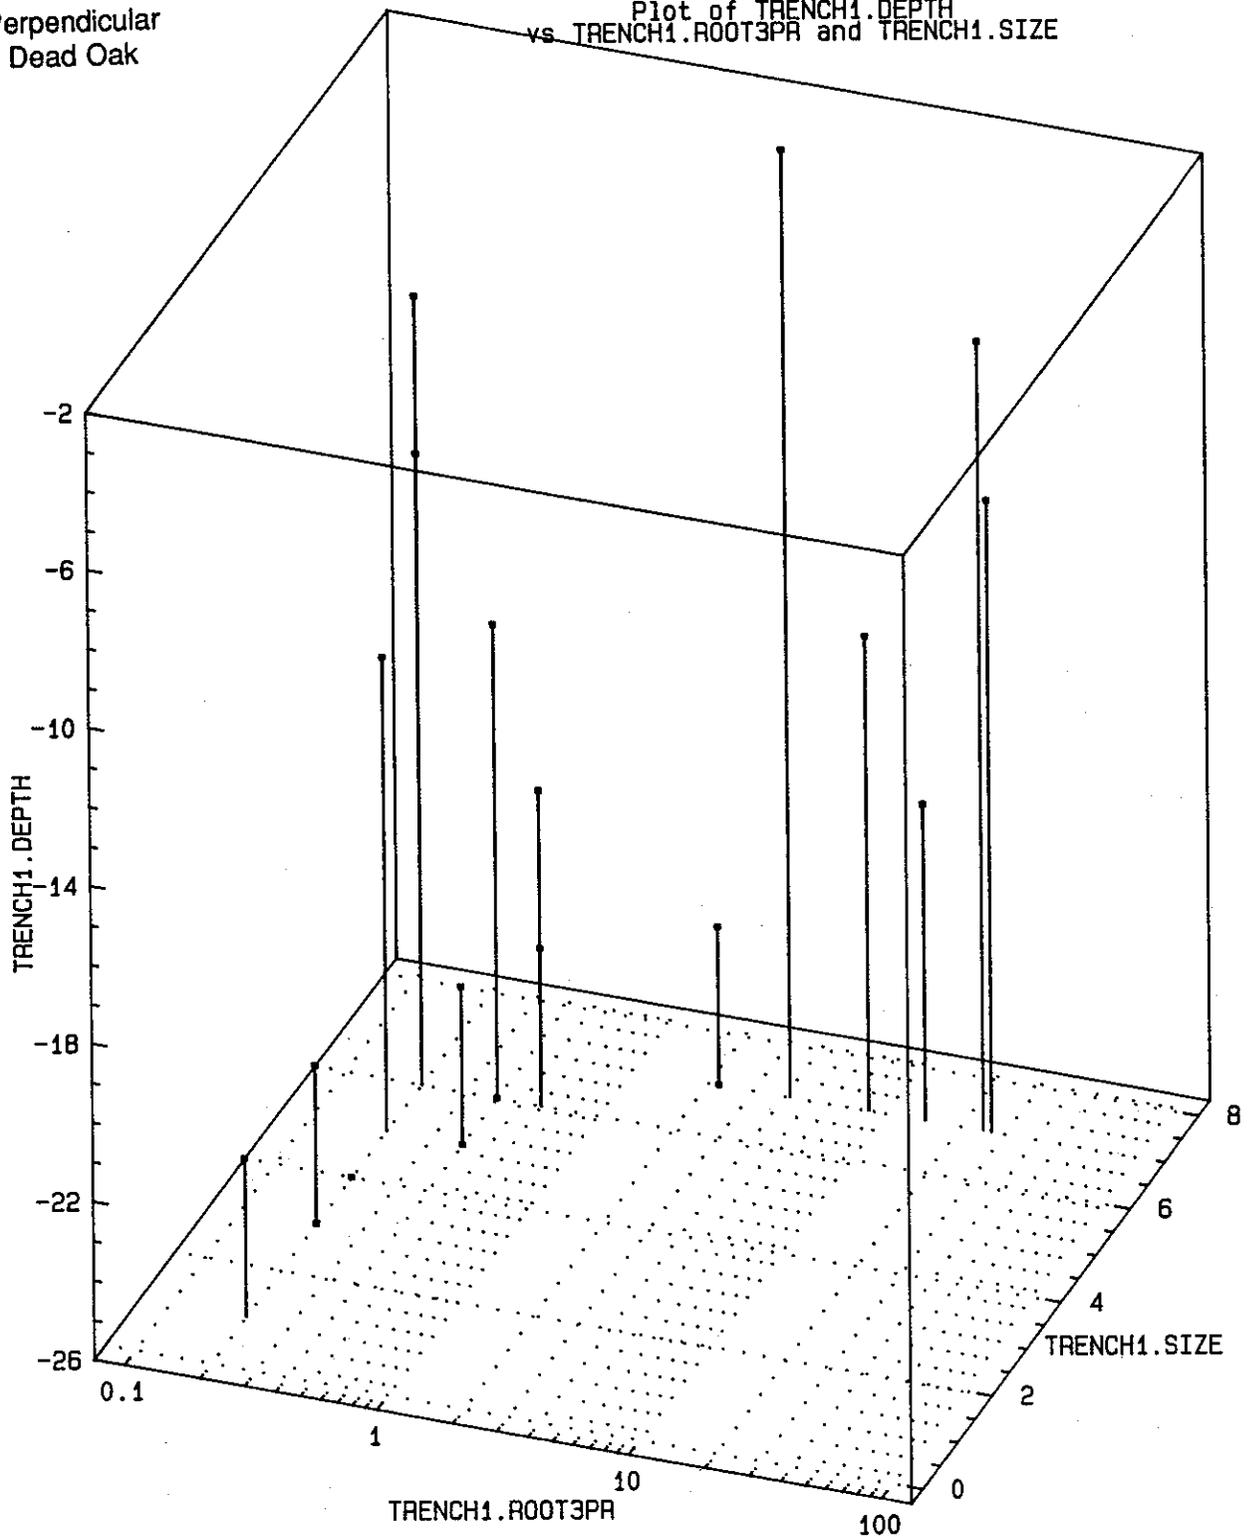
Site 3  
Perpendicular  
Dead Oak

Plot of TRENCH1.DEPTH  
vs TRENCH1.ROOT3PR and TRENCH1.SIZE

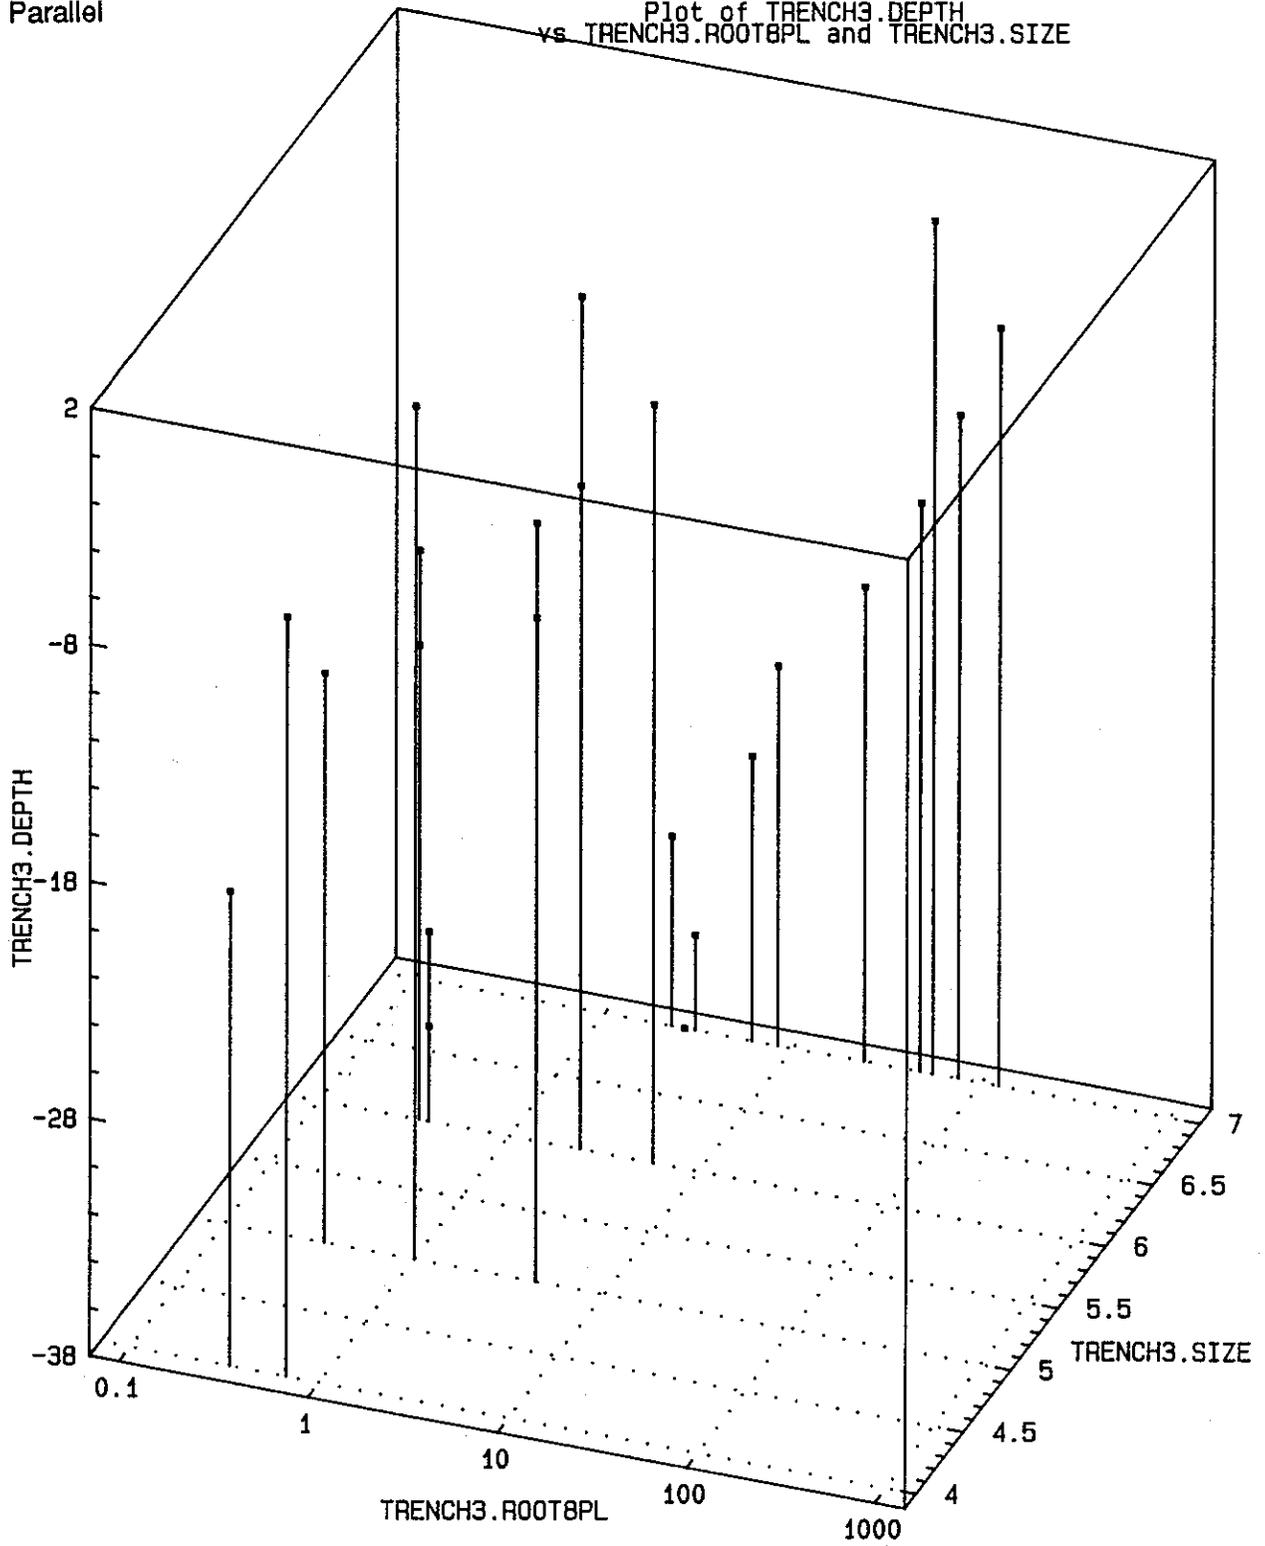
Site 8  
Parallel

Plot of TRENCH3.DEPTH  
vs TRENCH3.ROOT8PL and TRENCH3.SIZE

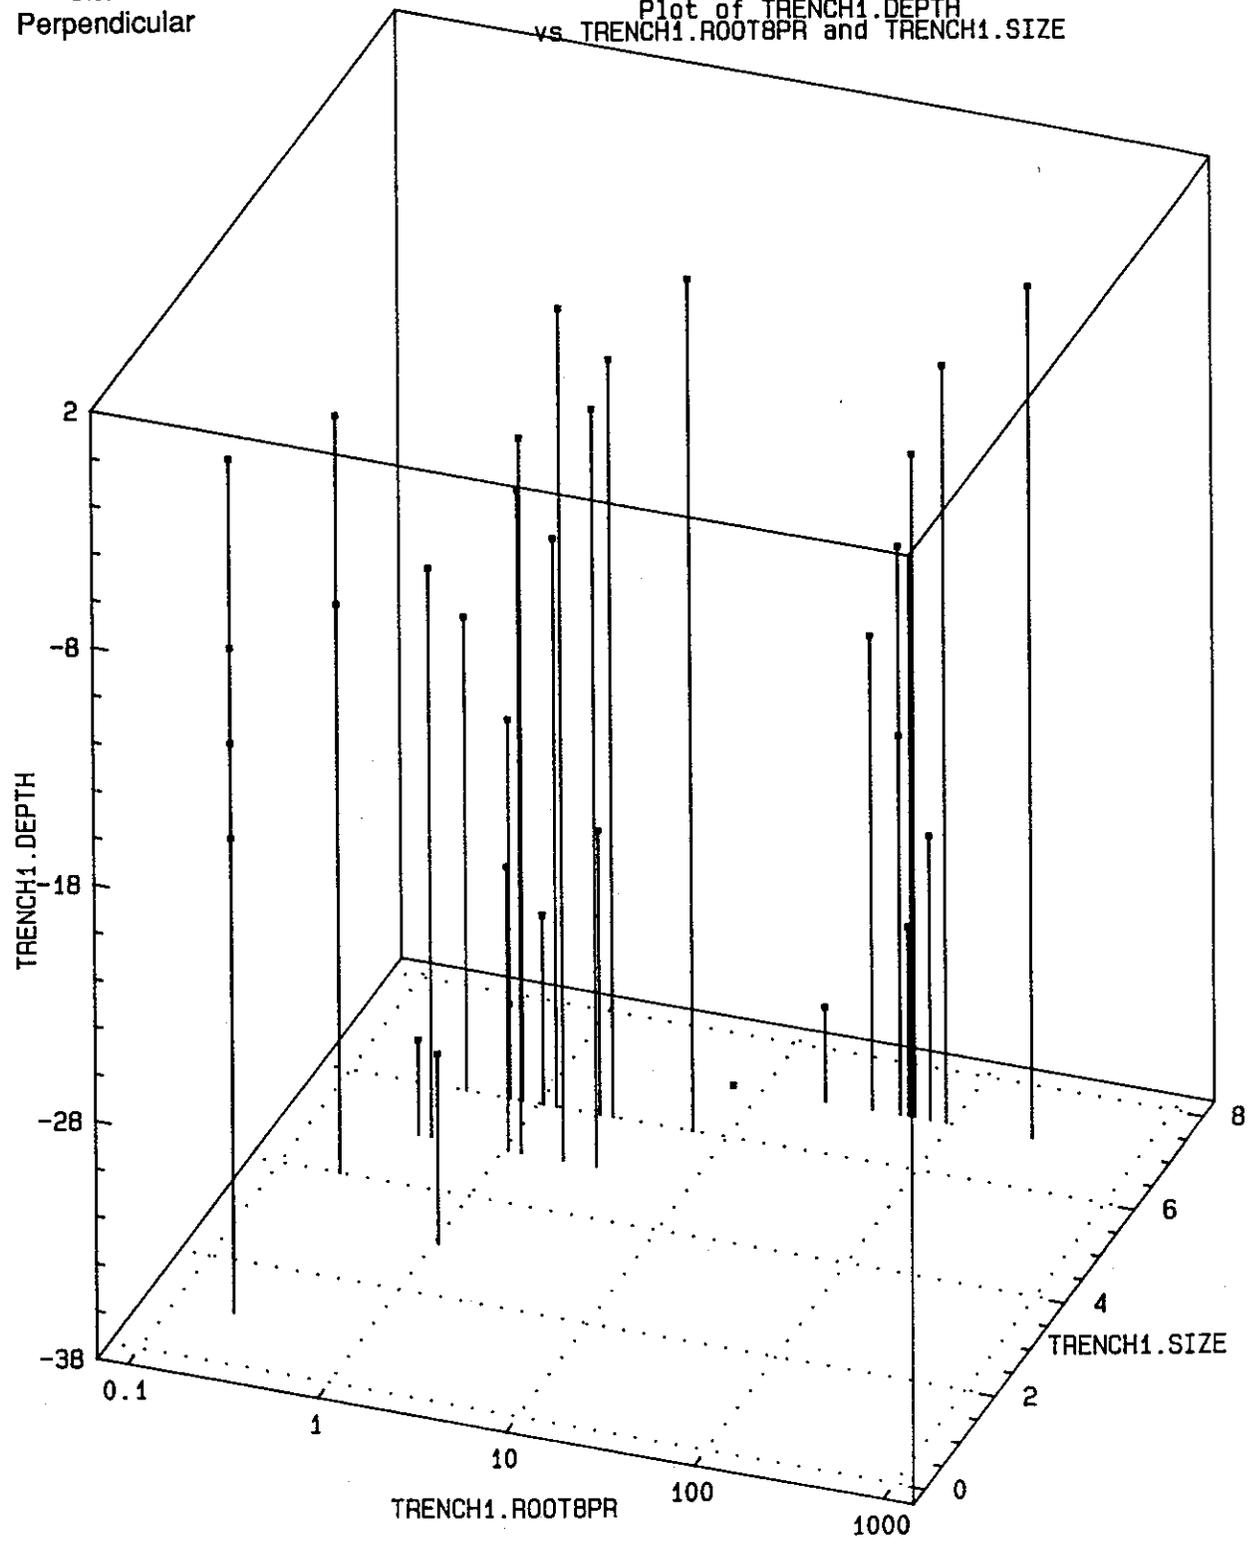
Site 8  
Perpendicular

Plot of TRENCH1.DEPTH  
vs TRENCH1.ROOT8PR and TRENCH1.SIZE
