ENVIRONMENTAL AND WATER QUALITY
OPERATIONAL STUDIES

TECHNICAL REPORT E-84-11

ENVIRONMENTAL FEATURES FOR
STREAMBANK PROTECTION PROJECTS

Jim E. Henderson, F. Douglas Shields, Jr.
Environmental Laboratory

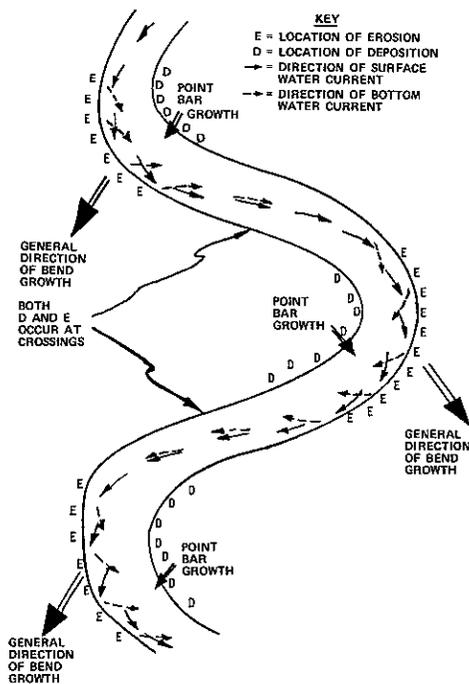
Figure 1. Migration of meander loop and cutoff development (adapted from Klingeman and Bradley 1976)

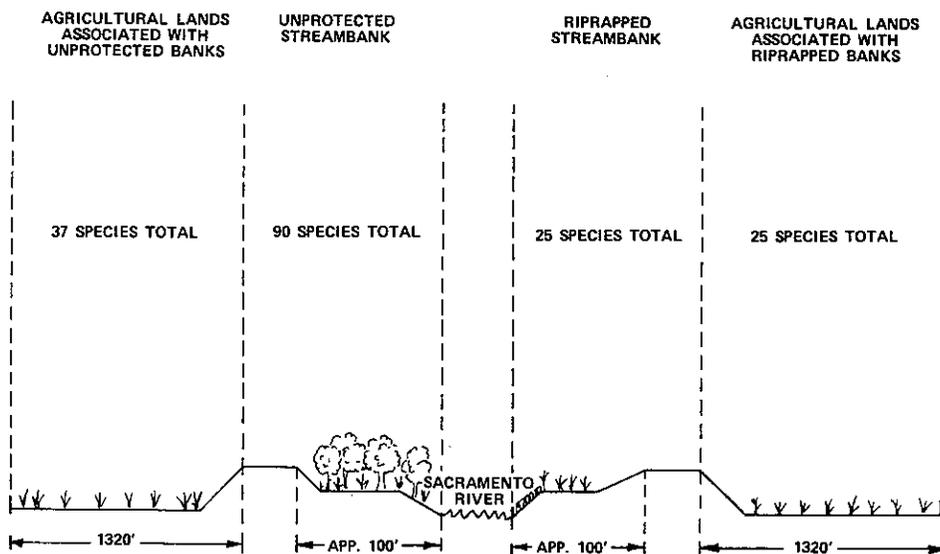
Figure 2. Bird use along natural and riprapped streambanks on the Sacramento River (adapted from Hehnke and Stone 1978)

39. Hehnke and Stone (1978) documented bird use of protected riprap and adjacent unprotected streambanks and nearby cultivated areas along the Sacramento River (Figure 2)*. Species diversity, the number of species per acre, was 71 percent lower on the riprapped banks than on the unaltered sites. The total number of birds per acre, avian density, was

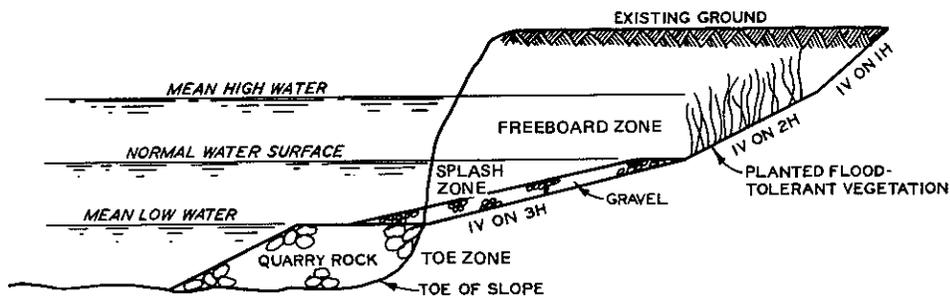
Figure 3. Typical composite revetment design
(from Allen 1978)

52. Concept. Streambanks may be divided into zones based on flow durations. The zonation scheme described below is developed more fully in the section Vegetation. Composite revetment utilizes different protection materials for each streambank zone (Figure 3). This streambank protection strategy is effective in a range of situations. It is particularly effective for deep channels where flows are concentrated along the bank line, but where depths or curvature preclude hard point systems and bank line or environmental conditions preclude windrow revetments. This composite revetment design was used extensively on Section 32 demonstration sites on the Missouri River.

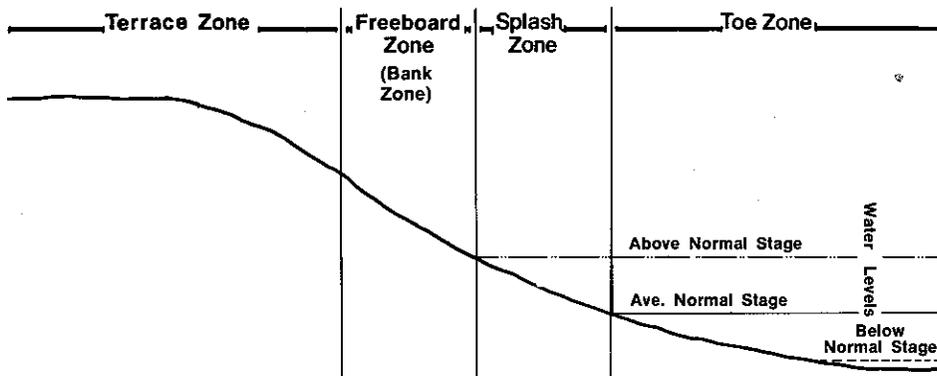
Figure 4. Streambank zones (from Logan et al. 1979)

54. Toe zone. The toe zone (Figure 4) is the portion of the bank below normal water elevation. This zone is subject only to river current erosion.

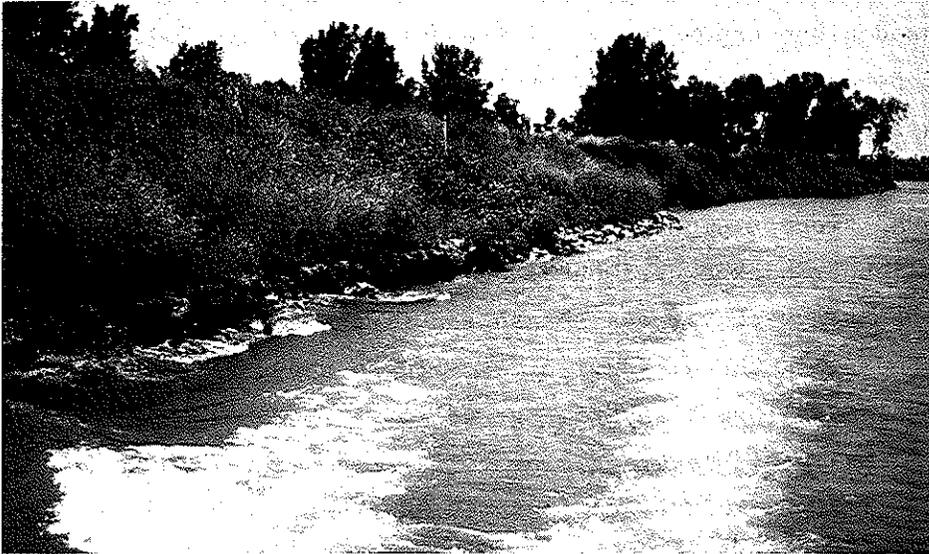
Figure 5. Composite revetment after establishment of vegetation

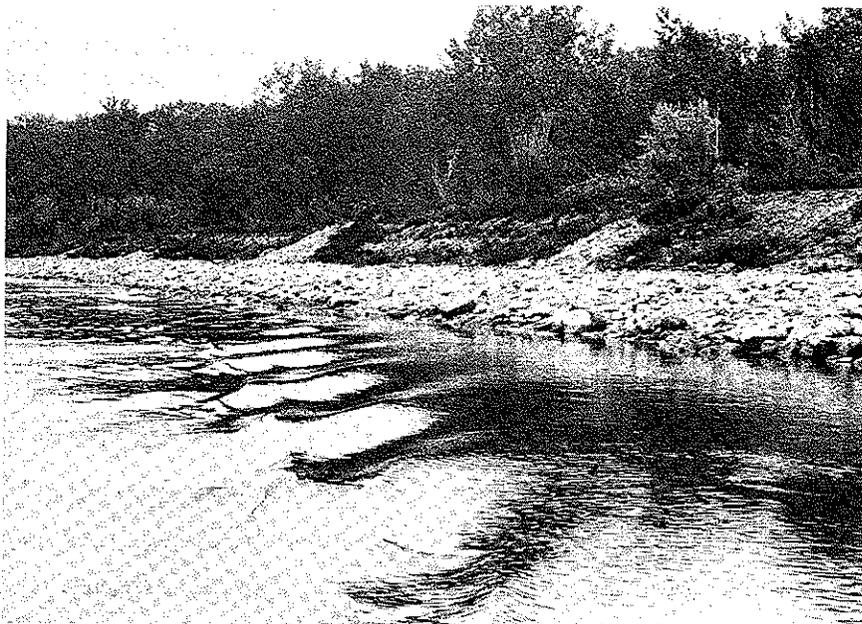
Figure 6. Reinforced revetment construction, showing tiebacks

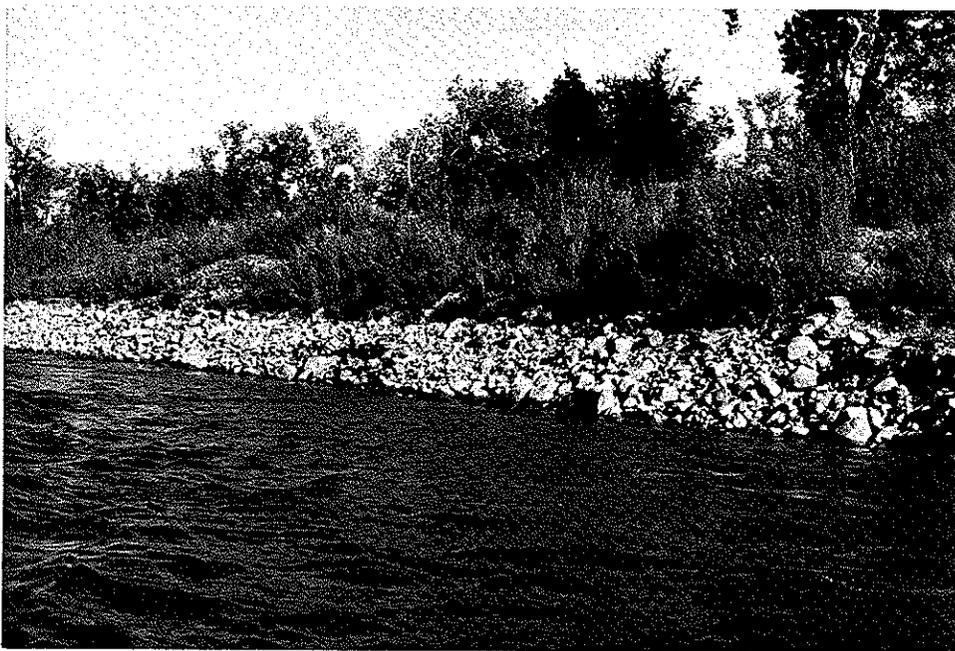
Figure 7. Vegetation established between tiebacks
(from OCE 1981, Appendix E)

If the cells between the tiebacks are graded, backfilled, and seeded, terrestrial impacts are minimized (Figure 7). The segmented revetment design used on the Missouri resulted in virtually no adverse impact to the streambank and riparian habitat between revetment segments. Water-based construction, where possible, further reduces terrestrial impacts by eliminating the need for haul roads. The stone used for toe protection provides stable substrate for benthic macroinvertebrates. A gravel covering over the stone toe improves the visual appearance of the structure when the toe is above the water surface. When the revetment toe crown is submerged, the structure can present a hazard to small boats.

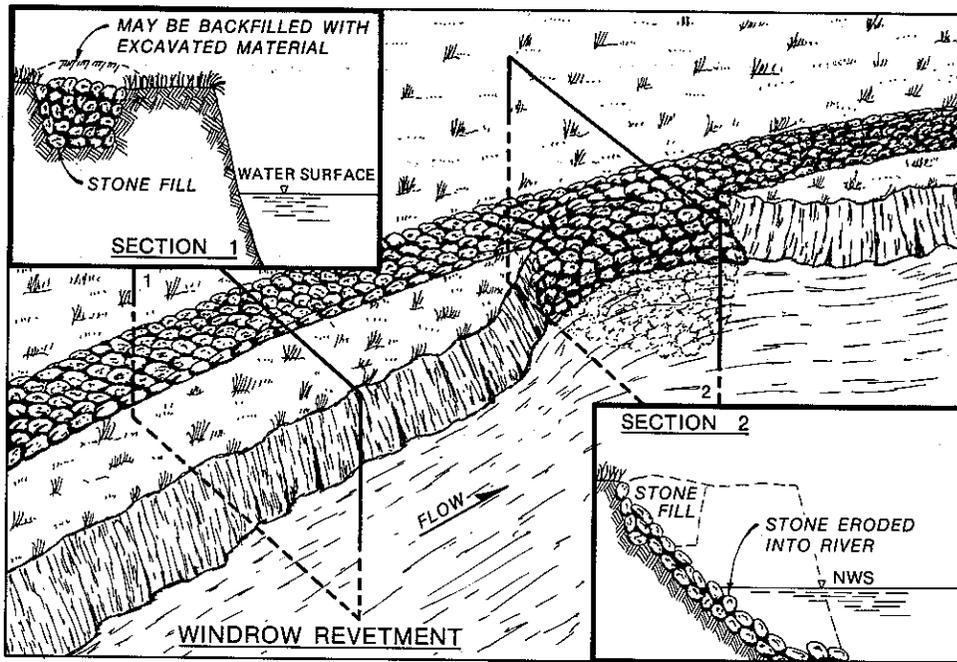
Figure 8. Windrow revetment (adapted from OCE 1981, Appendix E)

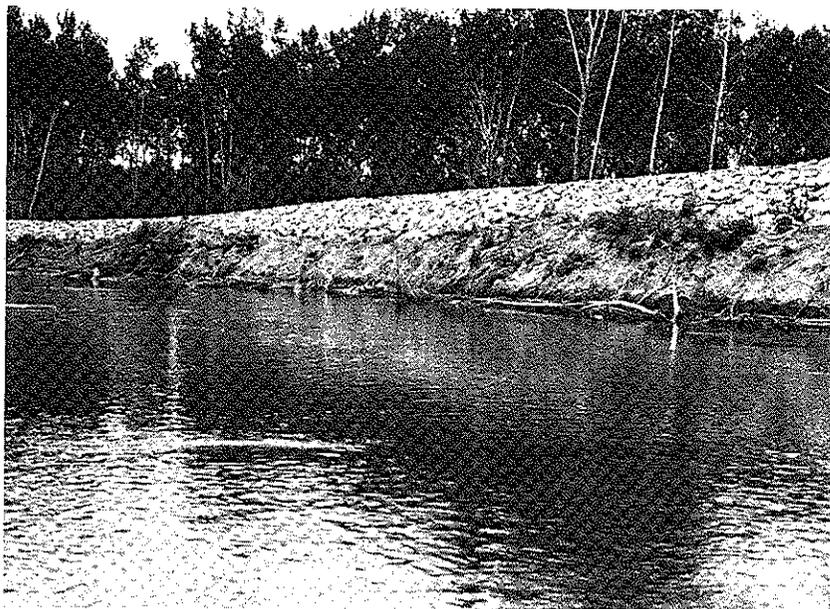
Figure 9. Notch placement of windrow revetment (from OCE 1981, Appendix E)

74. Construction may be either from land or water. Stone fill is placed in one of two ways, in an excavated notch at the top of the bank line (Figure 9) or in a trench excavated near the top of the bank, parallel to the bank line. Placement in a notch requires less bank clearing. The exposed surface of the stone is covered or backfilled with excavated material. Trench placement utilizes an excavation at least 2 ft deep. As further erosion takes place, the stone fill is "launched" down the bank and blankets the bank at a naturally established slope. Stone is then added on an as-needed basis until a stable equilibrium is

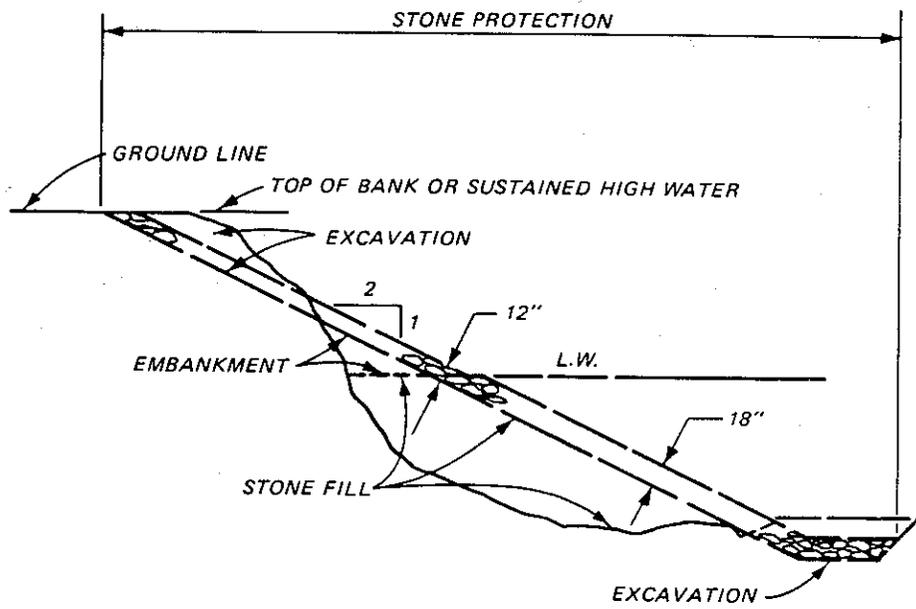
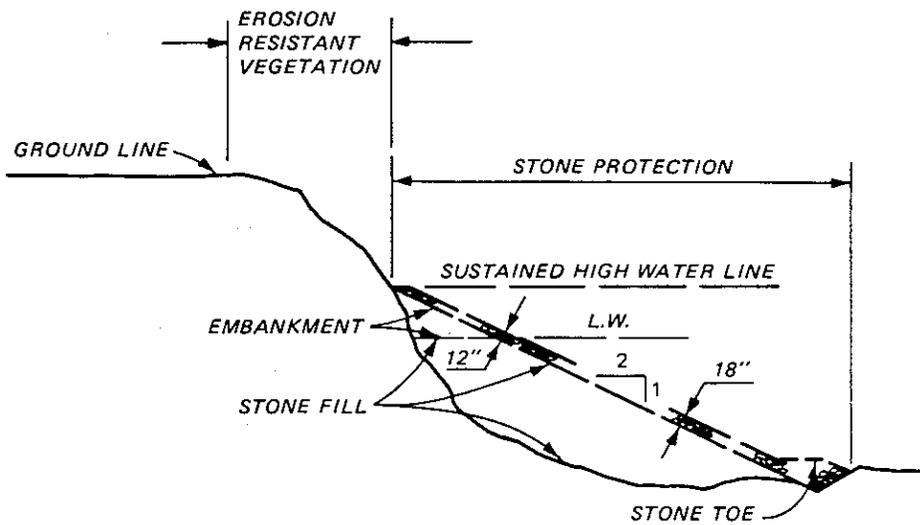
a. Standard rock revetment

b. Modified design--top of revetment lowered to sustained high-water elevation

80. The modified revetment design includes stone protection from the toe up to the sustained high-water elevation, i.e., the river stage elevation exceeded only 10 percent of the time. Above the high-water

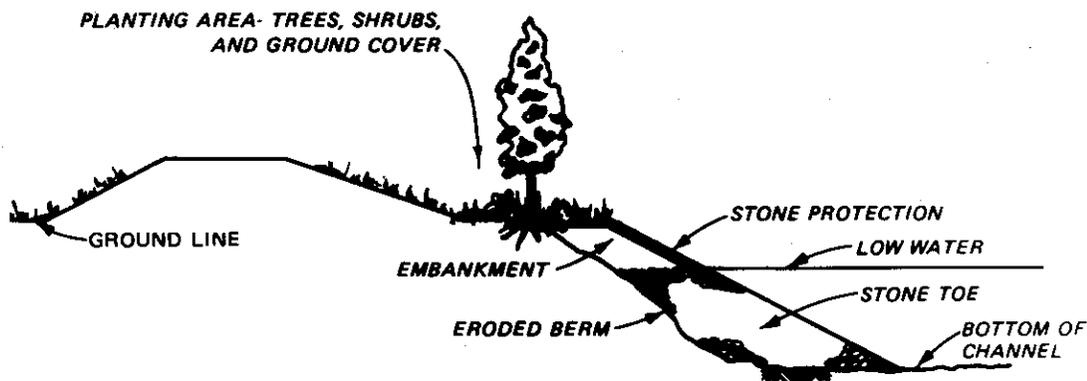
Figure 11. Berm restoration (from Mifkovic and Petersen 1975)

levees, other structures, or cultivation, eroding banks may be prepared for revetment construction by filling instead of excavation. Along the Sacramento River, this technique has been utilized on the narrow strip between the riverside levee toe and the river, and the technique is referred to as berm restoration. When revetments are being constructed adjacent to badly eroding berms, an embankment is formed over the remaining portion of the berm (Figure 11). Natural or constructed berms may be seeded and planted after revetment construction. These berm areas enhance the stability and integrity of the levees and sometimes support the only remaining natural vegetation in an area due to intensive agriculture and urban encroachment.

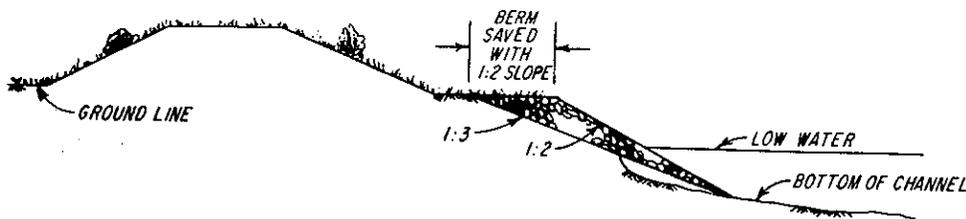
Figure 12. Berm preservation (from Mifkovic and Petersen 1975)

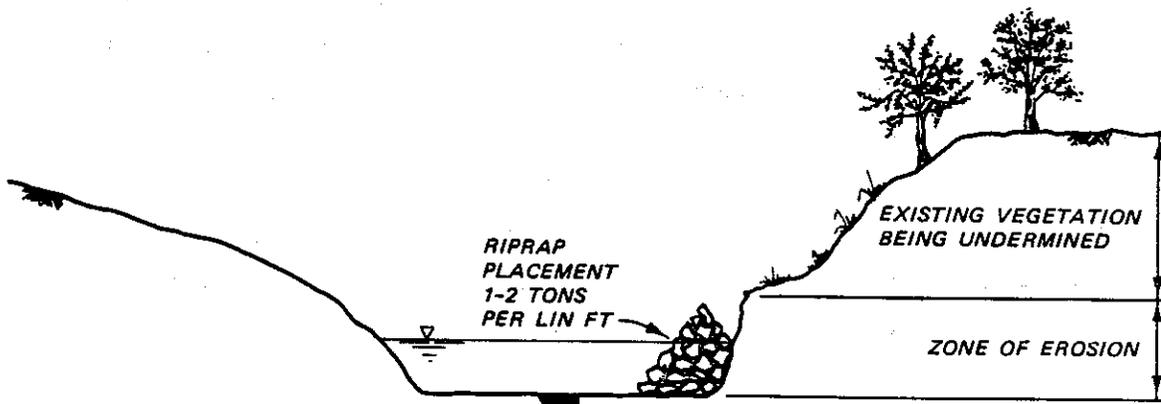
Figure 13. Toe protection design (after Personal Communication, 1981, Mr. Charles Elliott, US Army Engineer District, Vicksburg, Vicksburg, Miss.)

92. Concept. Stabilization of the toe area is critical for streams where bank erosion is caused primarily by toe erosion undermining the bank. In these cases, however, work on the middle and upper banks is often not needed. In such cases, environmental considerations are best served by preserving existing trees and shrubs above the toe (Figure 13). Revegetation of the bank above the toe protection depends on siltation and an adequate seed source, e.g., waterborne (Carlson 1982). Planting of woody species may be necessary to stabilize the banks until vegetation becomes established through natural invasion and sedimentation. Structural materials, e.g., stone riprap, fieldstone, or quarystone, may be used to stabilize the toe area. The toe protection deflects flow from the bank and promotes sediment deposition behind the structure. Stone tiebacks running from the toe into the bank are often used at either or both ends to prevent flanking.

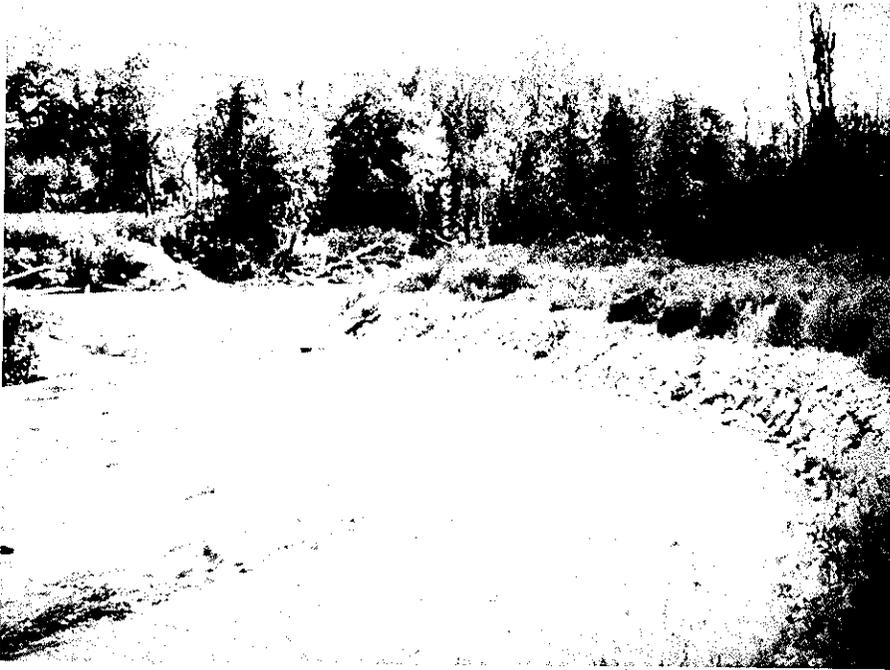
Figure 14. Vegetation established on bank area of toe protection design

93. Environmental considerations. Toe protection is beneficial to terrestrial habitat because the riparian nature of the streambank is restored, either through vegetative treatment of the upper bank or invasion of native species to the stabilized bank (Figure 14). Clearing

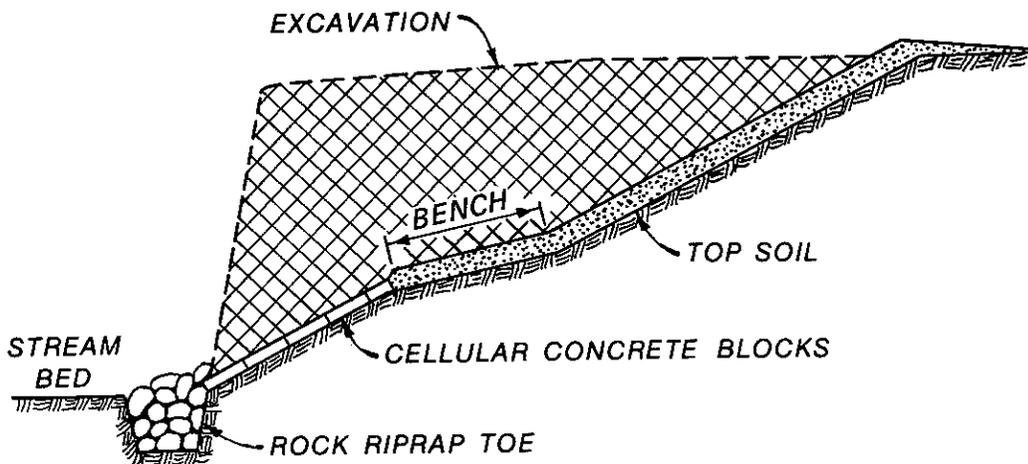
Figure 15. Excavated bench design (from Bowie 1981)

97. Concept. The excavated bench method is used on straight reaches of small streams and employs vegetation and structural protection (Figure 15). The design is used where toe stability and lower bank scour are problems. The purpose of an excavated bench is to provide a suitable growing environment for woody vegetation. A bench area is excavated parallel to the channel, and a trench is excavated along the toe and filled with riprap. Topsoil is excavated from the upper bank and the trench to develop the proper slope for the upper bank (2V:5H), bench area (1V:5H), and the lower bank (1V:2H). The lower bank is protected

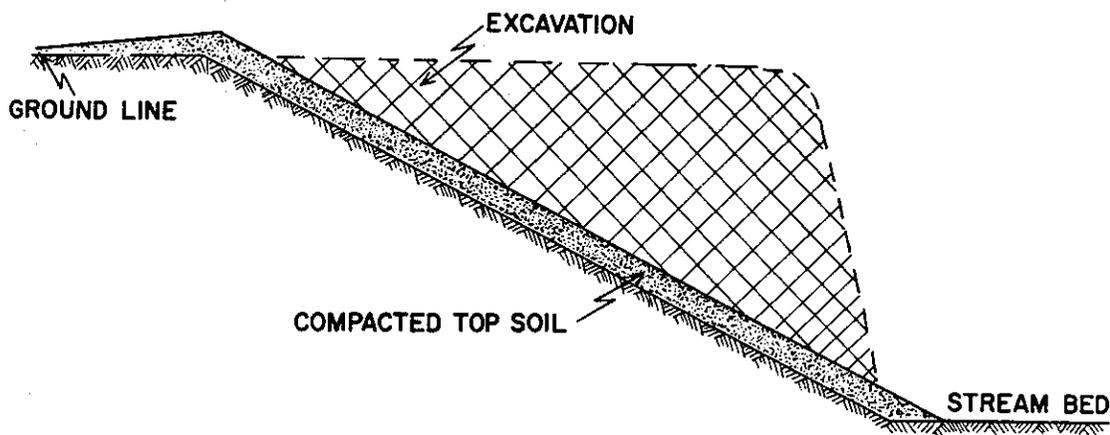
Figure 16. Bank sloping and revegetation (from Bowie 1981)

102. Concept. On a number of small, low-velocity streams in the Yazoo basin, bank erosion has been controlled along straight reaches by grading the eroding banks to a more gradual slope (2V:5H used in Yazoo basin) (Figure 16). The sloped bank is plated with topsoil, fertilized, and seeded (Bermuda grass or Alamo switchgrass was used in the Yazoo basin). No structural components are used. Herbaceous vegetation may also be planted, and native species are allowed to invade (Bowie 1981).

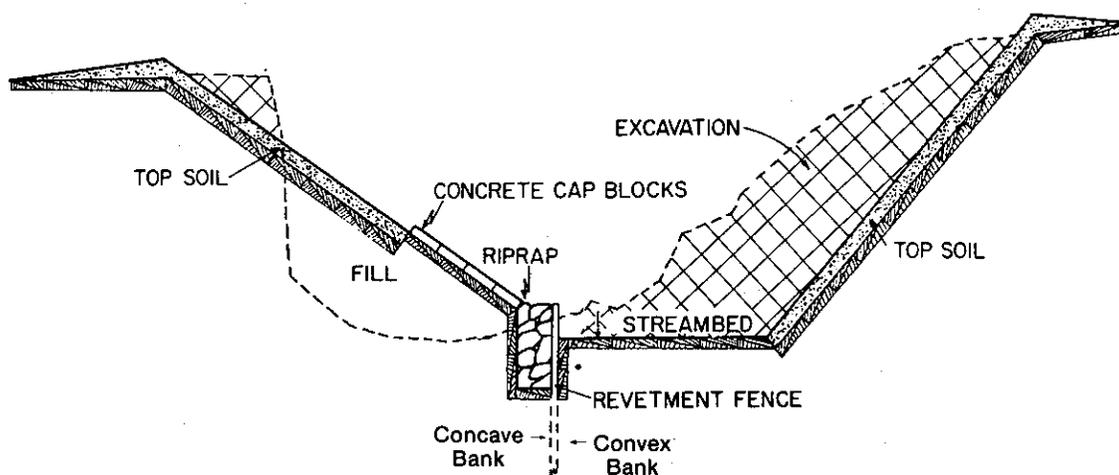
Figure 17. Channel relocation design (adapted from Bowie 1981)

107. Concept. Channel relocation has been used to protect concave meander banks along some Yazoo River tributaries (Figure 17). Channel relocation reduces the sinuosity of the stream by smoothing the transition between bendway crossings by shifting the thread of maximum velocity to the center of the channel. Channel sinuosity is reduced, but the thalweg slope is changed very little. The design results in a flatter

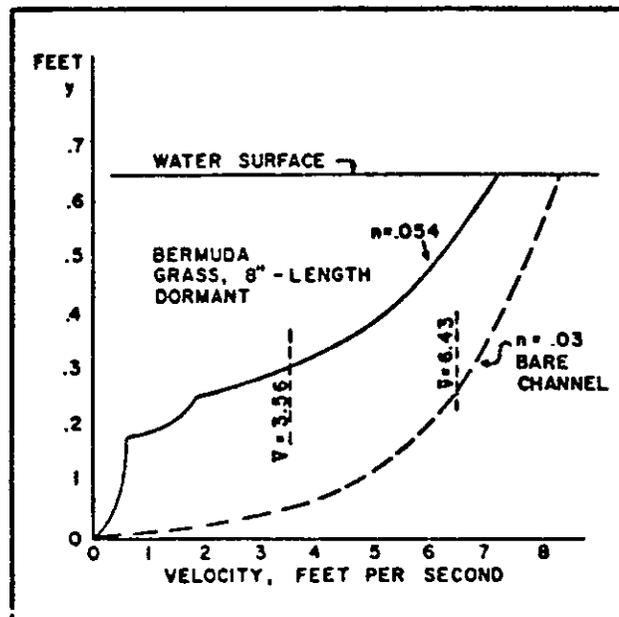
Figure 18. Influence of vegetation or variation of velocity with depth below water surface (after Parsons 1963)

115. Streambank stabilization by vegetation. Klingeman and Bradley (1976) point out four ways that vegetation protects streambanks. First, the root systems create a binding network that helps hold the soil together and increase the overall bank stability. Second, the exposed vegetation (stalks, stems, branches, and foliage) can increase the hydraulic resistance to flow and reduce the local velocities, causing energy to dissipate against the deforming plant mass and away from the soil--energy that otherwise might have exerted greater shear stress against the streambank soil. Figure 18 shows velocity profiles measured in a bare channel and a channel lined with Bermuda grass. Third, vegetation acts as a buffer against the abrasive effect of transported materials. Fourth, close-growing vegetation can induce sediment deposition by causing zones of lower velocity at the bank where shear stresses may become small enough to allow coarse sediment to settle out of the flow.

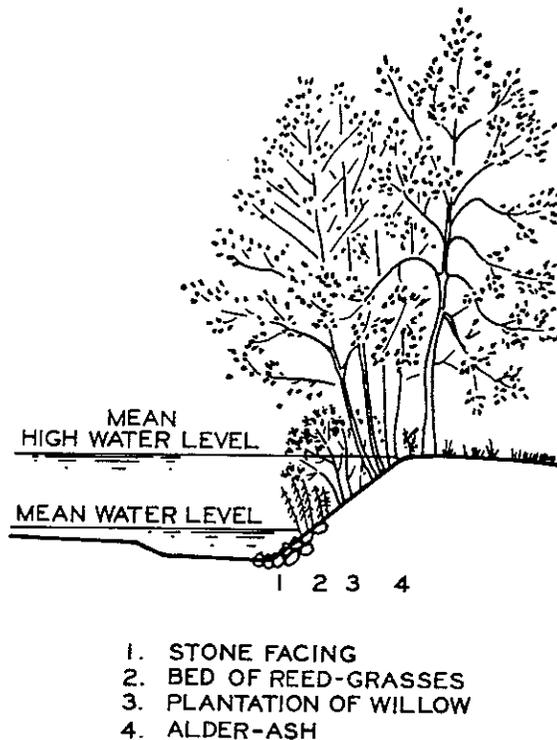
Figure 19. Vegetative community zones (after Siebert 1968)

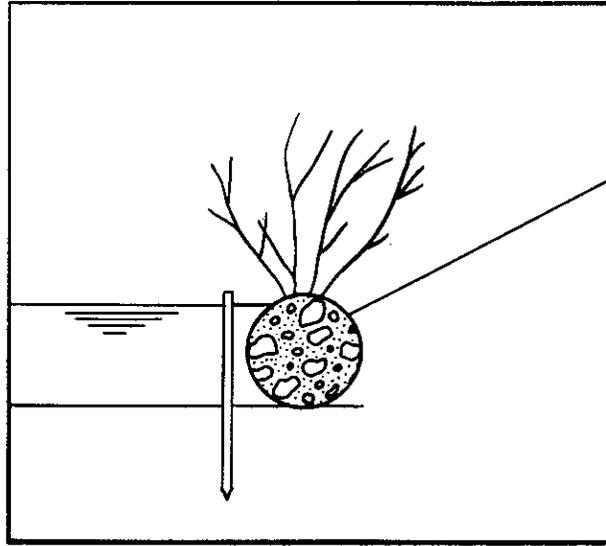
Figure 20. Reed roll (from Logan et al. 1979)

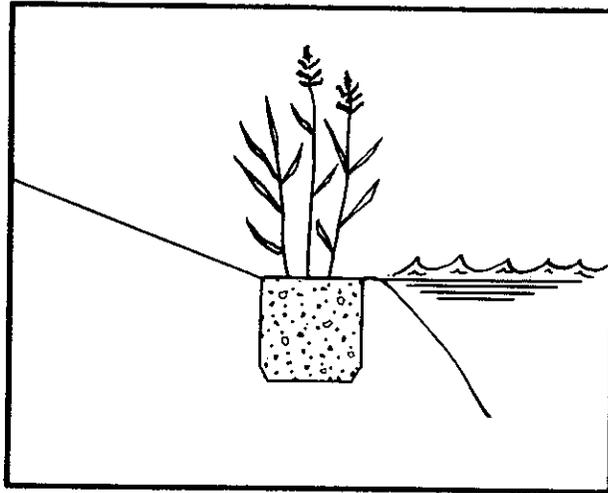
Figure 21. Sodding (from Logan et al. 1979)

- b. Bank zone. Both herbaceous (e.g., grasses, clovers) and woody plants may be used in the bank zone. Sodding with flood-tolerant grass species in the bank zone is possible if only mild wave action is anticipated (Figure 21). The sod is held in place with small wooden pegs or wire netting until it roots adequately (usually 2-3 weeks) (Allen 1982a). Where more severe erosion conditions are anticipated, supportive structures composed of vegetative materials are used. Structures such as willow barriers and fascines have been used successfully in Europe (Allen 1982a, Seibert 1968).
- (1) Willow barriers. Willow barriers (Figure 22) are interlaced willow switches 2 to 3 years old and 5 to 6 ft long that are placed on the bank perpendicular to the channel. The switches are interlaced so they are only 0.5 in. apart and are placed in a 6-in.-deep

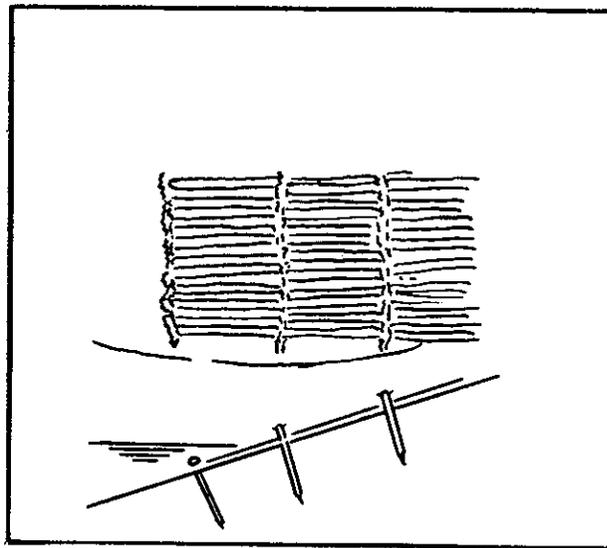
Figure 22. Willow barrier (from Logan et al. 1979)

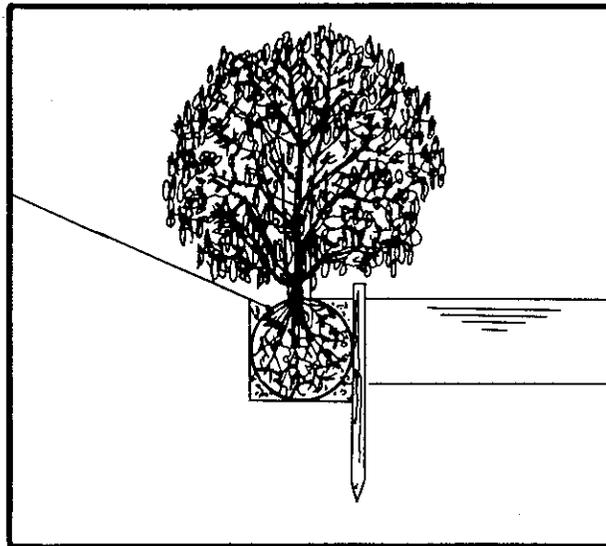
Figure 23. Cross section of fascine placement (from Logan et al. 1979)

- (2) Willow fascines. Fascines are composed of switches of willow or other species packed together in a continuous roll 10 to 60 ft in length and 4 to 5 in. in diameter. The roll of willows is buried parallel or nearly parallel to the stream and is supported on the stream side by stakes (Figure 23). On streambanks subject to wave and current action, fascines may be planted diagonally to the wave action. Fascines are built from 2- to 3-year-old willow switches, 4 to 6 ft long, and are held in a tight roll by wire. The entire roll is attached to the stakes with wire. Rows of fascines are set at 3- to 4-ft intervals. The fascines are lightly covered with earth to encourage sprouting. The fascine structures themselves and the sprouting properties of the willows result in an integrated system of stems, roots, wire, and stakes to hold the bank in place (Allen 1982a). Fascines provide an effective deterrent to downhill surface movement of soil caused by downward water flow, wind action, trampling of wildlife and livestock and the forces of gravity (Logan et al. 1979).

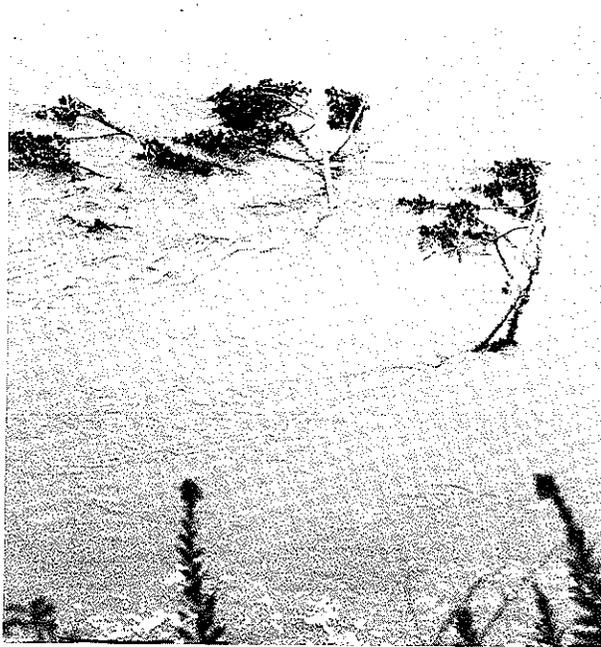
Figure 24. Tree retards (from OCE 1981, Appendix E)

134. Tree retards. Experimental tree retards generally proved ineffective on the Missouri River due to damage to the structures. The tree retards were made of locally available trees placed perpendicular to the bank (Figure 24). Tree retard units of two trees, 30 to 40 ft in length, were placed 100 ft apart. The trees were anchored below normal water level by cables and a 55-gal concrete-filled drum. The butts of the trees were placed in a trench excavated from the channel to a

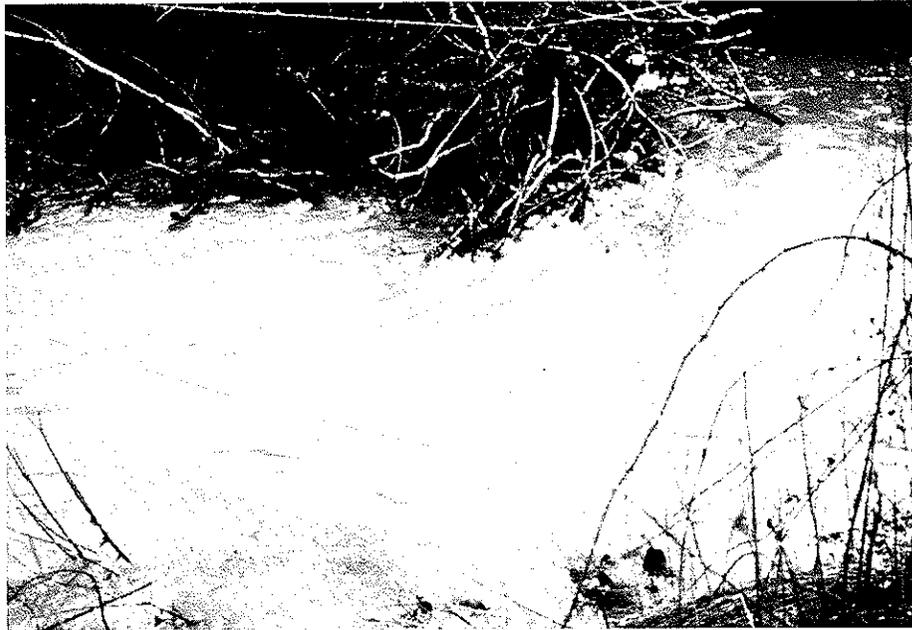
Figure 25. Tree tops placed against bank
(from Herbkersman 1982)

135. Tree retards have been used on small streams to effectively eliminate local erosion problems. Herbkersman (1982) presents an approach to streambank protection involving several components developed by George Palmiter for use on small midwestern streams. These techniques require minimal clearing and no bank excavation or sloping. Manual labor is used to remove log jams, fallen trees, and other debris that force flows against the streambank. Protection of eroded or eroding banks is accomplished by building retard-like structures with large, brushy tree tops or piles of logs and branches (Figure 25). The vegetative material is secured upstream from where erosion is occurring with the butt end of the trees facing upstream. The brush piles deflect the flow away from the eroding bank. Series of several brush piles are necessary to protect long reaches of eroding bank line. Properly

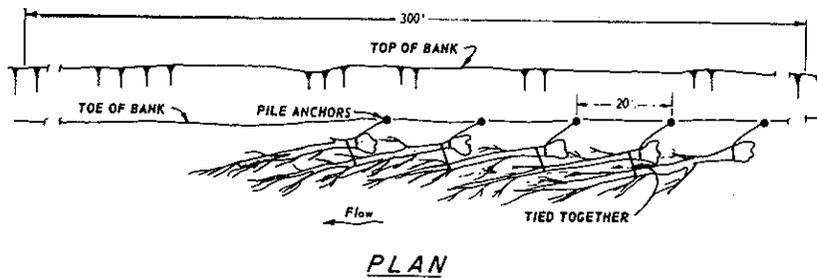
Figure 26. Tree pendant design (from
OCE 1981, Appendix G)

136. Tree pendants. A series of trees placed parallel to the streambank was used successfully on the Van Duzen River in California, on the Lower Chippewa River, Wisconsin, and on small streams in Oregon by the Soil Conservation Service (OCE 1981, Appendix G; Lines, Carlson, and Corthell 1979). On the Van Duzen River, a third of one 900-ft reach was protected by tree pendants. The rest of the reach was protected by pile fences. Along the face of the eroding bank line, whole trees, 40-50 ft long, were placed in a pattern overlapping the next upstream tree by one-third. Locally available redwoods were used (Figure 26). During cutting and transportation of the trees, portions of the root system broke off. The branches of the redwoods were brittle and many were lost, so that only the trunk and a few limbs survived placement.

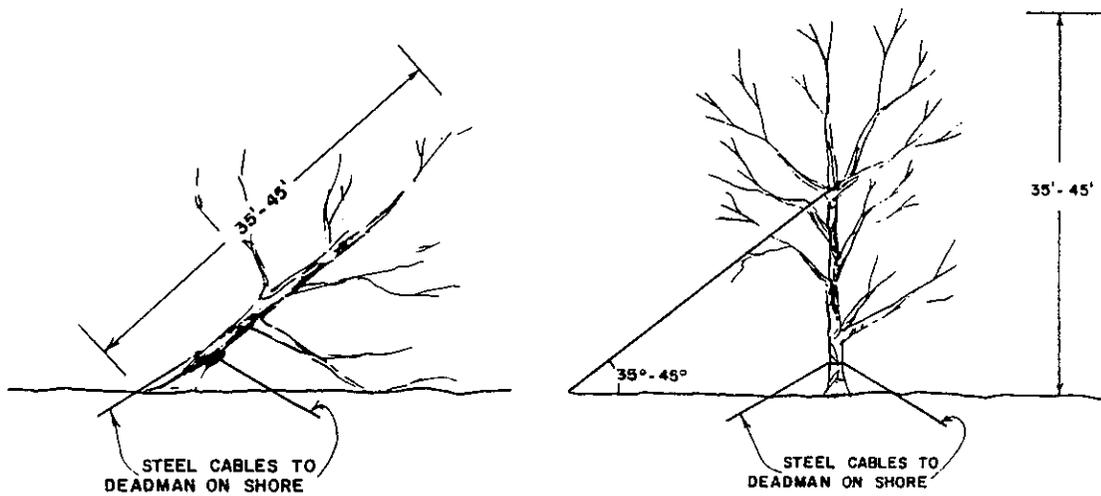
a. Trees angled downstream

Figure 27. Tree placement on Lower Chippewa River (from OCE 1981, Appendix G)

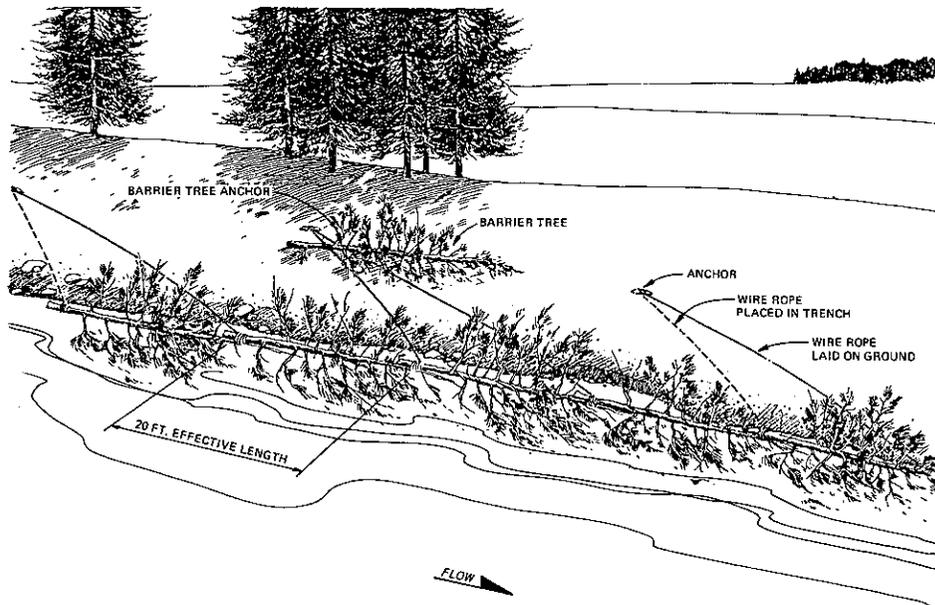
Figure 28. Conifer revetment design used on Salt River, Wyo. (adapted from Wyoming Game and Fish Dept. 1980)

138. Tree revetments. In Wyoming, conifers were used on the Salt River to form revetments along concave bends (Figure 28). The revetments provided more permanent protection (estimated life is 10 years) than temporary emergency measures (Wyoming Game and Fish Department 1980; Line, Carlson, and Corthell 1979). The trees are protected at the upstream end by a rock deflector and are anchored by trees and deadmen on the bank (Figure 29). The trunks and branches of the trees in the river provide extensive trout habitat (Wyoming Game and Fish Department 1980).

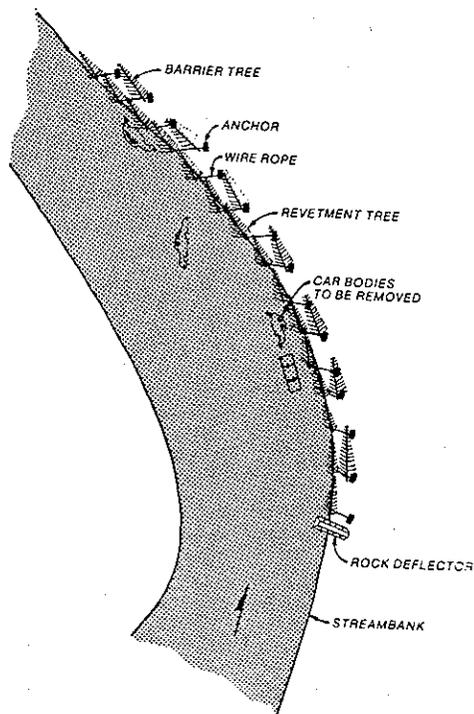
Figure 29. Alignment of trees, deadmen, and anchors on Salt River revetment (adapted from Wyoming Game and Fish Dept. 1980)

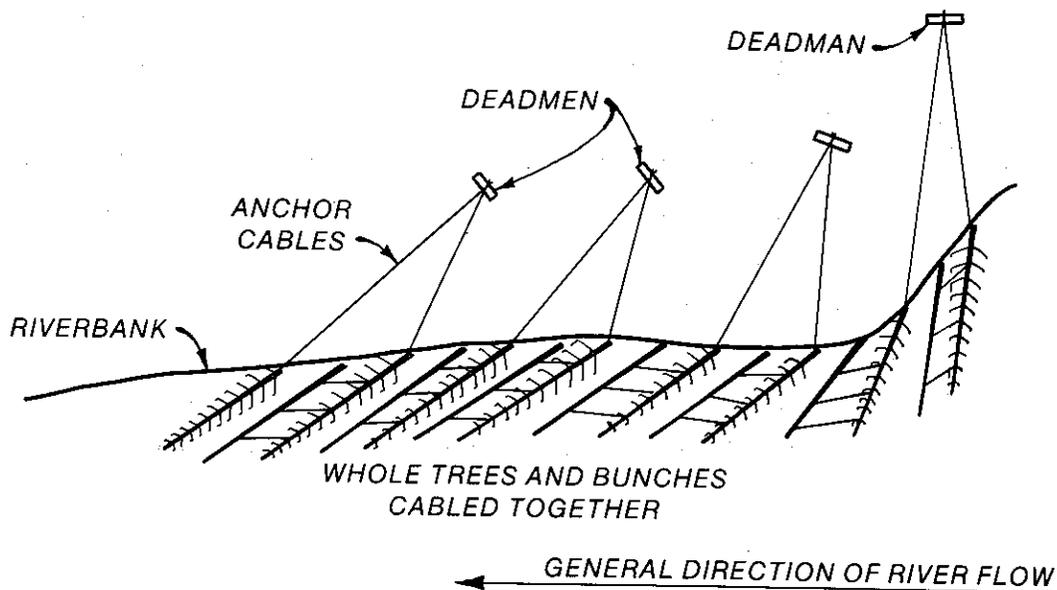
Figure 30. Tree revetment design (from OCE 1981, Appendix H)

139. A tree revetment scheme was used on a 680-ft reach of the Tanana River, Alaska. The revetment consisted of trees, mainly spruce, with and without root clumps. The trees were placed perpendicular to

the bank with only the end of each tree (butt end of sawed trees and root clump of whole trees) remaining on the bank (Figure 30). The revetment was composed of 51 groups of single and multiple trees. The single trees or tree clumps were anchored to deadmen buried on the bank. The revetment was placed by pushing the trees into the channel after assembling them on the streambank. The current carried each tree downstream to swing it into the river bank. The anchor cables were then tightened to stabilize the revetment. The trees or tree clumps overlapped each other, but not to the extent of the redwoods used on the tree pendants.

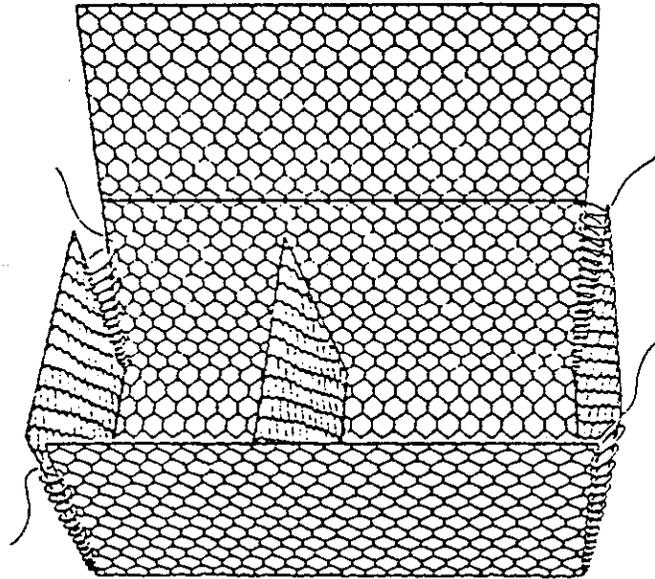
Figure 31. Typical gabion cage used for revetment (from OCE 1981, Appendix H)

148. Gabion works are used in place of bank linings such as riprap or concrete. These structures provide permeable protection, important where hydrostatic pressure or bank seepage is a problem. Gabions are used on slopes that are too steep for riprap (greater than 1V:2H).

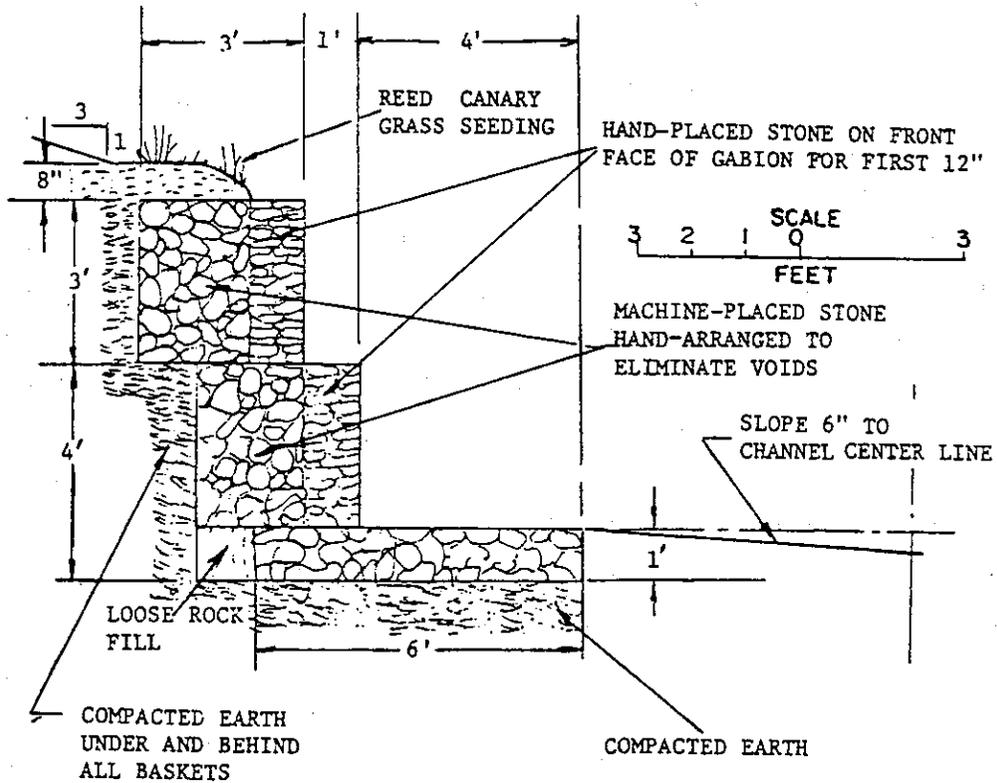
Figure 32. Gabion baskets stacked in stairstep fashion to form a continuous revetment (OCE 1981, Appendix H)

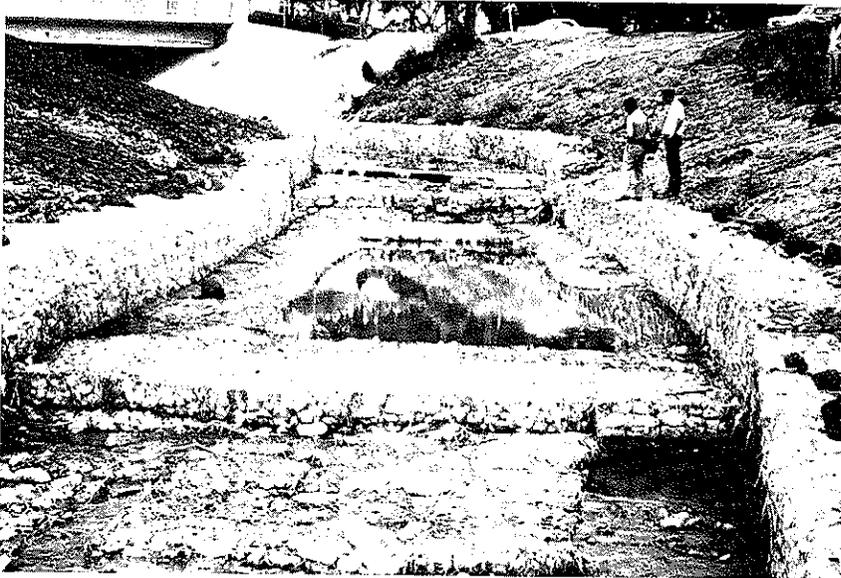
Figure 33. Gabions used for grade control
(from Linder 1976)

149. Gabion works may be used as toe protection only, or stacked to form grade control structures (Figure 33) (Maccaferri 1981). When gabions are used for toe protection, the upper bank may be graded and planted in grasses, or the upper bank may simply be backfilled behind the gabions. Gabions may be used in enlarged channels to define a low-flow channel as well as to provide toe protection (OCE 1981, Main Report). The USAED, Omaha, used gabions to realign a channel for urban development. This design incorporated gabion drop structures for grade control (OCE 1981, Appendix H).

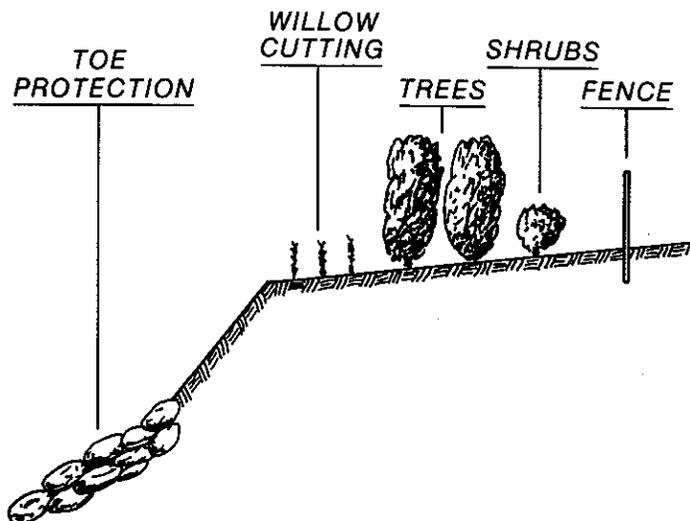
Figure 34. Fencing and buffer strip design
(adapted from SCS 1978a)

154. Concept. Cultivation, livestock grazing, and other agricultural activities can result in severe erosion along small streams. In some cases, erosion can be decreased by development of vegetative buffer strips. Fences may be constructed roughly parallel to the channel to exclude livestock and farm machinery from the riparian zone, thus allowing a buffer strip of riparian vegetation to develop (Figure 34) (Lines, Carlson, and Corthell 1979). When the riparian area is completely denuded, the buffer strip may be seeded after fencing with a grass-legume mixture to prevent further erosion. Plant species normally found along streams, such as willows, alders, cattails, and blackberry and snowberry vines, will invade the stabilized buffer strip. Planting of these species may be desirable if natural invasion is not rapid (Lines, Carlson, and Corthell 1979; Winegar 1977).

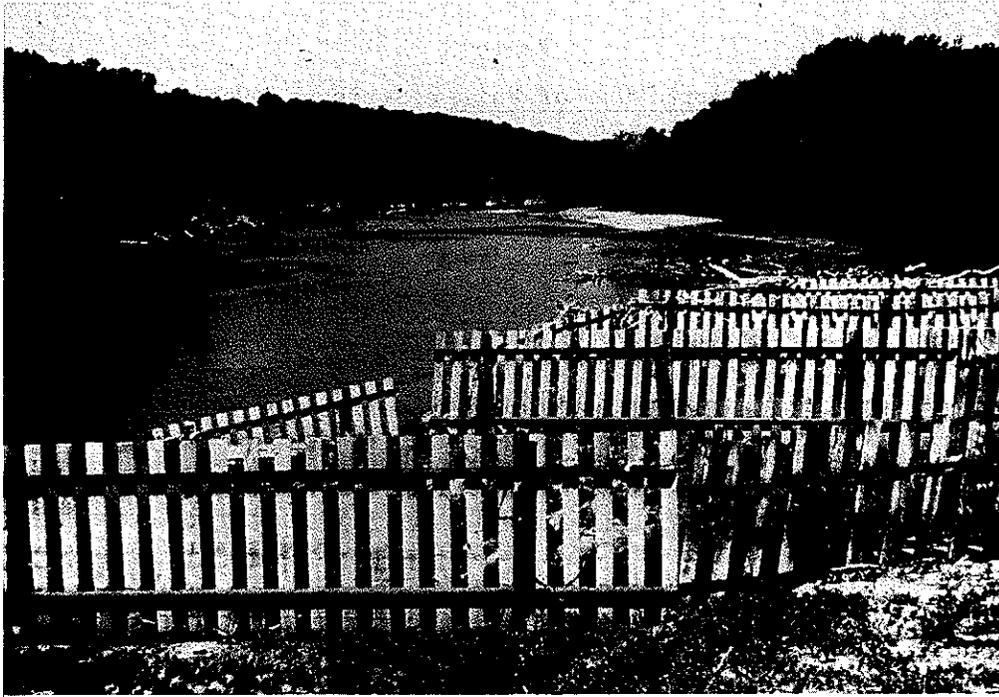
Figure 35. Fence retard

159. Concept. Board or wire fences may be used on small streams as flow retardance devices (Figure 35). Reduced flow velocities induce sedimentation, and vegetation is quickly established. Fences may be

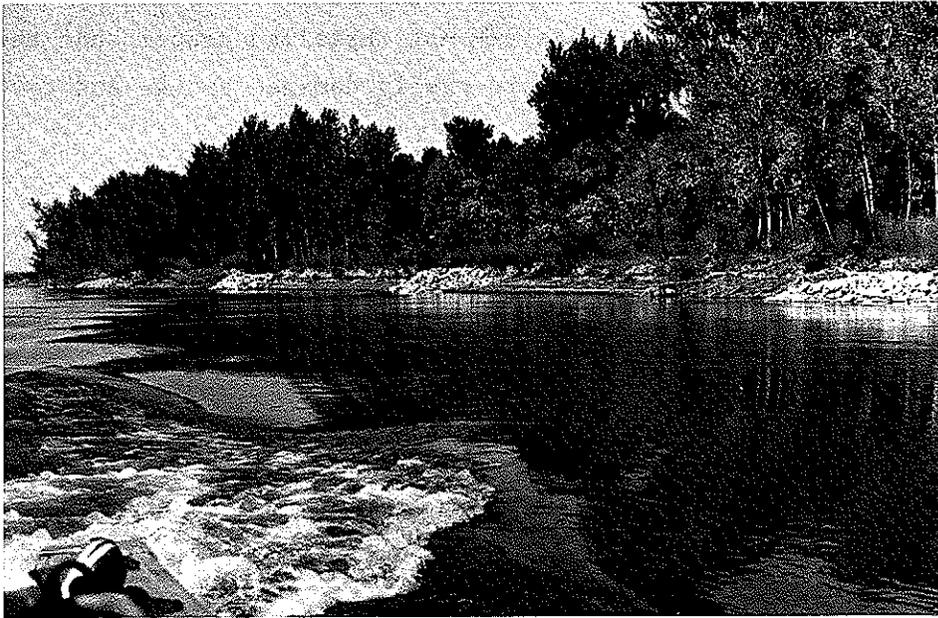
Figure 36. Hard point system (from OCE 1981, Appendix E)

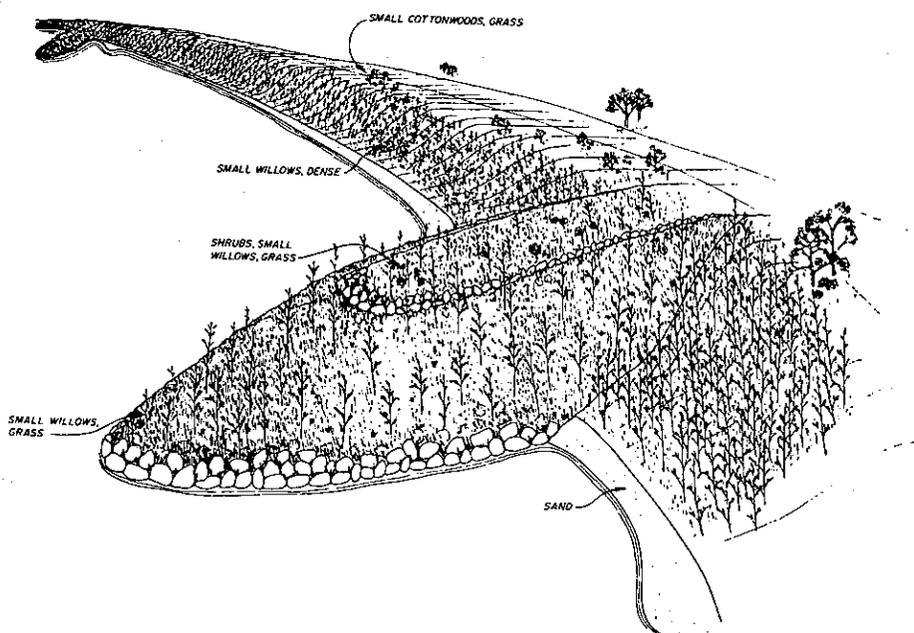
Figure 37. Vegetative plan for a hard point
(from Engineering Consultants, Inc. 1978)
