ENVIRONMENTAL AND WATER QUALITY
OPERATIONAL STUDIES

TECHNICAL REPORT E-84-11

ENVIRONMENTAL FEATURES FOR
STREAMBANK PROTECTION PROJECTS

Jim E. Henderson, F. Douglas Shields, Jr.
Environmental Laboratory

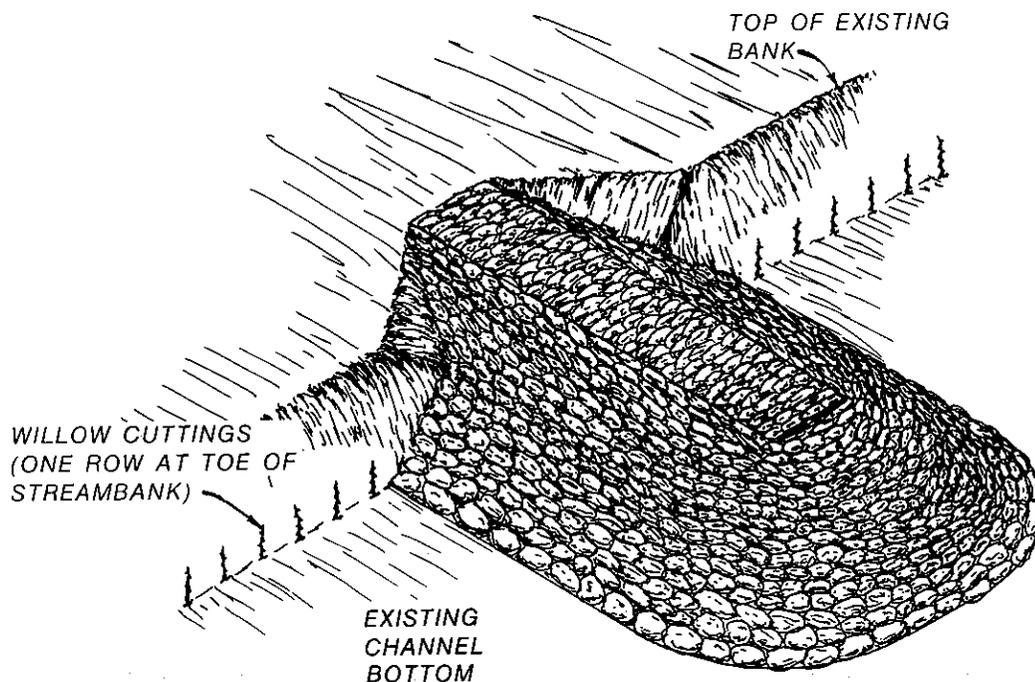
Figure 39. Jetty design for Wallowa County Streambank Protection Project, Oregon (adapted from SCS 1978b)

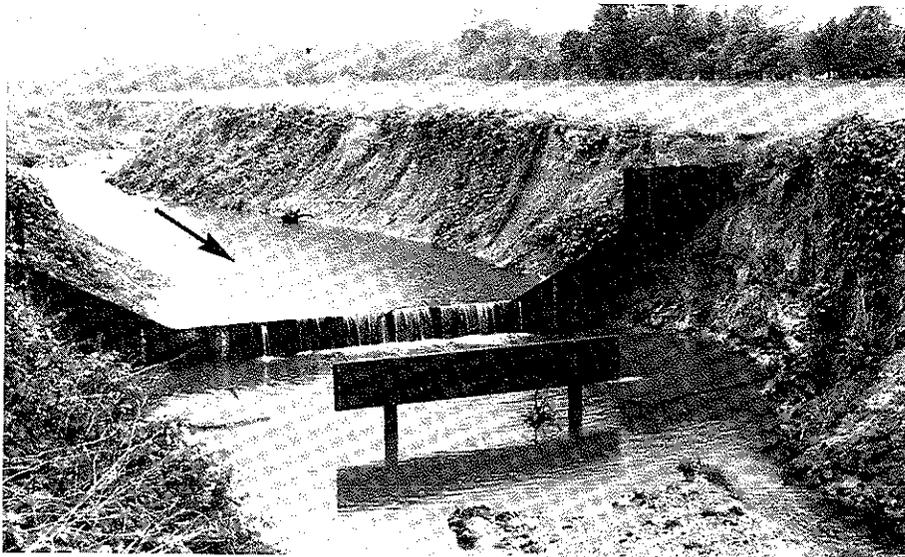
Figure 40. Drop structure consisting of a weir and baffle plate (from OCE 1981, Appendix F)

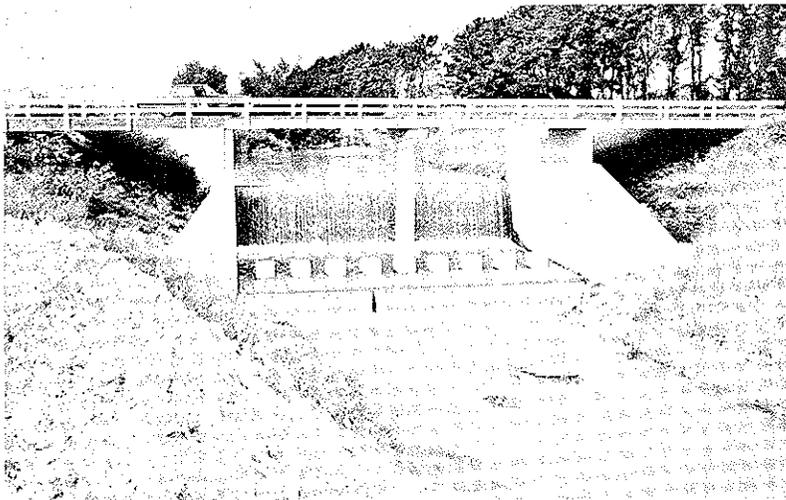
Figure 41. Drop structure using baffle piers; note vegetation on bank and minimal use of rock or other structure on the banks (from Linder 1976)

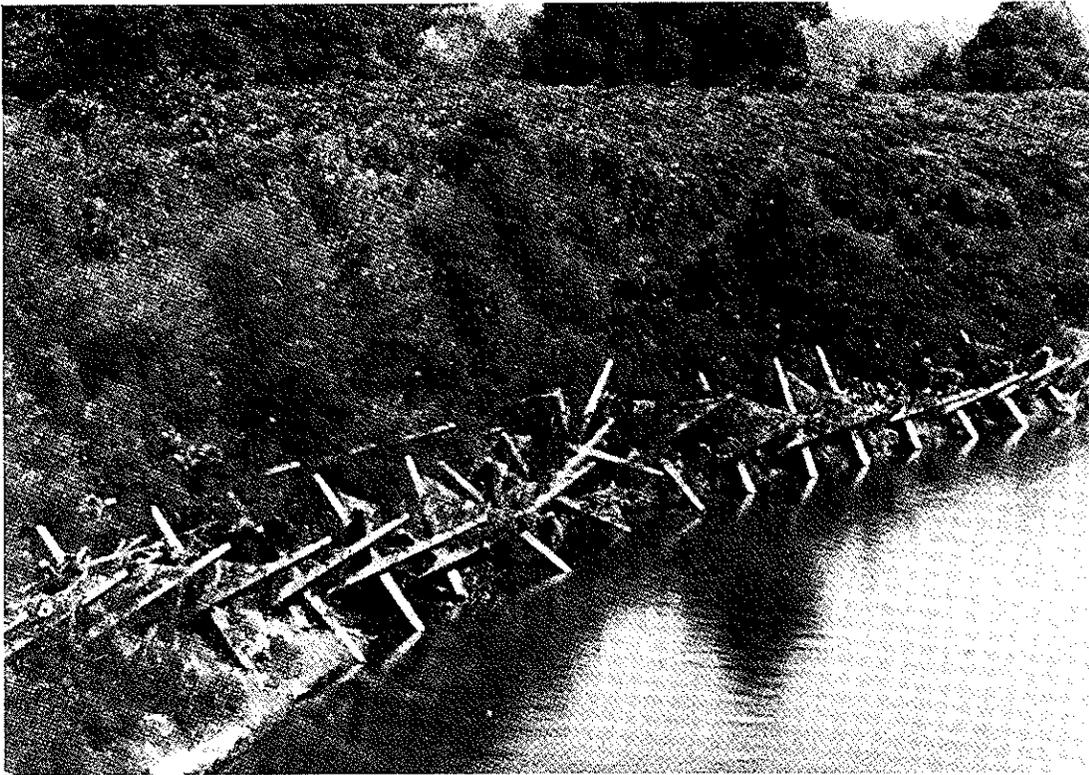
Figure 42. Kellner jacks placed longitudinally along the bank; note vegetation behind the jack line (photo courtesy of SCS)

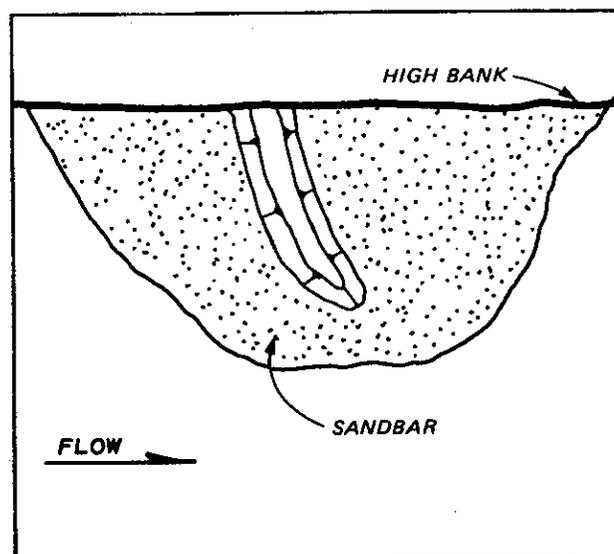
Figure 43. Earth core dike (from US Fish and Wildlife Service 1980)

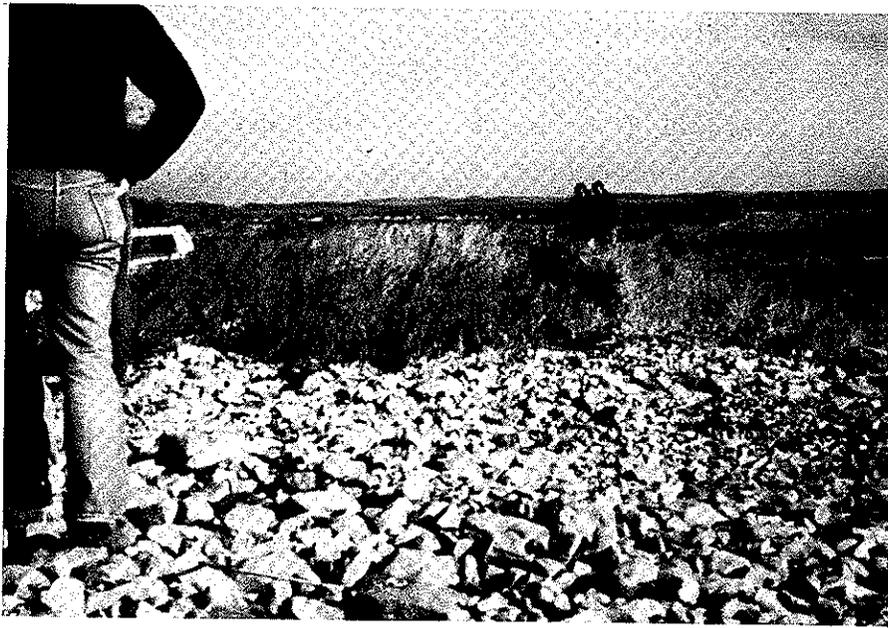
Figure 44. Vegetation on earth core dike

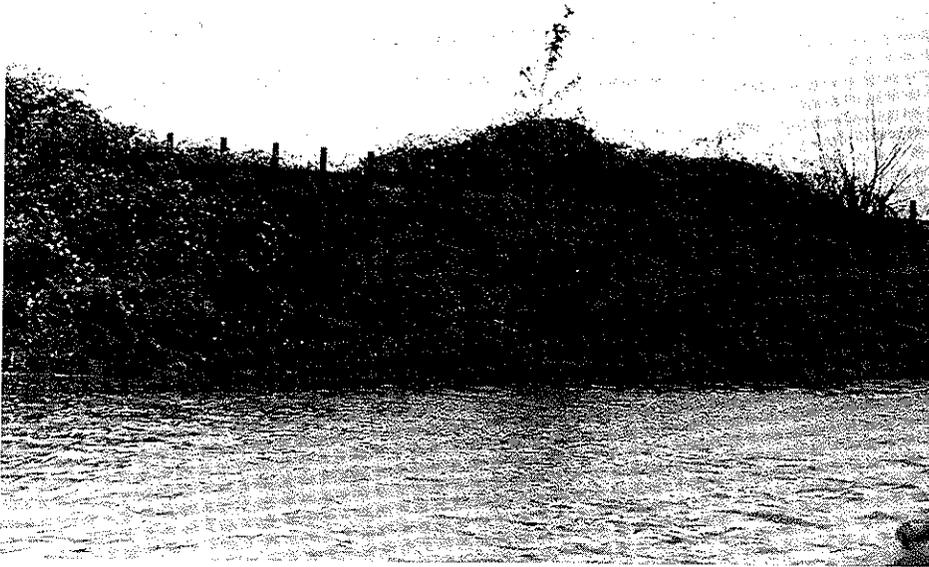
Figure 45. Woody vegetation and vine growth on riprap revetment

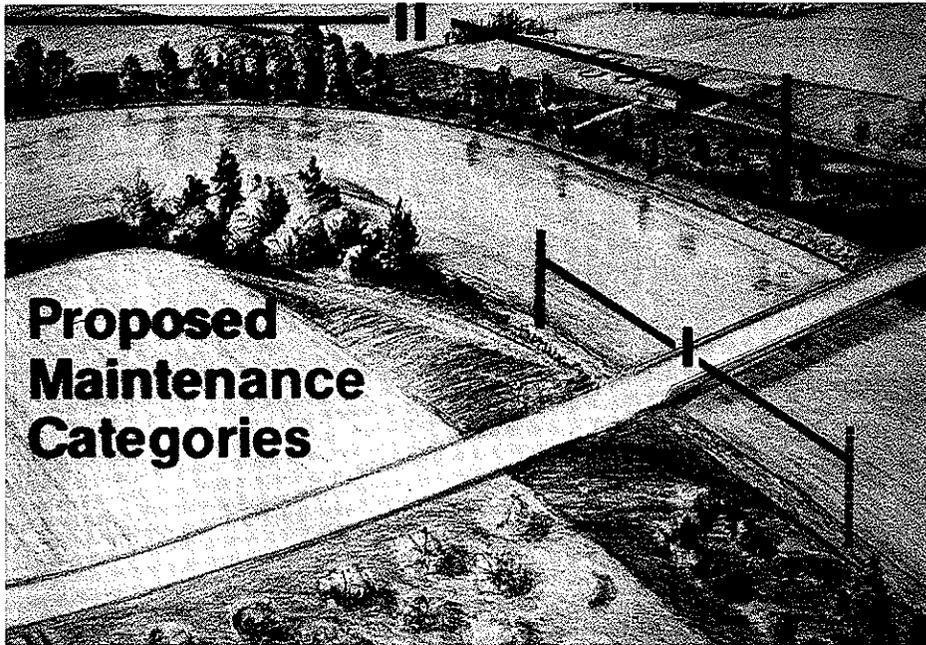
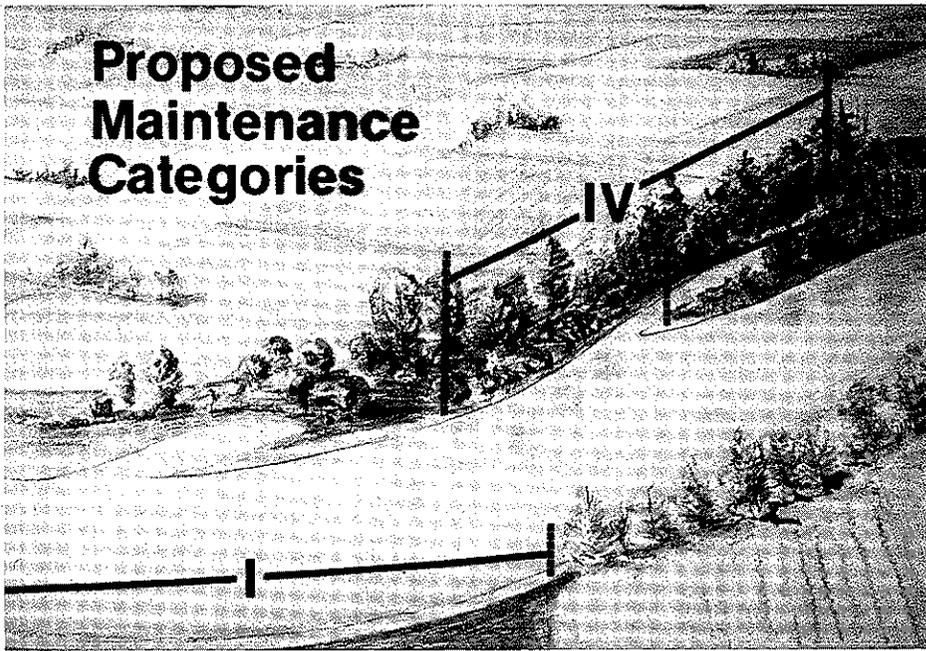
a. Categories I and II

b. Categories I, III, and IV

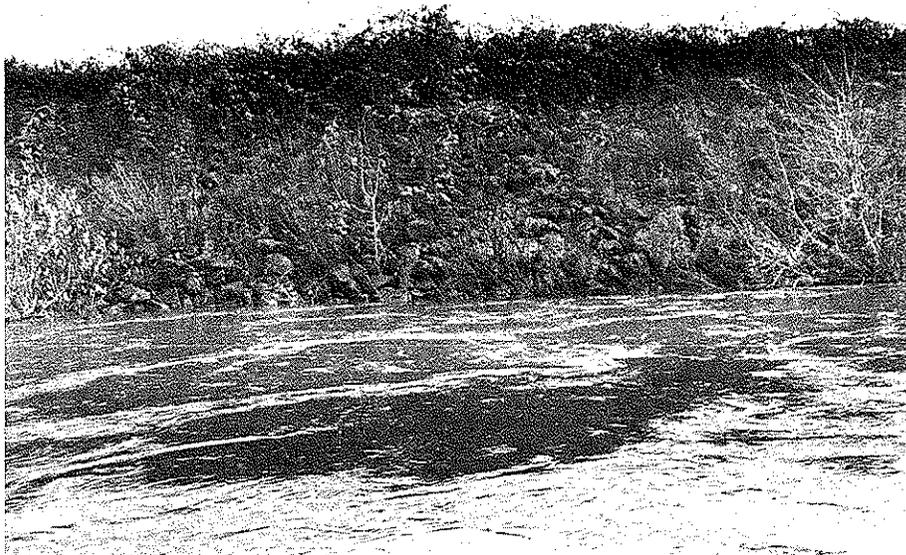
Figure 47. Vegetative growth on riprap

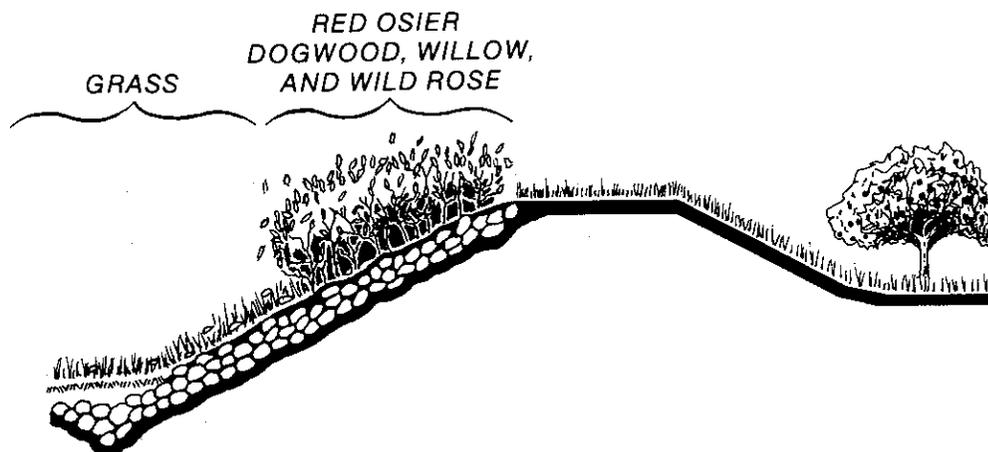
Figure 48. Vegetation plan for riprap on a levee (adapted from USAED, Seattle 1978)

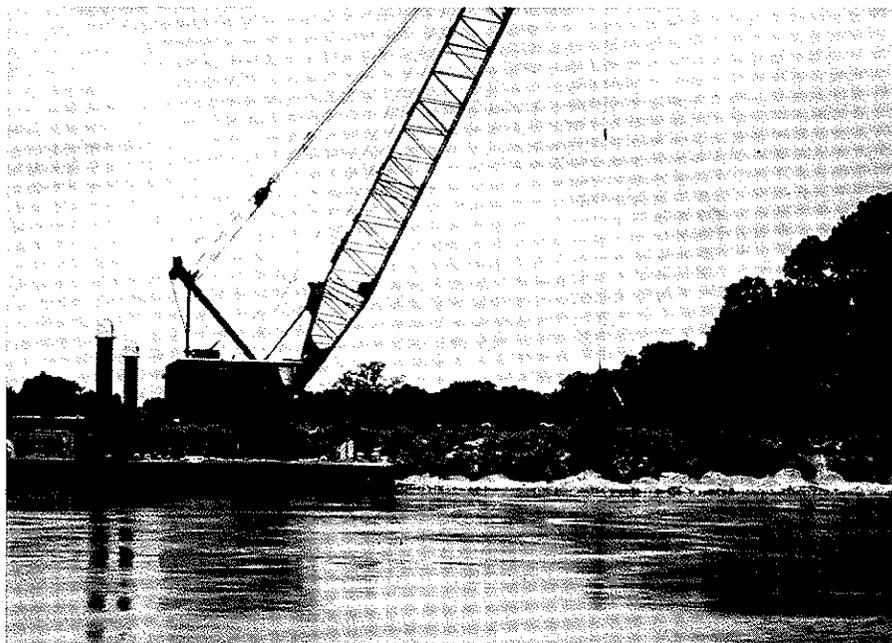
Figure 49. Floating plant construction

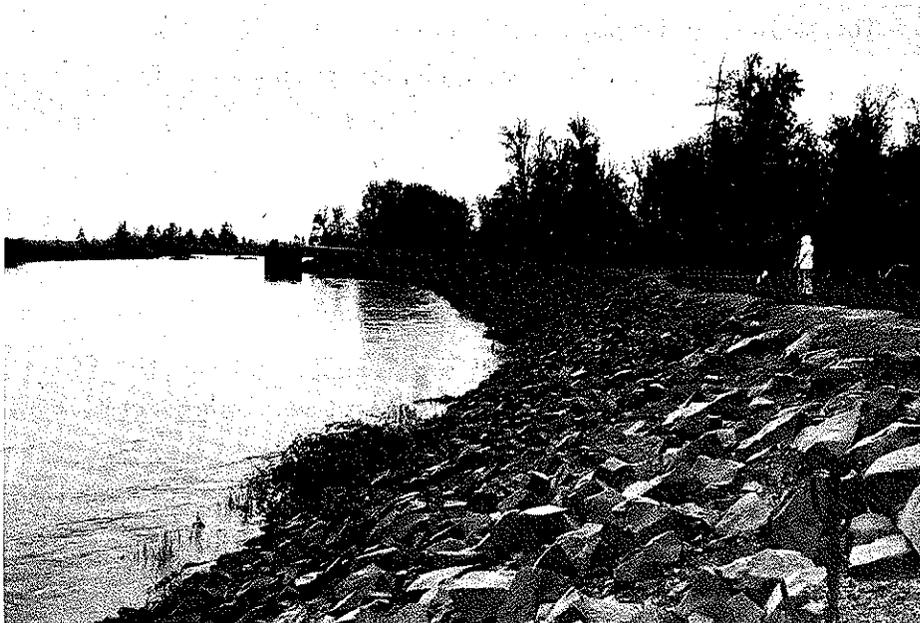
Figure A2. Stone revetment along the Willamette

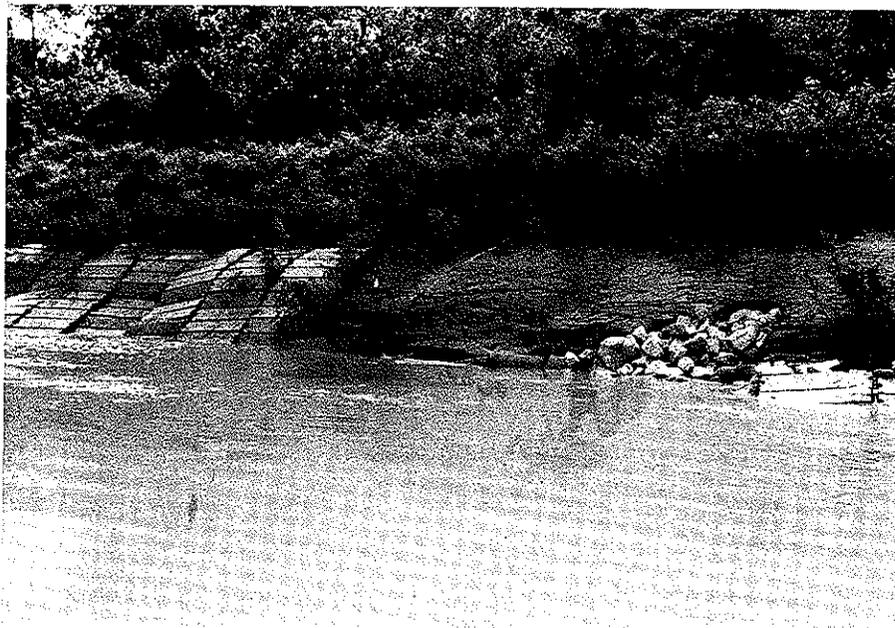
Figure A7. Articulated concrete mattress
on the lower Mississippi

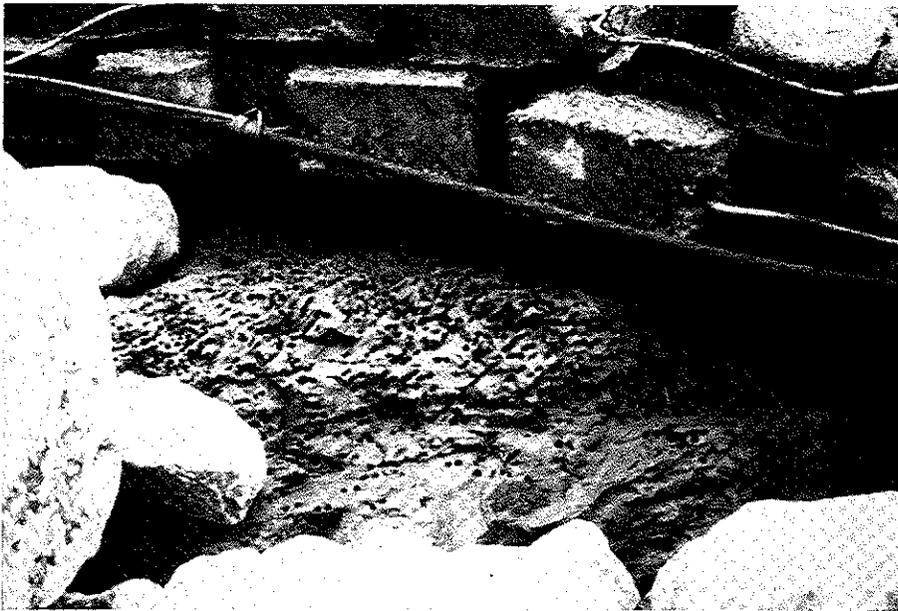
Figure A8. Mayfly burrows under ACM revetments
