Evapotranspiration, Water Table Fluctuations, and Riparian Restoration

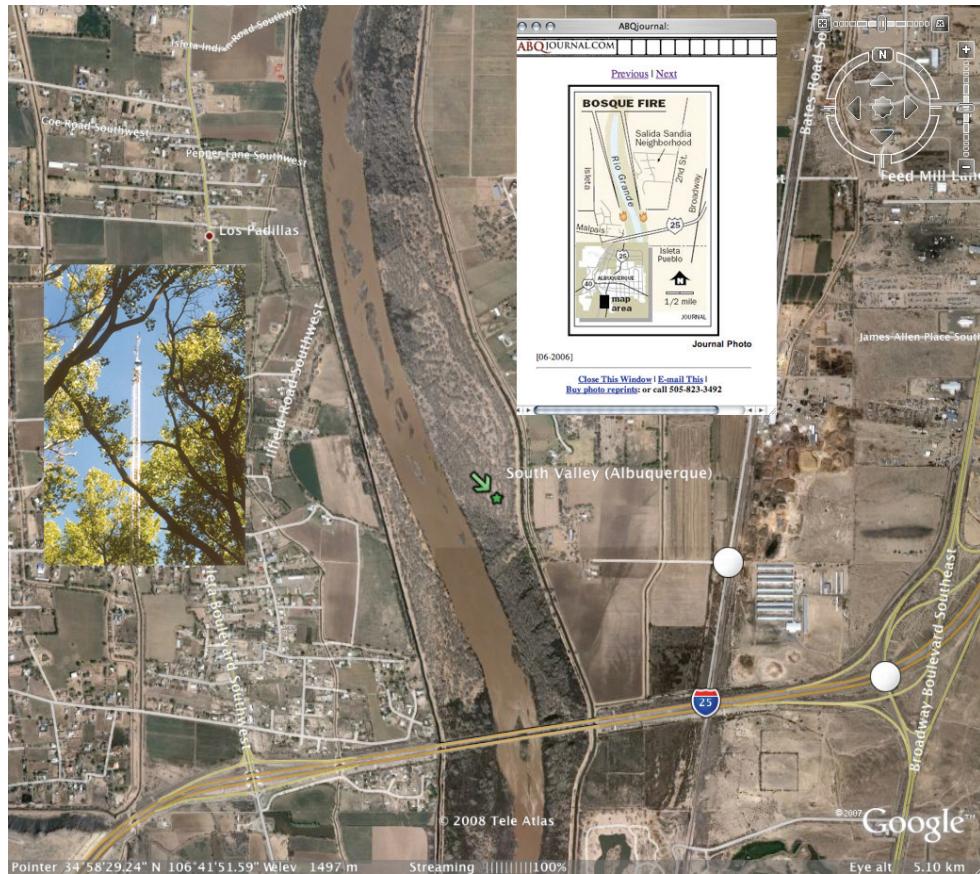
Map showing location of Albuquerque, NM evapotranspiration (ET) tower. Insets show the 25-m tower with instruments and the bosque (riparian zone) fire in June 2006 south of the tower site.
